# Service Bulletin

**Subject:** Creak or Pop Type Noise Coming from Windshield Area During Cold Ambient Temperatures

**Models:** 2011-2015 Chevrolet Equinox  
2011-2015 GMC Terrain  
Vehicles Built Prior to October 14, 2014

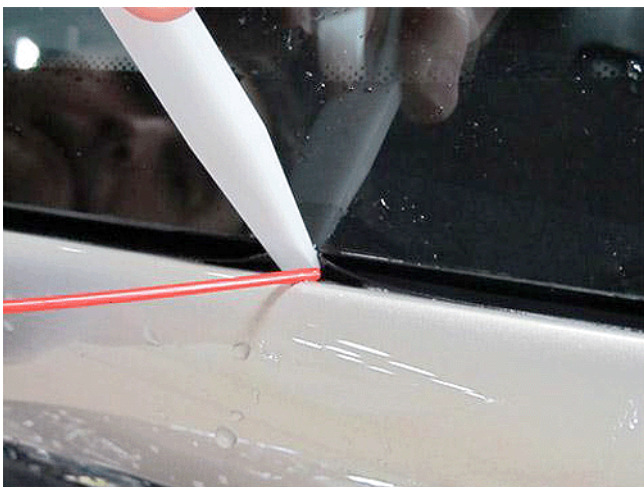
If the noise is coming from the upper windshield area, the condition may be caused by the windshield exterior molding binding with the windshield glass and/or the windshield opening. If the noise is coming from the base of the windshield, there may be a bind condition between the inside of the windshield glass and the foam seal at the front of the instrument panel upper trim panel.

If the noise is heard in the area surrounding the upper windshield area, spray GM Super Lube up and under the lip of the outside windshield molding.

1. Using a plastic trim stick, lift the windshield molding away from the windshield opening exterior surface.
