Service Bulletin

Bulletin No.: PI1488

Subject: Service Adaptive Headlamp Message Displayed, DTCs B257C and B257D

Models: 2013-2015 Cadillac ATS

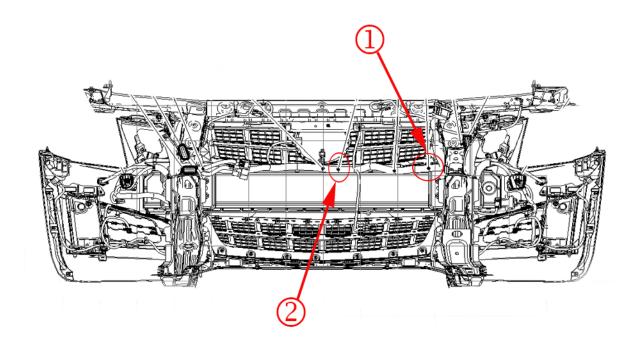
These codes may be caused by corrosion in splices J104 and/or J102 in the forward lamp harness.

- 1. J102
- 2. J104
- 2. Inspect both splices for corrosion. The locations are illustrated above.
- **3.** If corrosion is present, replace the forward lamp harness.

Important: General Motors does not recommend repair of this harness. Replacement of the harness is necessary.

- 4. If corrosion is not present, continue with diagnoses. Refer to the appropriate Service Information.
- 5. Reinstall the front bumper fascia. Refer to the Front Bumper Fascia Replacement in SI.
- 6. Clear all related codes.
