Service Bulletin

Subject: GM of Canada OnStar® Cellular Communication Upgrade

Models: 2000-2014 GM Passenger Cars and Light Duty Trucks
2015 Buick Enclave
2015 Cadillac Escalade Models (Built W/O VV4)
2015 Chevrolet Camaro, Express, Traverse
2015 Chevrolet Silverado 2500/3500, Suburban, Tahoe (Built W/O VV4)
2015 GMC Acadia, Savana
2015 GMC Sierra 2500/3500, Yukon Models (Built W/O VV4)
Equipped with OnStar® (RPO UE1)

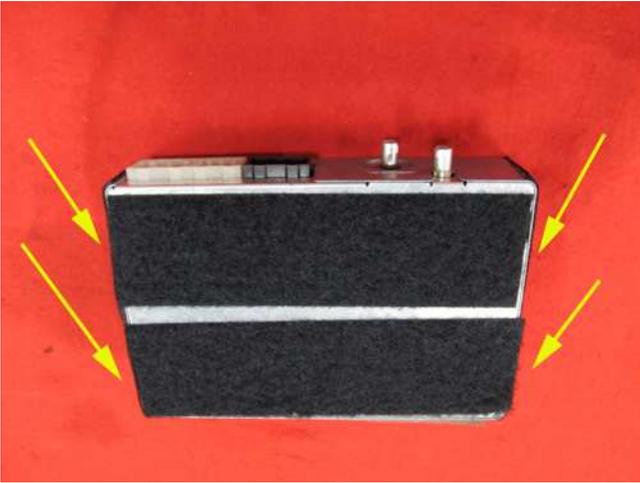
Note: After the removal of the original OnStar® module, modification of the new module is required to secure the module into place.

2. Obtain two strips, approximately 177 mm (7 inches) in length, of 2" Velcro® 191195 Reclosable Loop Fastener Tape (hook and loop) or equivalent and apply one side of the tape to the bottom of the module as shown above.

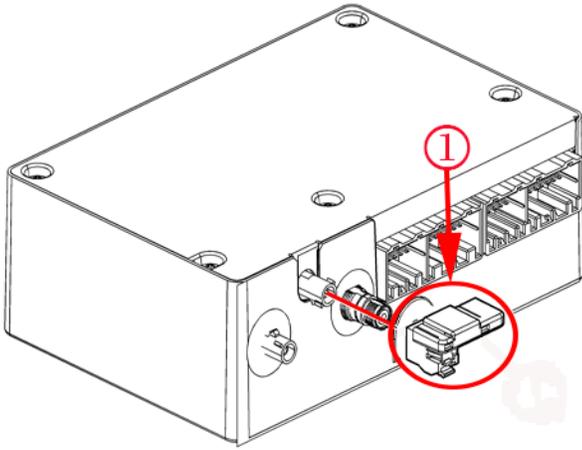
- During the installation of the OnStar® 3G/4G LTE module there may be interference with the module to the bracket not allowing the module to fully seat into place. If this occurs please refer to the “OnStar® Module Bracket Modification” section at the end of this bulletin.

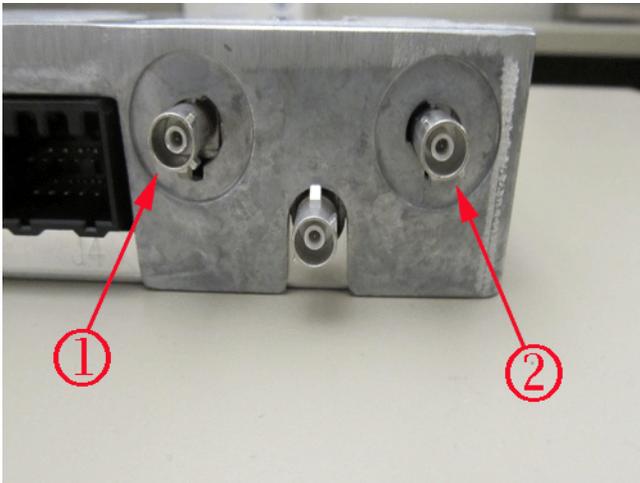
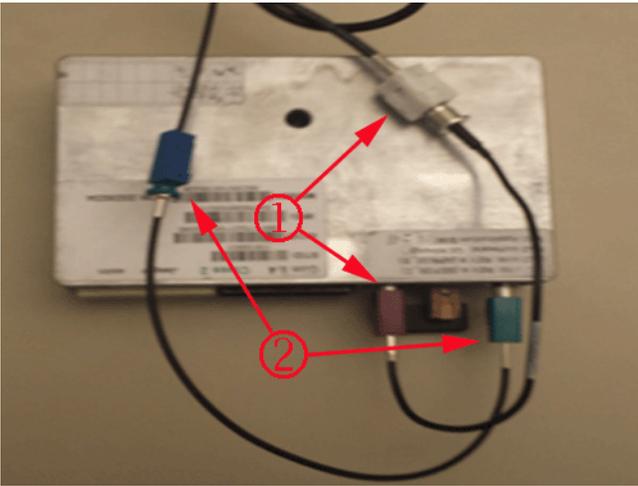
Note: The vehicle may have two different configurations, with or without UHF cable. Use the appropriate procedure below:

4. If the vehicle requires a UHF adaptor cable (P/N 23242478) proceed with this step:
 - 4.1. Install the UHF adapter cable (P/N 23242478) to the antenna connector (1) of the module.
 - 4.2. Install the female to male cable (P/N 23242476) to the module (2).
 - 4.3. Connect the UHF adapter (1) and the female to male (2) connector to the vehicle cables.

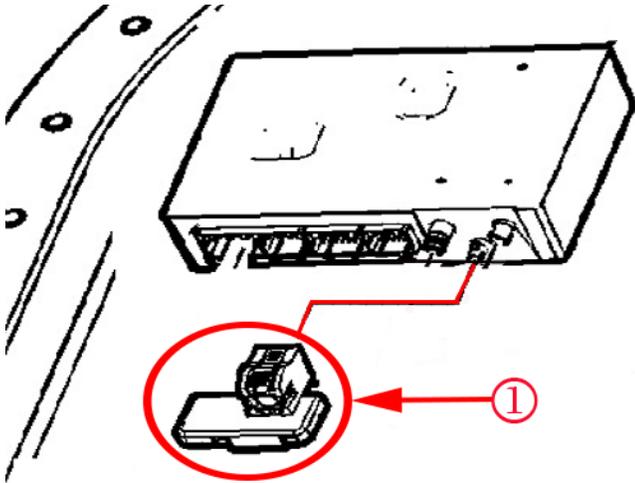
- During the installation of the OnStar® 3G/4G LTE module there may be interference with the module to the bracket not allowing the module to fully seat into place. If this occurs please refer to the “OnStar® Module Bracket Modification” section at the end of this bulletin.
 - Some modules are not as thick as the original modules and require installation of foam to the mounting bracket to prevent movement of the module. Refer to the “OnStar® Bracket Modification” section at the end of this bulletin
 - For labor time adjustment for the modification, please refer to the “OnStar® Bracket Modification” section at the end of this bulletin for information.
2. If installing the modules P/N 23230482, 23230536, 23230537, 23235220, 23235227, 23235234 and 23383877, transfer the Bluetooth Antenna(1), if equipped, to the new module.

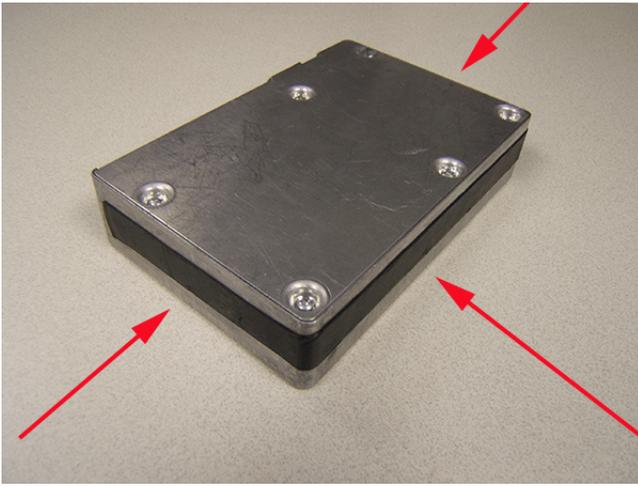
Note: Wrapping the module with rubber tape will help prevent movement in the bracket after installed.

Wrap the new module with Scotch™ Linerless Rubber Splicing Tape 130C, 19 mm (¾ in) wide, (rubber tape) or equivalent from left to right, covering the back side of the module as illustrated.
