Service Bulletin

PRELIMINARY INFORMATION

Subject: Information on Convertible Top Operation Below 0°C (32°F) in Snow, Rain or After Wet Conditions - Ice Formation in Water Management Bag

Models: 2011-2015 Chevrolet Camaro Convertible

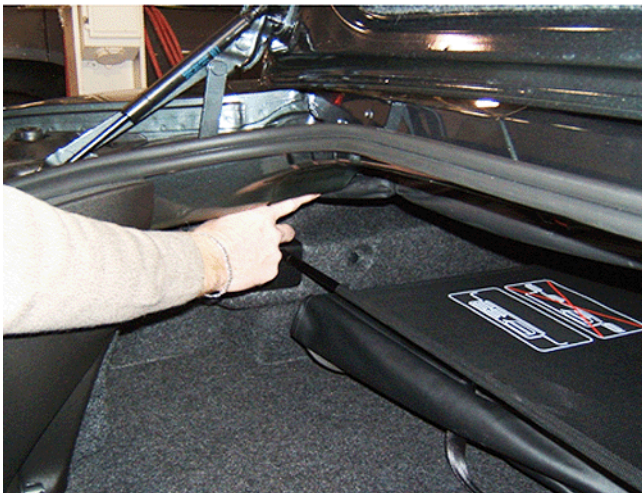
1. Open the trunk and access the water management bag in the rear compartment. The low points of the bag will be on the left and right sides of the vehicle.

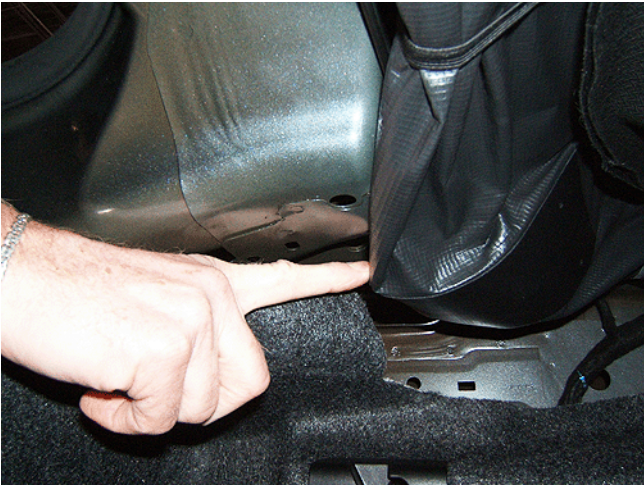
2. Squeeze the lowest locations of the water management bag (left side shown in the graphic above) listening and feeling for any indication of ice. If ice is present, DO NOT lower the convertible top until the ice has melted.

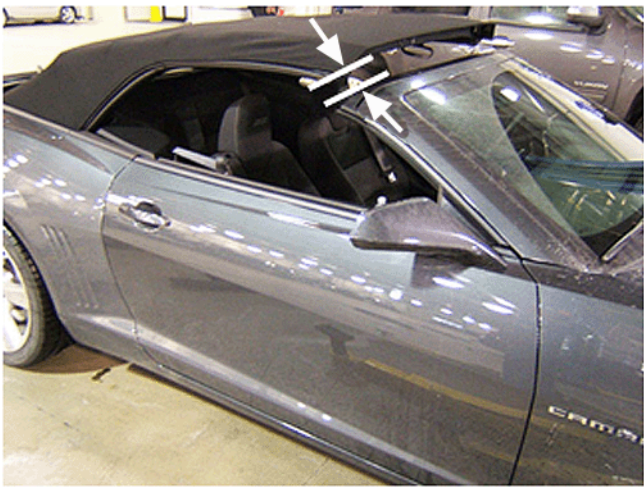
3. Carefully start to lower the convertible top and stop movement when the top is approximately 100mm (4 in) from the windshield header.

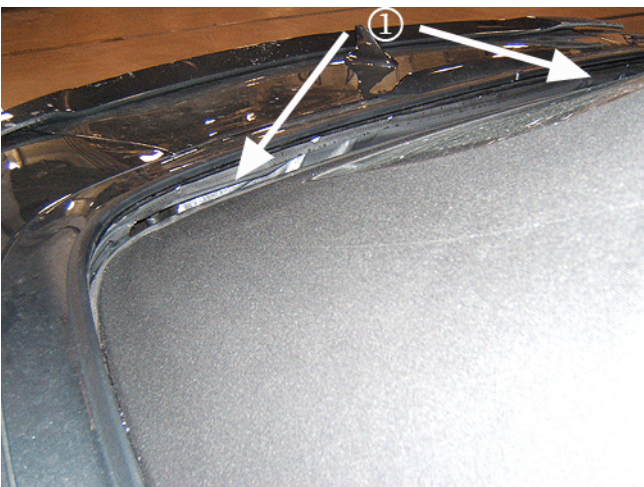
4. Inspect both sides of the water management bag for possible ice formation in the areas below the rear glass (1). If any ice is present, DO NOT lower the top any farther until the ice has melted.
