Bulletin No.: PI0406B

Service Bulletin

Subject: General Guidelines for Inspection of Convertible Water Management Bag Anytime Folding Top is Removed

Models: 2011-2015 Chevrolet Camaro Convertible

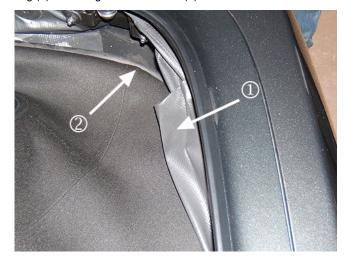
Dealership personnel should NOT operate the folding top until the water management bag can be inspected. The inspection is needed to ensure that the bag material is not bunching in the corners, which may create an interference with the folding top #5 bow during cycling. Two examples of the water management bag (1) interfering with the #5 bow (2) travel are shown below:

Failure to assure proper clearance of the folding top to the water management bag could result in damage to the #5 bow and/or brackets.

1. Start cycling the folding top with one person operating the top switch inside the vehicle, and a second person pushing down on the rear #5 bow.

- 2. Slowly cycle the top until the rear seal on the #5 bow clears and drops below the four studs (areas shown circled above) retaining the folding top stowage compartment bracket on each side.
- 3. Further cycle the folding top open and release the switch to stop travel in the mid-open position.

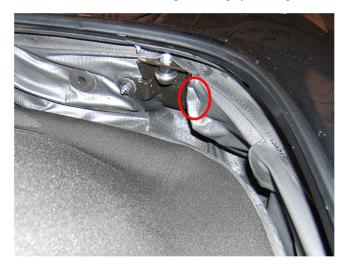
6. Inspect both side corners of the water management bag for excess bunching. If the bag pleats are able to be pulled inboard covering the outboard stud on the stowage compartment bracket (as shown circled in the graphic above), the excess material will need to be repositioned following the steps below:

- 4. Manually open the trunk using the cylinder located in the left quarter trim panel and the ignition key.
- 5. Finesse the fit of the water management bag by reaching inside the trunk and pulling any excess material downward on both sides.

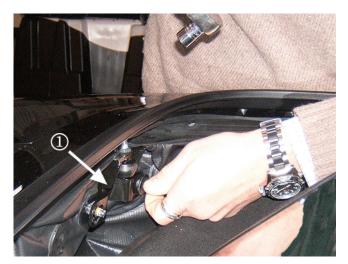
**6.6.** The repositioned water management bag should look like the view shown above. The bag should be positioned completely outboard the #5 bow seal (1), and should have no interference with the bow/seal during top cycling.

- **6.1.** Mark the position of the stowage compartment bracket on the affected side(s).
- 6.2. Remove the stowage compartment bracket retaining nuts and bracket (1) on the affected side(s).

**6.3.** Gather together several of the excess pleats/folds of bag material.

**6.4.** Push the pleats toward the trunk, then pull the pleats and bag material taut, and position the folds next to the outboard bracket stud.

**6.5.** Reinstall the stowage compartment bracket(s), capturing the folds beneath the bracket, and tighten the nuts.

Tighten: Tighten the bracket nuts to 23 Y (17 lb ft).
