# Service Bulletin

**Subject:** Loss of High Speed GMLAN Communications, Intermittent No Crank, IP Gage Fluctuation, Intermittent Door Lock Cycling, Intermittent Chime Operation, Various IP Warning Lamps Illuminated, Transmission May Not Shift, Engine May Stall, Communication DTCs U0073, U0100, U0101, U0102, U0109, U0121 or U0140 Set (Repair Terminals in Transmission Harness Connector, Repair Open or Shorted GM High Speed LAN Circuits, Open or Shorted Data Link Resistor, Corrosion or Poor Connections in Various Control Module Connectors)

**Models:** 2007-2009 Cadillac XLR  
2007-2014 Cadillac Escalade Models  
2009-2013 Cadillac Escalade Hybrid  
2007-2013 Chevrolet Avalanche, Silverado 1500  
2007-2014 Chevrolet Corvette, Silverado 2500/3500, Suburban, Tahoe  
2008-2013 Chevrolet Silverado Hybrid, Tahoe Hybrid  
2007-2013 GMC Sierra 1500  
2007-2014 GMC Sierra 2500/3500, Yukon Models  
2008-2013 GMC Sierra Hybrid, Yukon Hybrid  
2008-2009 HUMMER H2  
Equipped With Gasoline Engine and 6 Speed Automatic Transmission 6L80 (RPO MYC) or 6L90 (RPO MYD)  
Equipped With Hybrid Propulsion (RPO HP2) and Two Mode 2ML70 Automatic Transmission

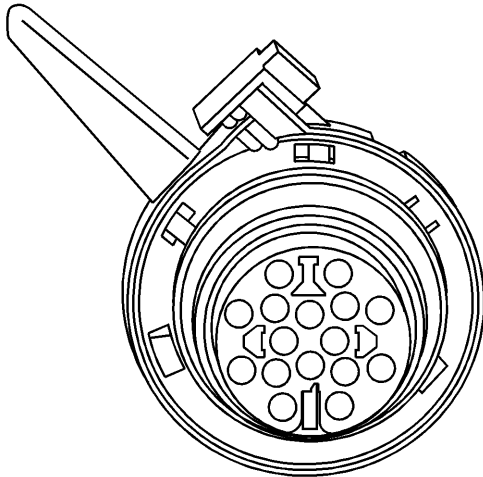
5. **Before** disconnecting the 16-way connector, **inspect** for any backed out terminals (1) as shown. Fully seated terminals (2,3) are shown for comparison.
  - 5.1. If a backed out terminal (1) is found, identify the terminal(s) on the **repair order**.
  - 5.2. Look at the connector in order to identify the number of the cavity with the backed out terminal. Refer to Wiring Systems and Power Management > Component Locator > Master Electrical Component List in SI.

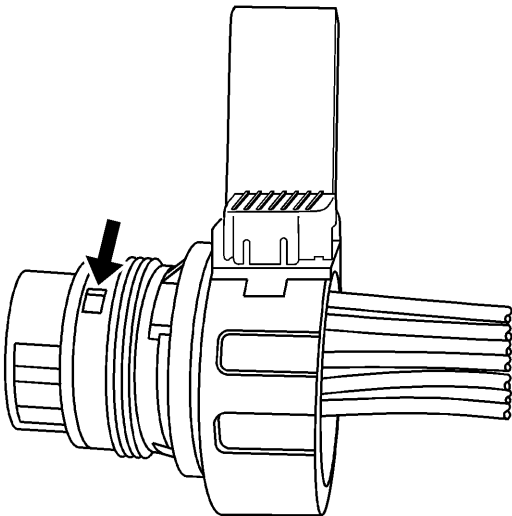
7. **Inspect** for any backed out terminals (3) as shown. Fully seated terminals (1,2) are shown for comparison.
  - 7.1. If a backed out terminal (3) is found, identify the terminal(s) on the **repair order**.
  - 7.2. Look at the connector in order to identify the number of the cavity with the backed out terminal. Refer to Wiring Systems and Power Management > Component Locator > Master Electrical Component List in SI.
8. Repair or replace the terminal(s) as necessary using the following procedure:

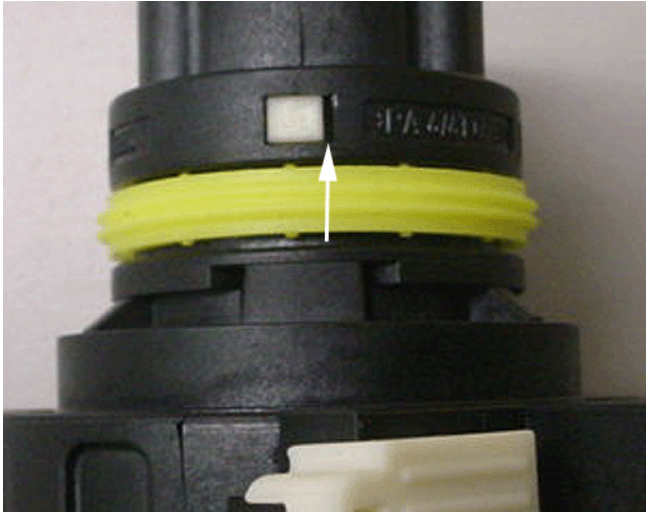
- If the TPA is off-center in the check window as shown, then it is only partially seated. Note the large gap at the arrow. Reseat the TPA lock and ensure that it is fully seated.

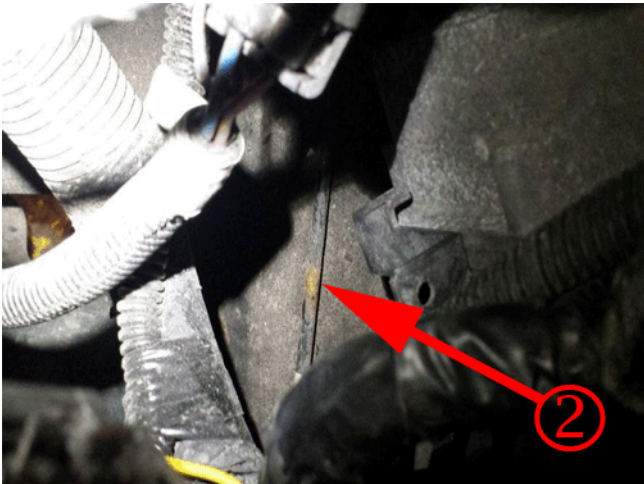
2. Brake Pipe That's Subject to Rubbing
3. Inspect for chafed, damaged, pinched, open or shorted wiring on the engine harness in areas illustrated above.
  - ⇒ If the wiring is damaged, repair as needed. Refer to Power and Signal Distribution > Wiring Systems and Power Management > Diagnostic Information and Procedures in SI. Protect the harness by covering any sharp edge with butyl tape and the harness with woven polyester (PET) electrical tape. Secure the harness as needed.
4. Connect the negative battery cable. Refer to Battery Negative Cable Disconnection and Connection in SI.
5. Clear any DTCs that may be present with a scan tool and verify the proper operation of the vehicle.

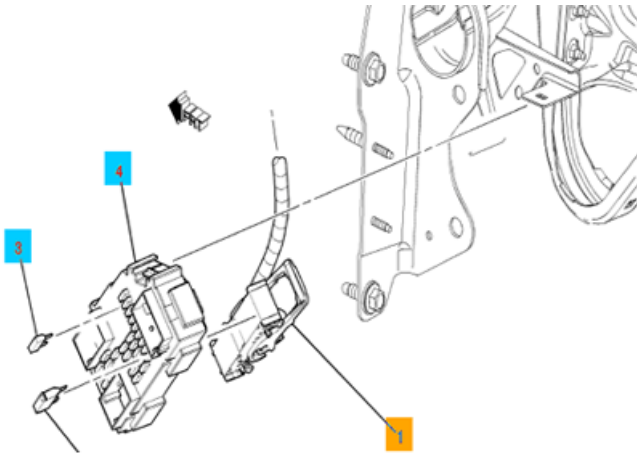
4. Inspect connector X1 (1) on the back of the fuse block for a loose connection. Secure the connector as needed.
5. Install the left side fuse block.
6. Connect the negative battery cable. Refer to Battery Negative Cable Disconnection and Connection in SI.
7. Clear any DTCs that may be present with a scan tool and verify the proper operation of the vehicle.

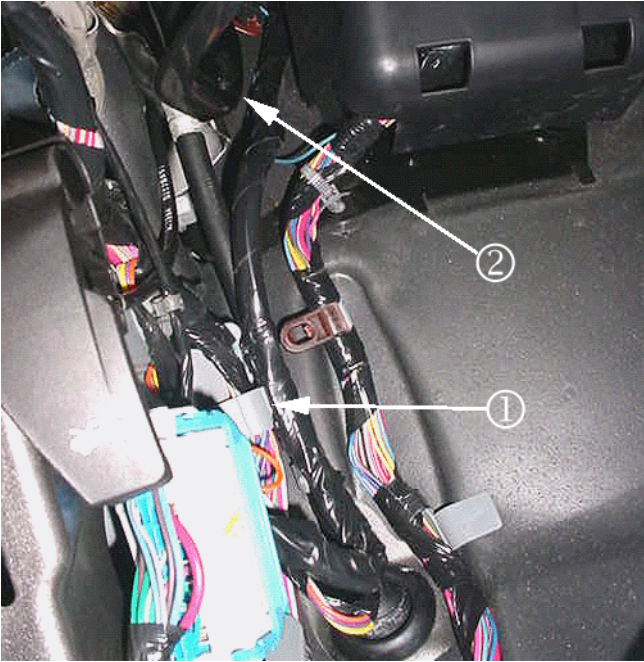
- The IP wiring branch to C202 may have been routed outboard of the junction block (left IP) and the retaining clip (1) off the branch may not have been fully seated. Possible point of contact (2).

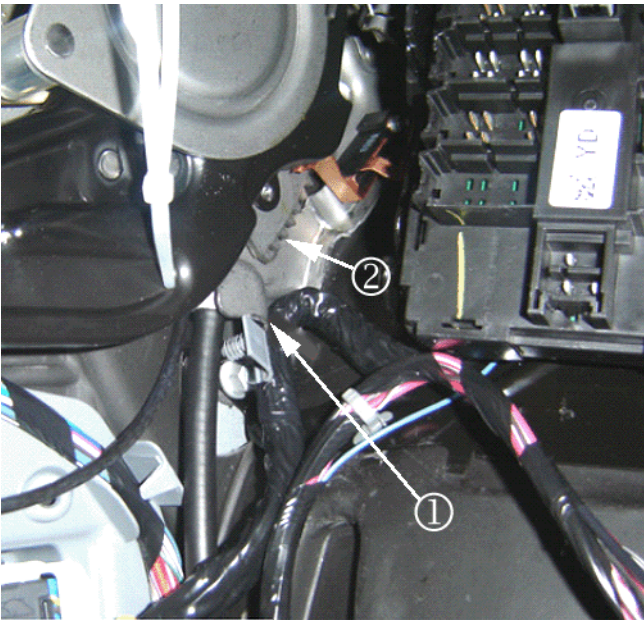
- The IP wiring branch to C202 may have been pushed up and forward into the park brake assembly and the retaining clip off the branch may not have been fully seated. Possible points of contact (1, 2).

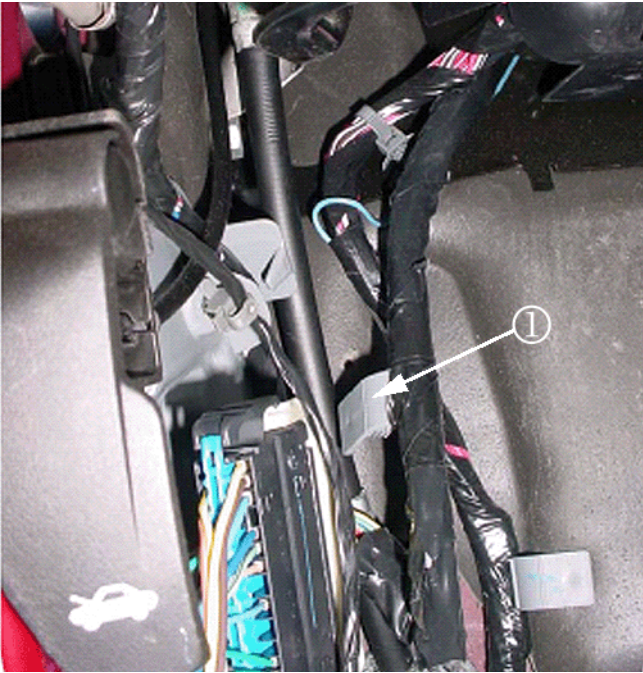
- The IP wiring branch to C202 may not have been secured into place as the gray retaining clip (1) off the branch was never seated.

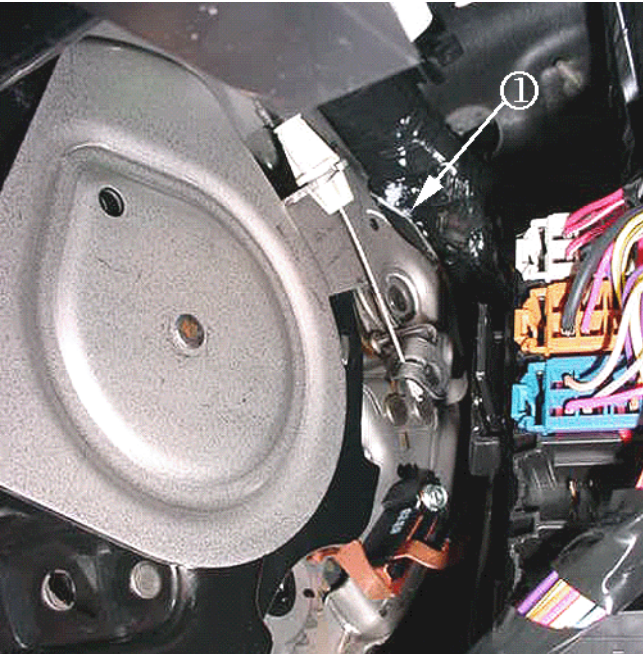
- The IP harness may be in hard contact with the top rear edge (1) of the park brake assembly.

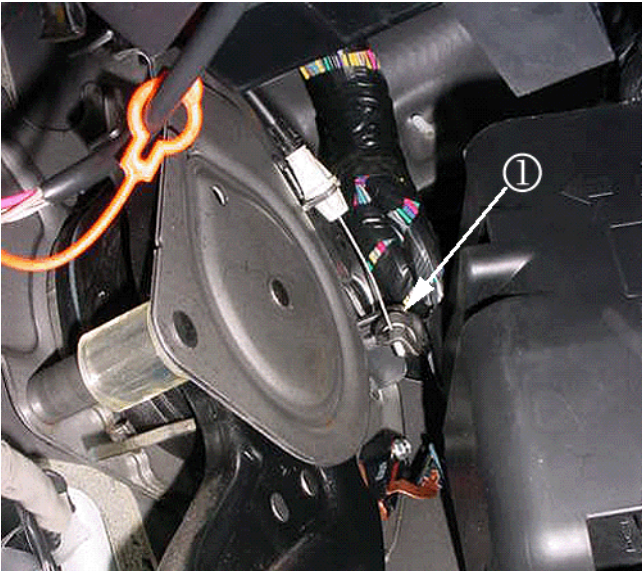
- When releasing the park brake pedal, the moving part (1) at the end of the park brake release cable may be coming into hard contact with the IP harness.

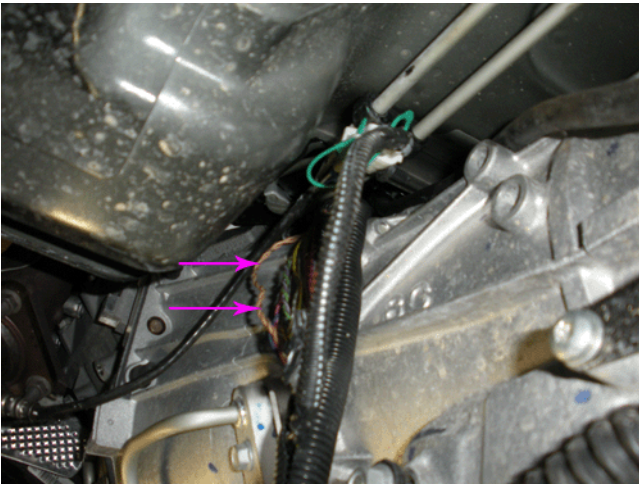
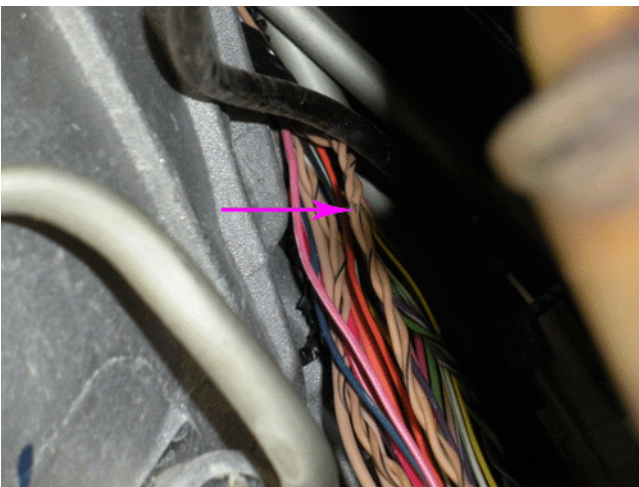
8. Examine the harness for wiring that may be exposed outside of the conduit. Inspect all areas for chafed, damaged, pinched, open or shorted wiring as shown. If damage to the wiring is not observed, then extract the wiring from the conduit and inspect all remaining areas as needed.

- ⇒ If the wiring is damaged, repair as needed. Refer to Power and Signal Distribution > Wiring Systems and Power Management > Diagnostic Information and Procedures > Wiring Repairs in SI. Protect the conduit by covering any sharp edge with butyl tape and the harness with woven polyester (PET) electrical tape. Secure the harness as needed.

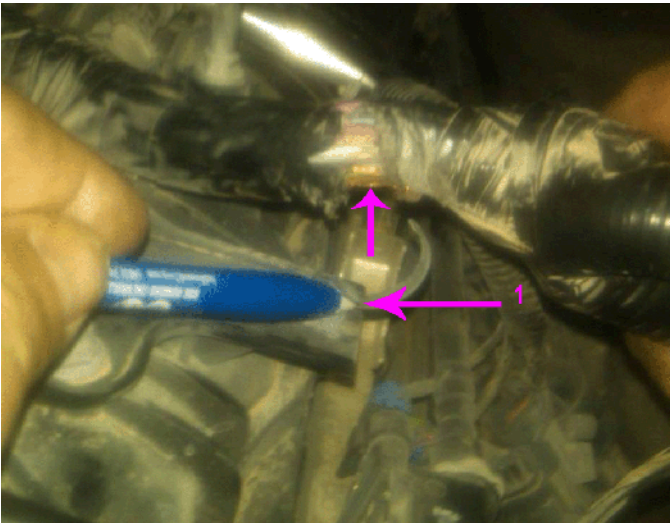
4. Inspect the wiring harness for damage from contact with the steel bracket (1).
  - ⇒ If the wiring is damaged, repair as needed. Refer to Power and Signal Distribution > Wiring Systems and Power Management > Diagnostic Information and Procedures > Wiring Repairs in SI.
5. Cover any sharp edge on the bracket with butyl tape and the harness with woven polyester (PET) electrical tape.

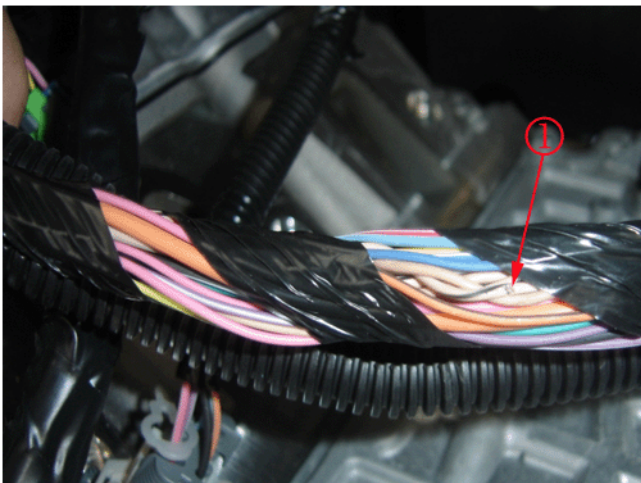
Inspect for chafed (1), damaged, pinched, open or shorted wiring. If damage is not observed, then extract the wiring from the conduit and inspect all of the remaining areas as needed.

⇒ If the wiring is damaged, repair as needed. Refer to Power and Signal Distribution > Wiring Systems and Power Management > Diagnostic Information and Procedures.

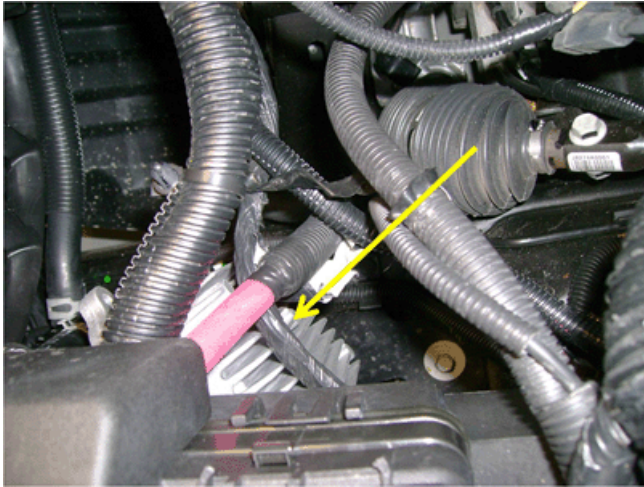
4. Inspect for a misrouted harness having chafed, damaged, pinched, open or shorted wiring from rubbing on the cooling fins of the Transmission Auxiliary Fluid Pump Control Module as shown.
- ⇒ If the wiring is damaged, repair as needed. Refer to Power and Signal Distribution > Wiring Systems and Power Management > Diagnostic Information and Procedures in SI. Protect the conduit by covering any sharp edge with butyl tape and the harness with woven polyester (PET) electrical tape. Secure the harness as needed. Proceed to Step 8.
- ⇒ If the wiring is not damaged, proceed to Step 5.

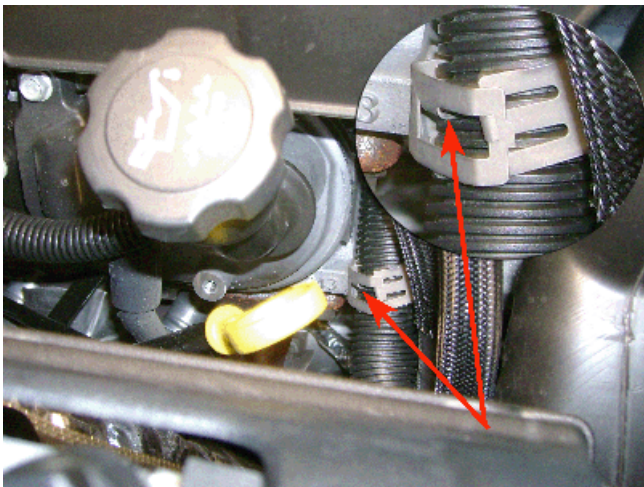
5. Inspect for chafed, damaged, pinched or shorted wiring caused by a mispositioned harness retaining clip as shown. This condition usually occurs when the tab of the clip is aligned with a slot in the conduit.

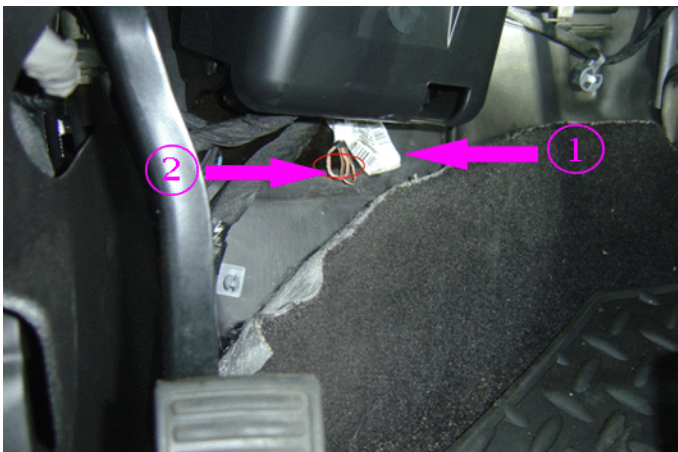
5. Inspect the jumper harness loop connector (1) for chafed (2), damaged, pinched, open or shorted wiring from contact with the IP brace.
  - ⇒ If the wiring is damaged, repair as needed. Refer to Power and Signal Distribution > Wiring Systems and Power Management > Diagnostic Information and Procedures in SI. Protect the harness by covering any sharp edge with butyl tape and the harness with woven polyester (PET) electrical tape. Secure the jumper harness loop connector as needed. Proceed to Step 6.

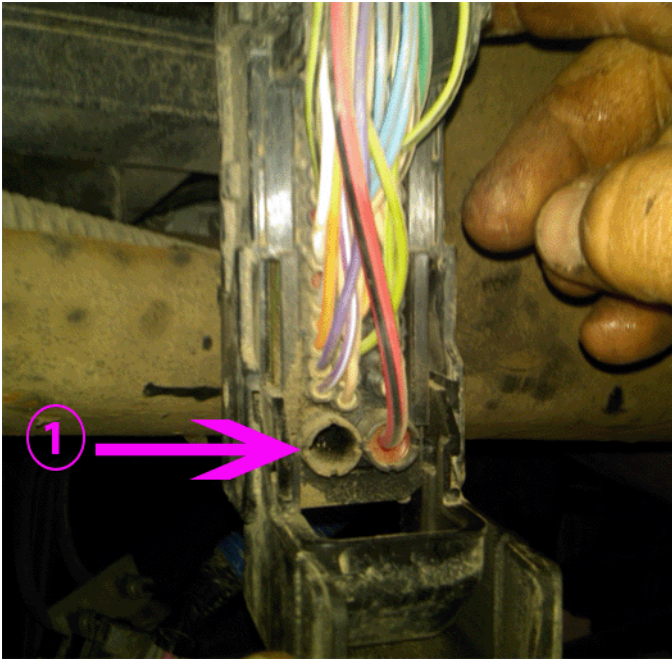
4. Inspect the connector of the ESC module for weather plugs that are missing from: **Not Used** cavities (1). Refer to > Power and Signal Distribution > Wiring Systems and Power Management > Component Locator > Master Electrical Component List > Electronic Suspension Control (ESC) Module > Connector End View for a list of cavities that are: **Not Used**.  
⇒ If a weather plug is missing from any **Not Used** cavity, repair as needed.
5. Install the connector (2) to the ESC module (1).
6. Clear any DTCs that may be present with a scan tool and verify the proper operation of the vehicle.

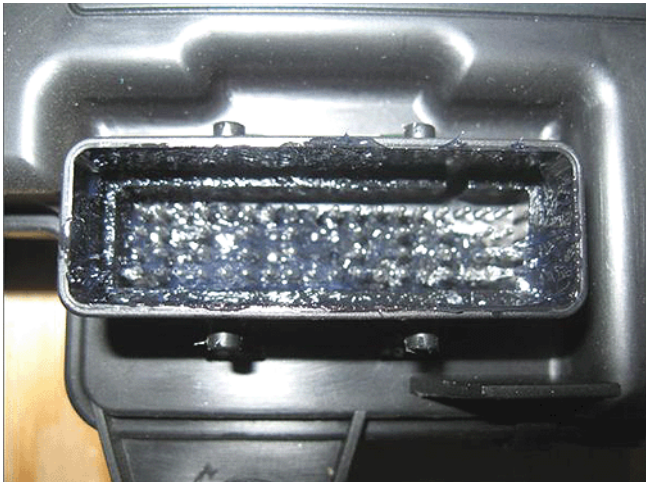
2. **DO NOT** apply an excessive amount of dielectric lubricant as shown, to the connectors as hydrolock may result when attempting to mate the connectors. This could cause terminals to back out, resulting in an intermittent connection.
