Service Bulletin

PRELIMINARY INFORMATION

Subject: Water Present on Front Passenger Floor, A/C Drain Hose Not Positioned Correctly

Models: 2014-2015 Cadillac ELR
2011-2015 Chevrolet Volt

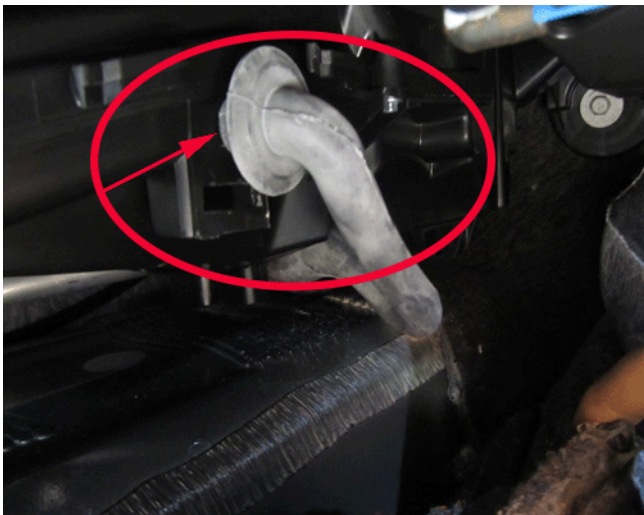
Note: Shown in the illustration above is where the plant temporary installs the A/C hose during Instrument panel installation. Do not drill out the

temporary holder for any reason.

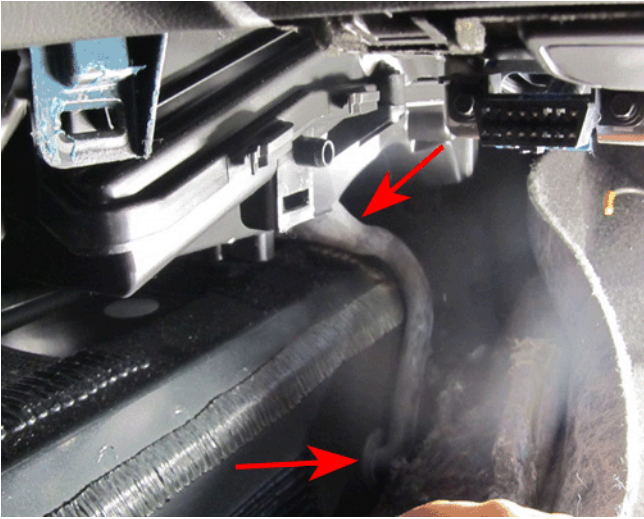
Note: Shown in the illustration above is the A/C hose properly installed onto the correct drain port.
