Service Bulletin

Subject: Diagnostic Tips for DTC P0741: Torque Converter Clutch Stuck Off

Models: 2015 Chevrolet Colorado
2015 GMC Canyon
Equipped with 6L50 Automatic Transmission (RPO MYB)

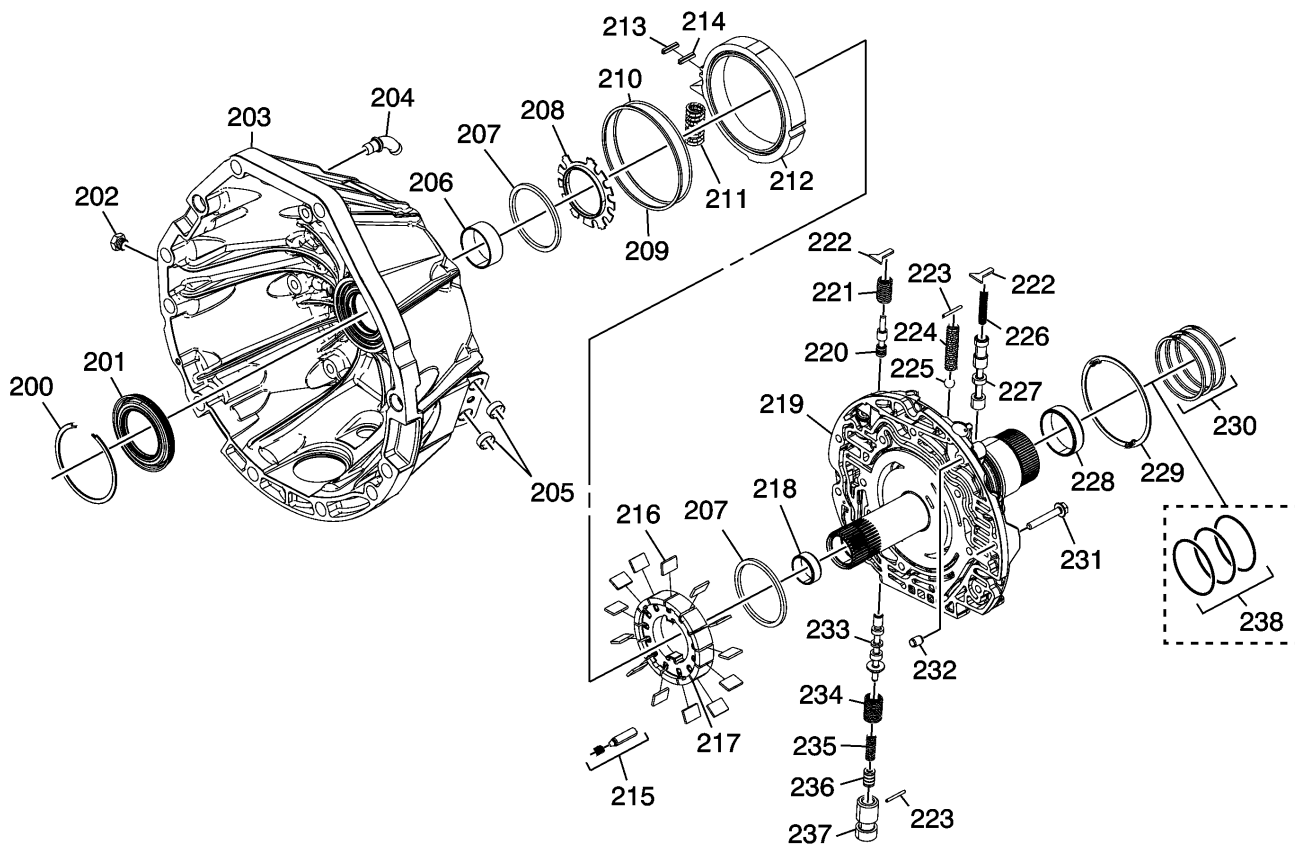
This condition may be caused by a damaged turbine shaft front bushing (218). The turbine shaft may also be damaged in the journal area that is in contact with this bushing.

Disassemble the pump to inspect the turbine shaft front bushing (218). If the bushing is damaged, replace the pump cover and the 4-5-6 (w/Turbine Shaft) Housing Assembly (441).
