# Service Bulletin

## PRELIMINARY INFORMATION

**Subject:** Engine Rough Run with Check Engine Light (CEL) On/Low Compression on Cylinder with Misfire, DTC P0300 Set

**Models:** 2013 Cadillac ATS  
2013 Chevrolet Malibu  
Equipped with 2.0L Turbo Engine (RPO LTG)

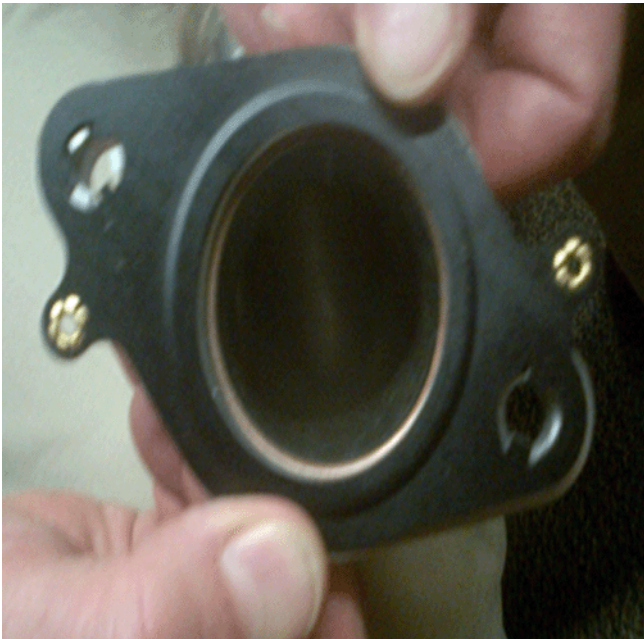
**Note:** When installing the turbo outlet gasket, make sure to position on the studs correctly as shown in the illustration above.

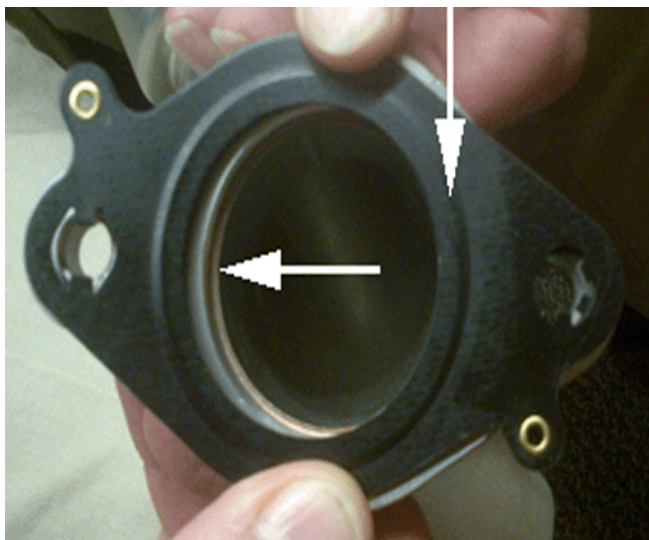
**Note:** If the gasket is flipped, as shown in the illustration above, it will reduce the outlet flow.
