Service Bulletin

Subject: Wiper Blades Skip/Chatter Across Windshield

Models: 2015 Chevrolet Colorado
2015 GMC Canyon
Built Between October 1-31, 2014

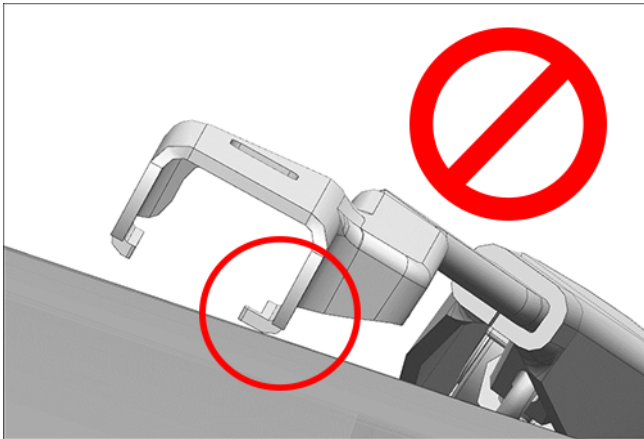
Technicians may find the wiper arm(s) to be twisted in the incorrect direction, affecting the wiper blade angle, causing the wiper blade element to bind during operation.

Incorrect Wiper Arm Angle

If this condition exists, replace the affected wiper arm(s). Refer to the Windshield Wiper Arm Replacement in SI.

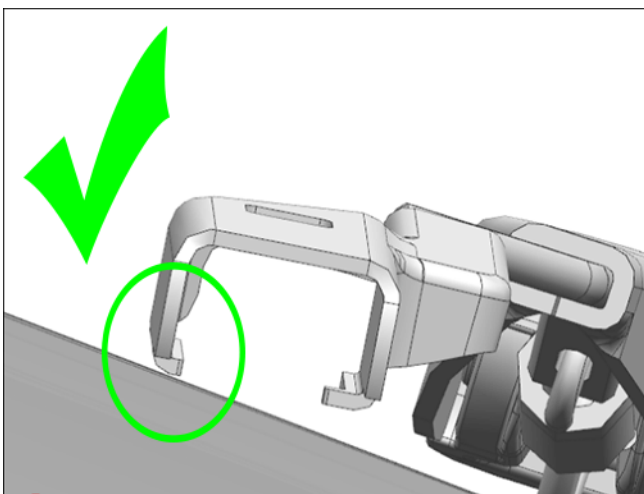
Correct Wiper Arm Angle
