# Service Bulletin

**Subject:** Intermittent Clicking/Rubbing Noise when Side Door Glass is Moving Up or Down at Cold Temperatures

**Models:** 2015 Cadillac Escalade  
2015 Chevrolet Silverado, Suburban, Tahoe  
2015 GMC Sierra, Yukon, Yukon XL

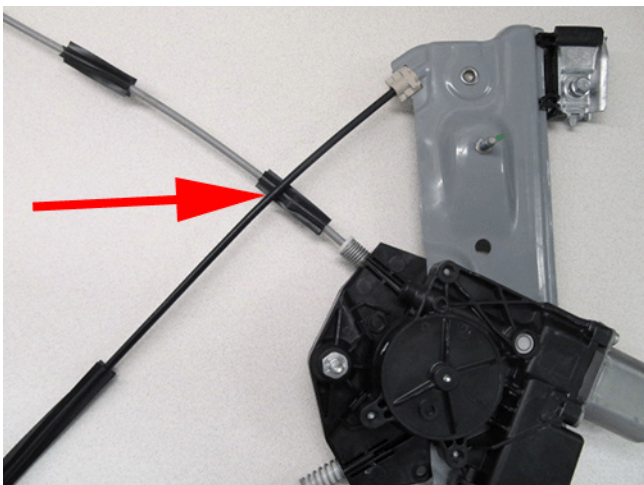
This may be caused by an incorrectly routed window regulator cable, causing a noise that could be described as a click or rub.

1. Remove the affected door trim panel and visually inspect the window regulator cables location. Refer to the correct door trim panel replacement procedure in SI.
  - If the grey window regulator cable is located on the inner side of the black regulator cable, continue diagnosis referring to SI.

- If the grey window regulator cable is located on the outer side of the black regulator cable as illustrated above, continue on to Step 2.
2. Remove the window regulator from the affected door. Refer to the correct window regulator replacement procedure in SI.
