# Service Bulletin

**Subject:** IPC Gauges Sweep, Loss of Power Steering Assist, Intermittent No Crank, Reduced Engine Power and Multiple U-Codes

**Models:** 2013-2015 Cadillac XTS, XTS Professional  
2014-2015 Chevrolet Impala (VIN 1)  
Built Prior to March 26, 2015

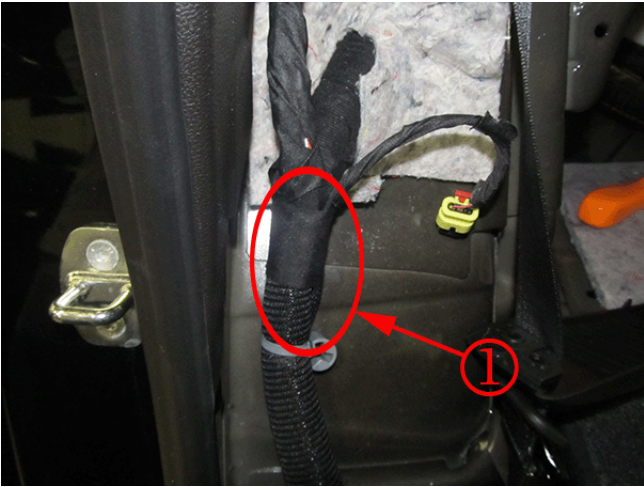
These symptoms may be caused by the right rear seat back bolster bracket contacting the body harness. The bracket may have rubbed passed the anti-abrasion tape and wiring insulation causing a short to ground.

3. Inspect the body harness (1) at this section above for any evidence of affected wiring.
4. If no evidence of bracket interference, continue diagnosis. Refer to the appropriate Service Information.
5. Repair the wire or wires as necessary. Refer to the Wiring Repairs in SI.
6. Rewrap that section of the body harness with woven polyester electrical tape (PET) or equivalent anti-abrasion tape or electrical tape.
