Service Bulletin

PRELIMINARY INFORMATION

Subject: Vehicle Rides Rough and/or Fluid Leak from Rear of Vehicle Near Tire

Models: 2015 Chevrolet SS

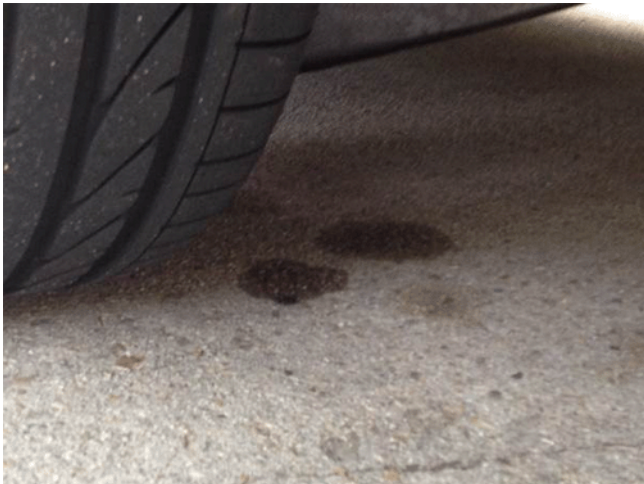
Some customers may comment that the vehicle rides rough in the rear and/or that the vehicle is leaking from the rear shock absorber location. This may be caused by a defective seal within the rear shock absorber, leaving particles which will not allow the absorber to work as intended.

If you encounter a vehicle with the above concern, visually inspect for a leaking rear absorber.

Replace the affected shock absorber. Refer to Shock Absorber Replacement in SI.
