Service Bulletin

PRELIMINARY INFORMATION

Subject: Exhaust Leak or Vibration/Rattle Noise at Approximately 900 RPM, Fuel Smell, White Smoke, Oily Substance on Exhaust Downpipe

Models: 2011-2015 Chevrolet Express 2500/3500/4500, Silverado 2500HD/3500HD
2011-2015 GMC Savana 2500/3500/4500, Sierra 2500HD/3500HD
Equipped with 6.6L Duramax® Diesel Engine (RPOs LML or LGH)

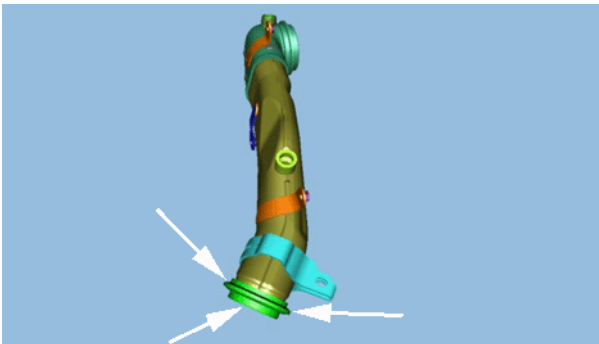
Note: The illustration above is the updated turbocharger exhaust pipe with a pilot flange.

If the above alignment procedure does not correct the condition, the turbocharger exhaust pipe may need to be replaced on trucks built prior to the breakpoints listed below with an updated turbocharger exhaust pipe with a pilot flange. If the turbocharger exhaust pipe has the new flange, you should not need to replace it. Refer to the Turbocharger Exhaust Pipe Replacement procedure in SI.

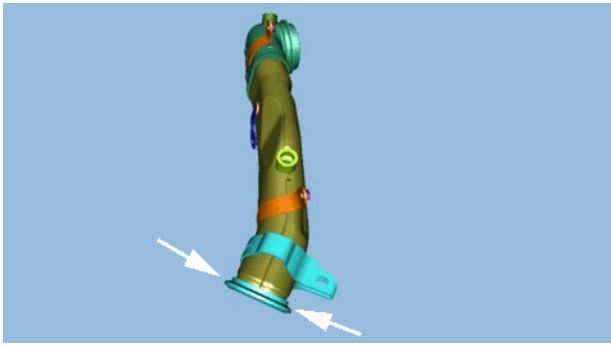
Note: The illustration above is the turbocharger exhaust pipe without a pilot flange.

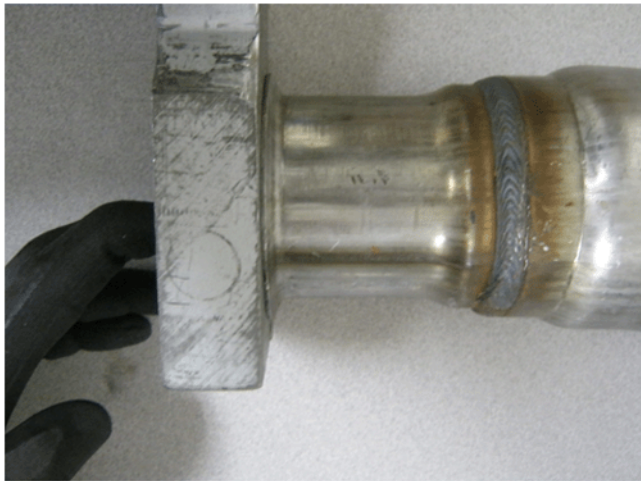
In most cases it will not be necessary to replace the exhaust downpipe/catalytic converter assembly for this condition. However if the mating flange on the exhaust downpipe/catalytic converter assembly is not true, it is possible a leak may occur.

This can be inspected easily by placing a gauge block flush against the flange and inspect for excessive gaps or damage to the flange.

If there are gaps, the converter may need replacing, but the new gasket should compensate for minor surface variation. It is preferred that the alignment process is attempted prior to replacing the converter. There have been very few cases that required the converter to correct this condition.
