Service Bulletin

PRELIMINARY INFORMATION

Subject: Information on Vibration Analysis and Diagnostic

Models: 2014 Chevrolet Silverado 1500
 2015 Chevrolet Silverado 1500
 2014 GMC Sierra 1500
 2015 GMC Sierra 1500

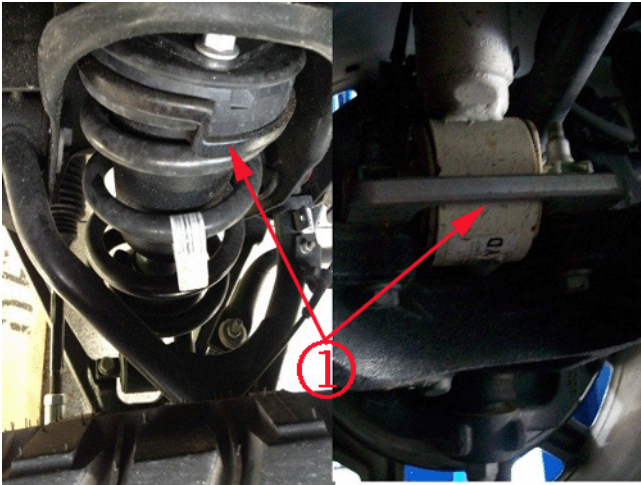
1. Inspect the truck for any aftermarket equipment installations. For example: non factory tires, wheels and/or lift kits or leveling kits – shims (1) installed as shown above. Aftermarket equipment does include running boards, bug deflectors, and window shades, etc. Remove any aftermarket that might cause vibration transmission paths.
2. Mark each tire valve stems location on the tire. This will be utilized to check for tire slippage on the rim.

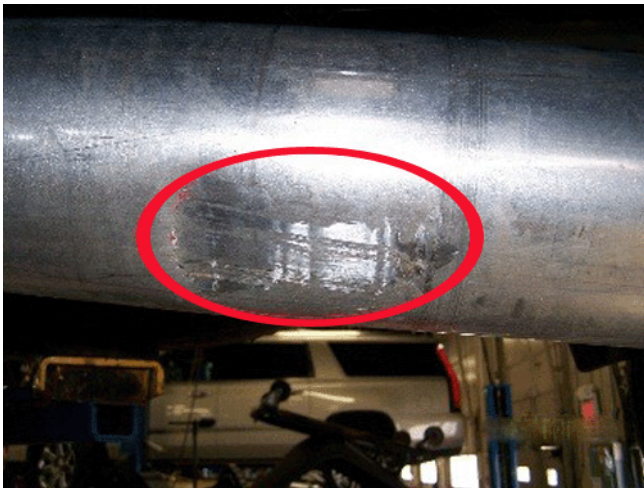
- Inspect the propeller shaft for dents or damage. There have been many cases of dented propeller shafts.
- For 4WD Trucks, remove the rear propeller shaft, seal output shaft and drive the vehicle in 4WD. If the vibration is gone, the rear prop shaft could be the problem.
- For vehicles with a 3:08 with a one-piece steel shaft, this can be replaced with a one-piece aluminum one that is utilized on all 3:42 and 3:73 ratios (K15543 and K15753 Models only).
- PIP5140: Low Speed Vibration 30-35 mph (48-56 km/h).
- Inspect the transmission output shaft bushing for irregular wear.

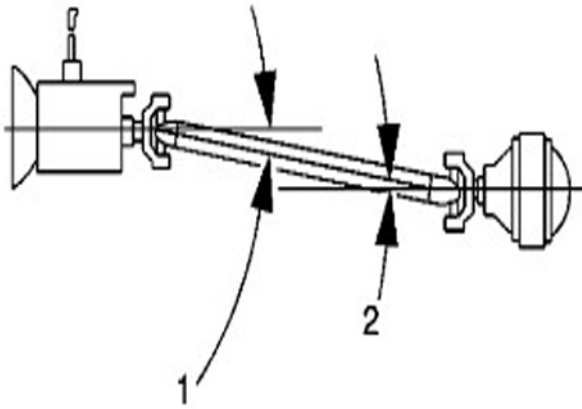
Measurement	Notes:
Yoke to Shaft		The first (forward most) U-joint action on a two piece driveshaft system is not canceled out by another U-joint. Because of this, the first U-joint working angle should be between 0.5 and 0.75 degrees.
Front Shaft to Center Support Bearing (if equip)		U-joint pairs cancel each other. Neither U-joint working angle should exceed 4 degrees, nor the allowable range of difference between cancelling U-joint working angles is 0.00 to 1.0 degrees.
Shaft to Diff Yoke

Propeller systems containing only 1 U-joint: The U-joint working angle should be between 1/2 and 3/4 degrees.

Allowable range of difference between cancelling U-joint working angles: 0.25 to 1.0 degrees.

1. Originally, trucks were built with a 14 mm spacers under the transfer case (4WD only). In some cases, reducing this shim to a 7 mm shim may correct the condition.
2. A 2 degree axle shim (P/N 23469809 – Qty 2) can be placed between the leaf spring pack and the axle perch. To rotate the pinion up to correct this; the “fat end” of the shim must face backwards, to the rear of the truck.

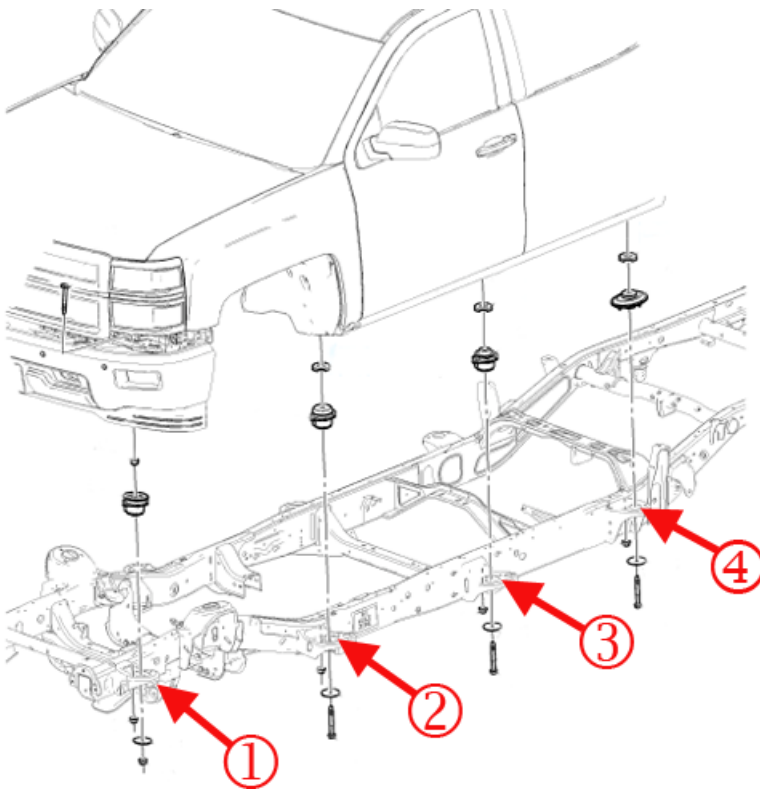
The cab / body mount position location

The numbers in the picture below indicate the specific mount position. The mounts on the passenger side of the vehicle are identified the same way. This will assist the technician to identify the correct location of each mount so they can be torque to the proper specification.

- 1 = body mount cushion front
- 2 = body mount cushion position number 1
- 3 = body mount cushion position number 2
- 4 = body mount cushion position number 3

Visually verify that the cab to box alignment is correct before re-torquing all mounts to specification found in Service Information, body repair, frame and under body section.
