Service Bulletin

PRELIMINARY INFORMATION

Subject: Gauge Fluctuation, Various DTCs, Wiring Harness Chafing/Rubbing on A/C Line

Models: 2011-2013 Chevrolet Silverado
2011-2013 GMC Sierra
Equipped with 6.6L Duramax™ Diesel Engine (RPO LML)

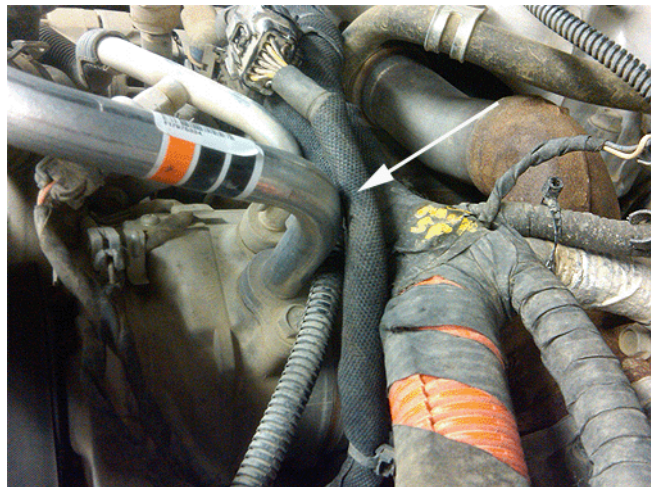
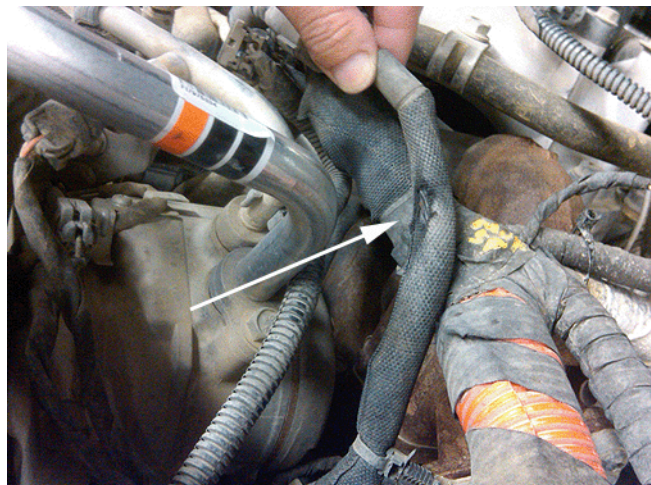
Some customers may comment that the oil pressure, oil level and/or the coolant temperature gauge fluctuates.

Technicians may find one or more of the following DTCs set: P0193, P0341, P0521, P0522, P0523, P0641, P125A, P125B, P128E, P2294, P2295, P2296, P00CA, P0090, P00CA, P0091, P0092, P0087, P0088, P0182, P0183, P1088.

The engine wiring harness may be rubbing on the A/C line.
