Service Bulletin

Subject: Wax Coating on Frame Peeling, Metal Shows Corrosion/Rusting (U.S. and Canada Only)

Models: 2011-2016 Cadillac Escalade Models
2011-2013 Chevrolet Avalanche
2011-2016 Chevrolet Express, Silverado, Suburban, Tahoe
2011-2016 GMC Savana, Sierra Models, Yukon Models

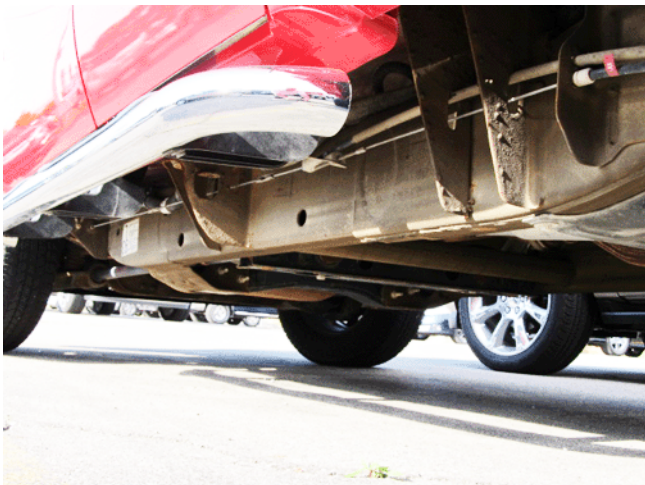
Truck Example Photos

Some customers may comment that areas of the frame wax coating are peeling off and rust/corrosion is visible on the metal in these areas. Several examples of this condition are shown in each group of graphics below.

A combination of specialized metal coating products manufactured by Lloyds and Daubert have been found to be the most suitable products to provide corrosion control and protection to address this type of repair. Our recommendation is to prep the metal surface using *Lloyd's Pure Prep™ Metal Surface Preparation P/N 25418, then topcoat with both *Lloyds Kryptonite Metal Treatment P/N 36502 Life Long Rust Protection and *Daubert Non-Rust® P/N X-121B One Coat Rust Preventative Coating. It is strongly recommended they be applied according to the manufacturer's procedures.
