Service Bulletin

Subject: Wet Carpet/Floor at Driver and/or Passenger Footwell Areas

Models: 2010-2016 Chevrolet Equinox
2010-2016 GMC Terrain

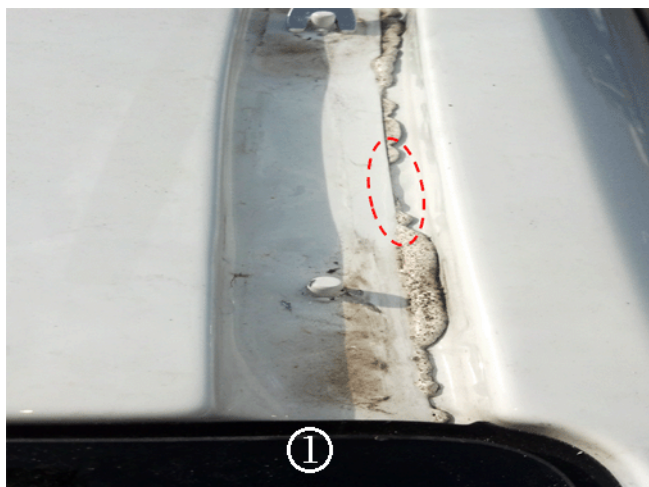
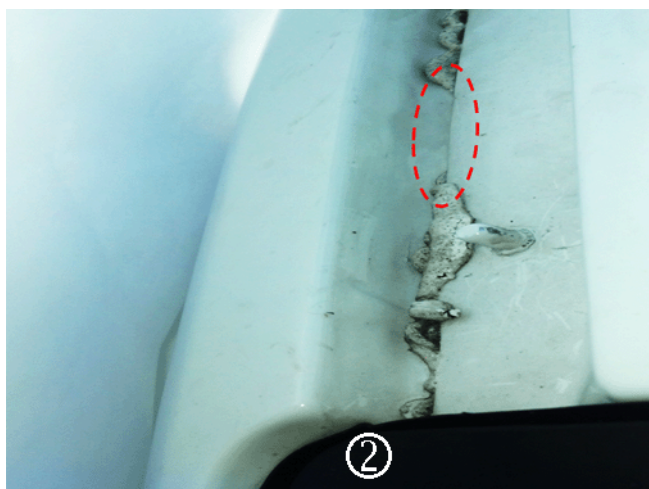
2. Inspect for voids/gaps in the seam sealer along the outboard edge of the roof ditch. Examples of this condition are shown in the driver side (1) and passenger side (2) graphics above.
3. Clean the affected area and seal all gaps with *Kent Automotive High-Tech™ Clear Seam Sealer, P/N 10200 (5 oz tube), or equivalent. Avoid excess sealer build up within the ditch while assuring any voids in the factory seal are filled.
4. Allow the seam sealer to adequately set-up, then water test by placing a water hose mid-roof near the ditch, allowing water to run forward to the A-pillar. Visually inspect for any water leaks along the inner roof, A-pillar and floor areas.
5. Once the repair is verified, reinstall the roof ditch molding. Refer to Roof Panel Molding Replacement in SI.
6. Dry the interior of the vehicle as needed. Refer to Floor Carpet Drying in SI.
