Service Bulletin

PRELIMINARY INFORMATION

Subject: Intermittent No Crank No Start Fob Program Message Displayed

Models: 2012 - 2015 Buick LaCrosse
Equipped with PEPS Keyless Start (RPO ATH)

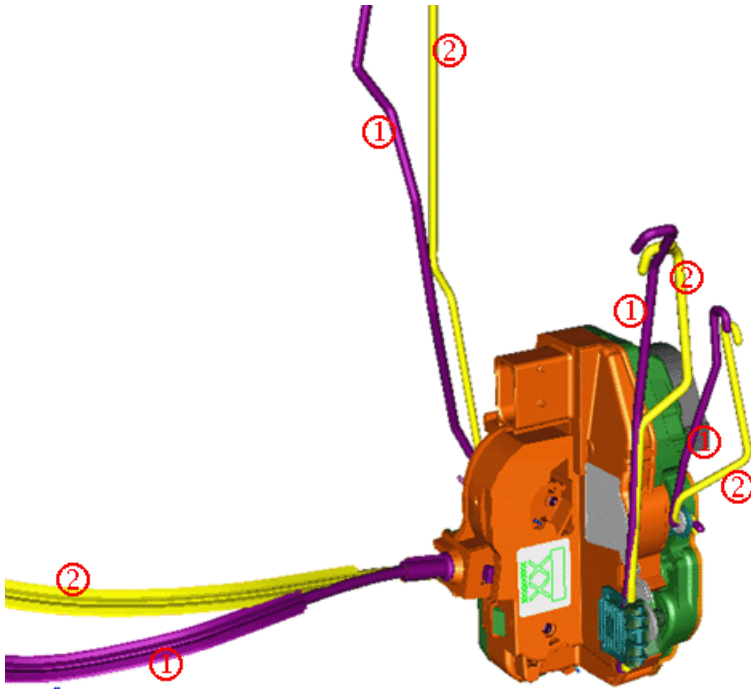
The 2012 to present Buick LaCrosse and 2013 to present Chevrolet Malibu share the same driver's door latch part number but the linkages that connect the latch to the door key lock cylinder, lock button and the external door handle are different for each vehicle. If the vehicles happen to be built with the incorrect linkage or linkages, this concern may be present.

Lacrosse Linkages - purple (1)

Malibu Linkages - yellow (2)

If either message is displayed or the customer has commented on a similar concern, use the key to check the rotation of the drivers door lock cylinder. If the key rotates further when unlocking then the normal 90 degrees, the vehicle may have been assembled with the incorrect door lock cylinder to latch rod. Please remove the door latch assembly and check the rod. See the photos below to determine linkage configuration and replace the door lock cylinder to latch rod as required. Reference the Electronic Parts Catalog (EPC) to determine the correct rod to order / install.
