# Service Bulletin

## PRELIMINARY INFORMATION

**Subject:** Possible Oil Consumption - Oil Leaks - Blue Smoke From The Exhaust - MIL - Or Fuel Trim Codes

**Models:** 2011 - 2014 Chevrolet Cruze  
2013 - 2014 Buick Encore  
2013 - 2014 Chevrolet Sonic  
2013 - 2014 Chevrolet Trax (Canada Only)  
Equipped with 1.4L (RPO LUJ or LUV)

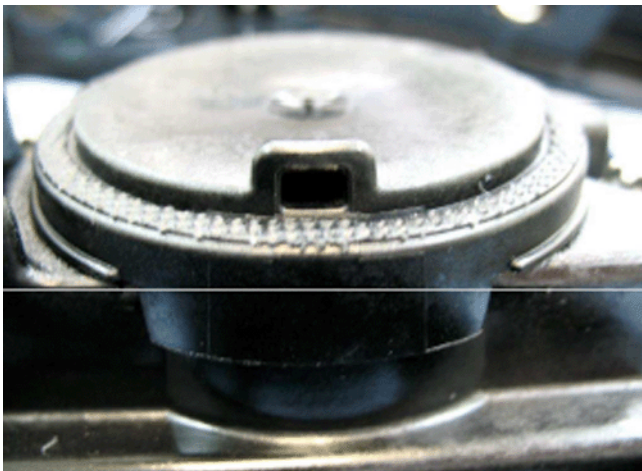
Check the PCV orifice for leaking oil or drawing vacuum at idle thru its external port. (The PCV orifice is an integral part of the camshaft cover). (See picture below).

If the PCV orifice external port is leaking oil or vacuum, replace the camshaft cover assembly.

Clean oil from all induction system components and retest for oil consumption, leaks or DTCs resetting.

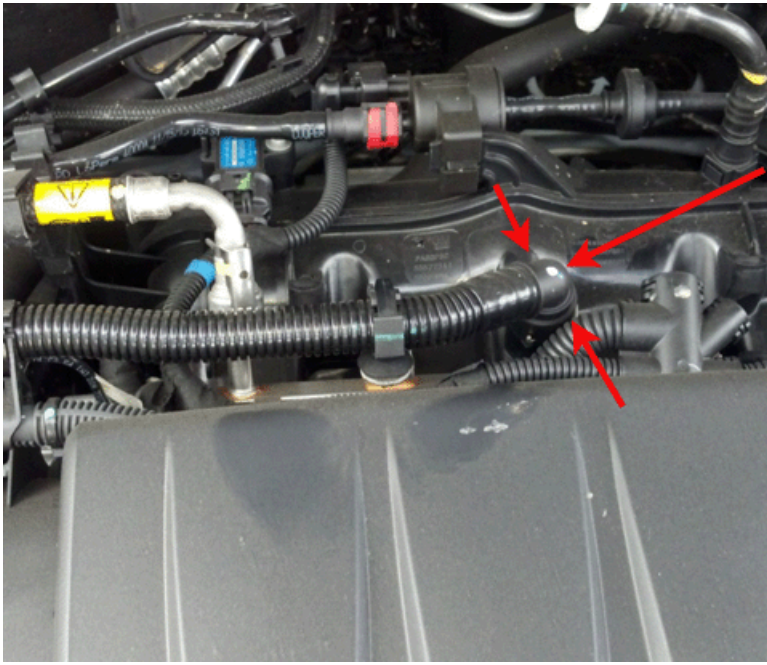
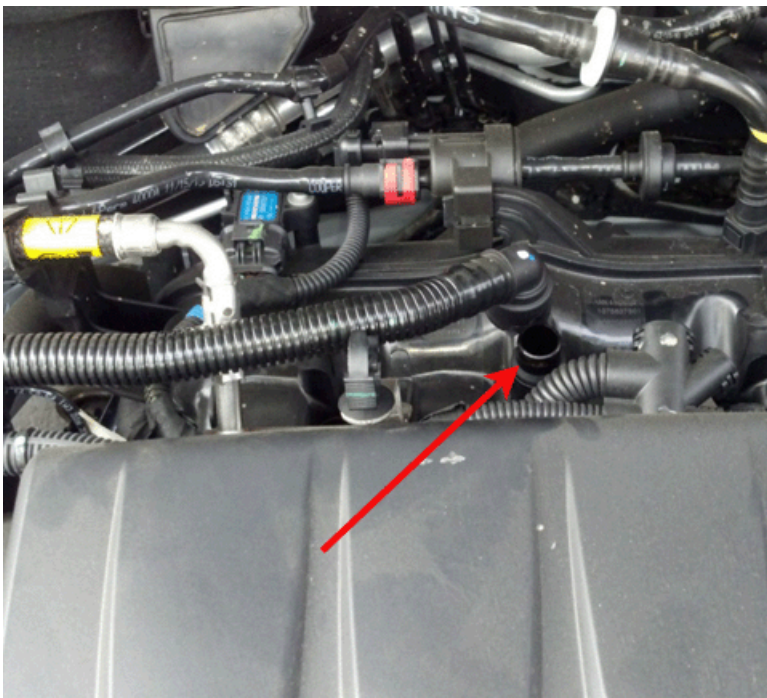
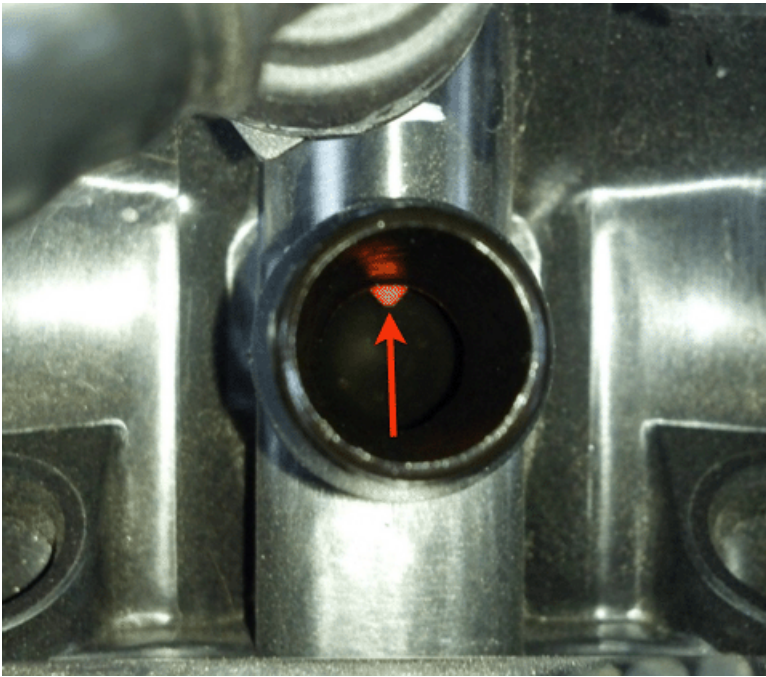
Check for a missing intake manifold Non Return Valve that may have damaged the PCV orifice diaphragm. (See pictures below for inspection procedure).

If the non return valve is not visible as shown in picture, then use a long cotton swab to wipe any excess oil from the valve to validate.

If the non return valve is still not visible, then intake manifold removal for inspection is required to validate.

If the intake manifold Non Return Valve is missing, then replace the intake manifold assembly,

Clean oil from all induction system components and retest for oil consumption, leaks or DTCs resetting.

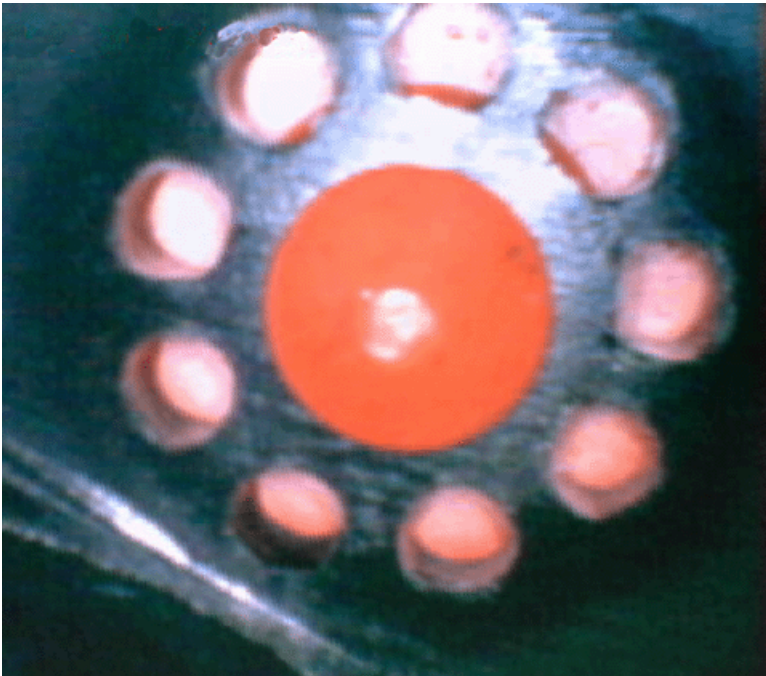
Properly seated Non Return Valve as viewed with the intake manifold removed.

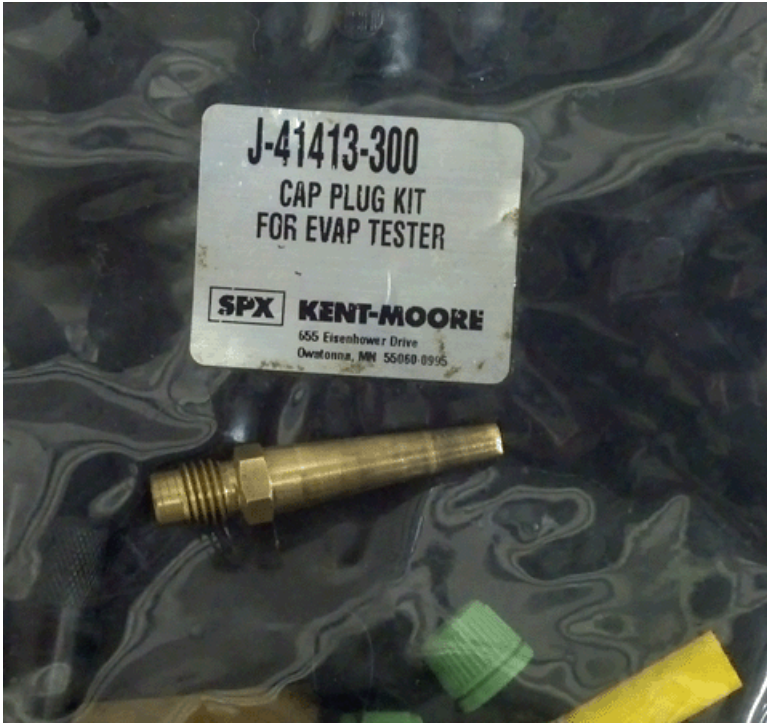
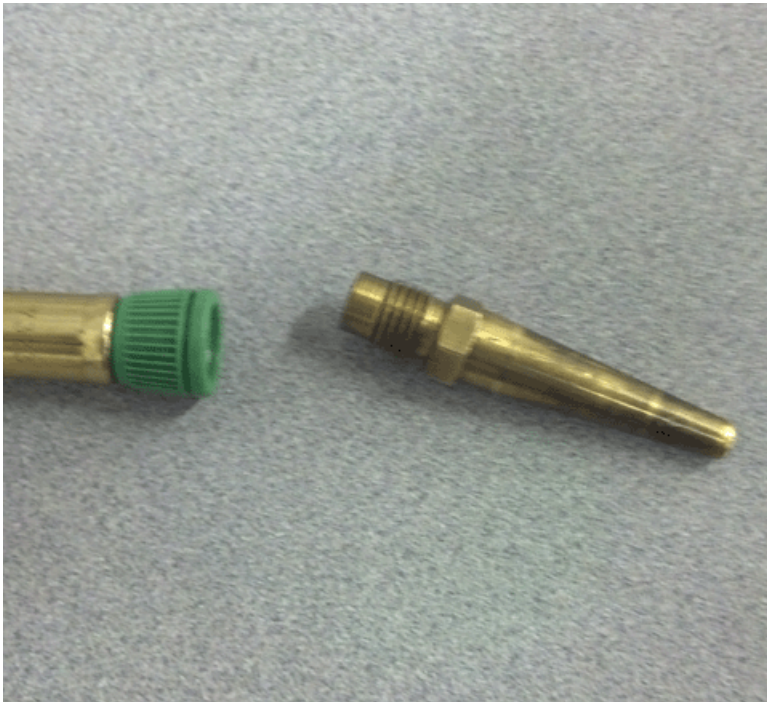
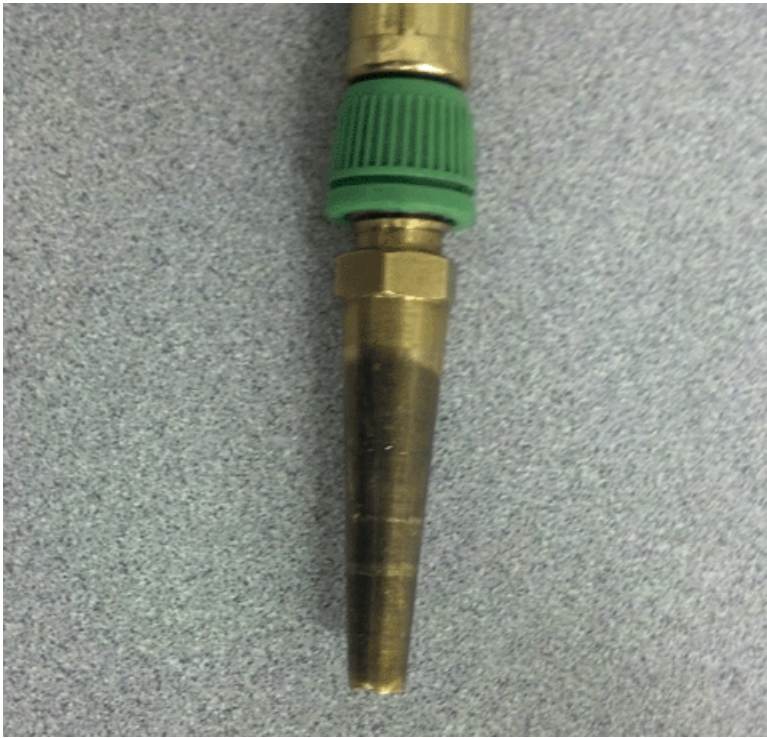
Record the crankcase pressure. (Normal crankcase pressure readings are between -11 & -18 inches of water in park at hot idle) / (ESST gage works best,

see pictures below for connection of ESST at the engine oil dipstick hole in the camshaft cover ).

**Note:** The connection must be made with the engine off. The engine is then started and the pressure reading is recorded.

If the crankcase pressure is excessively positive, above 0 inches of water (0 inches of HG / vacuum) then a cylinder leakage / crankcase pressure concern exists.

If the crankcase pressure is excessively negative, below -30 inches of water (-2 inches of HG / vacuum) then excessive intake vacuum is being applied to the crankcase, requiring further PCV system testing.

If the crankcase pressure is in the proper range, clean oil from all induction system components and retest for oil consumption, leaks or DTCs resetting.
