Service Bulletin

PRELIMINARY INFORMATION

Subject: Headlight Performance (BCM Calibration and Bulbs)

Models: 2015 GMC Sierra
2014 GMC Sierra 1500

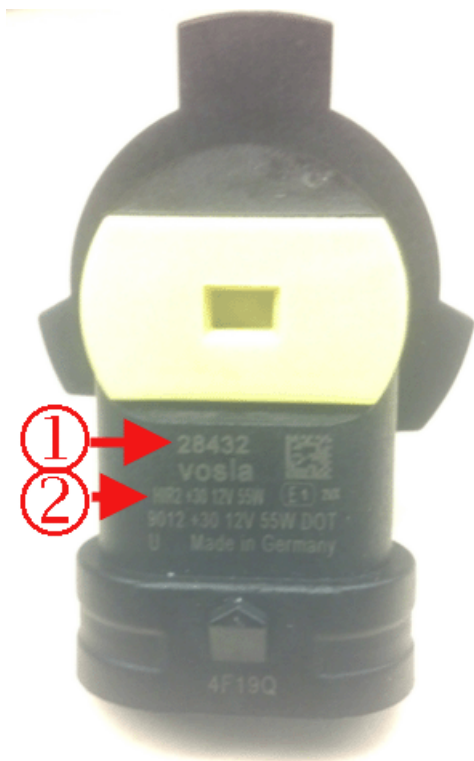
1. 28432
2. HIR2+30

2. Replace both headlight bulbs with updated bulb part number 23342527. IMPORTANT: Verify the correct bulb is being installed by confirming the following markings on the bulb:

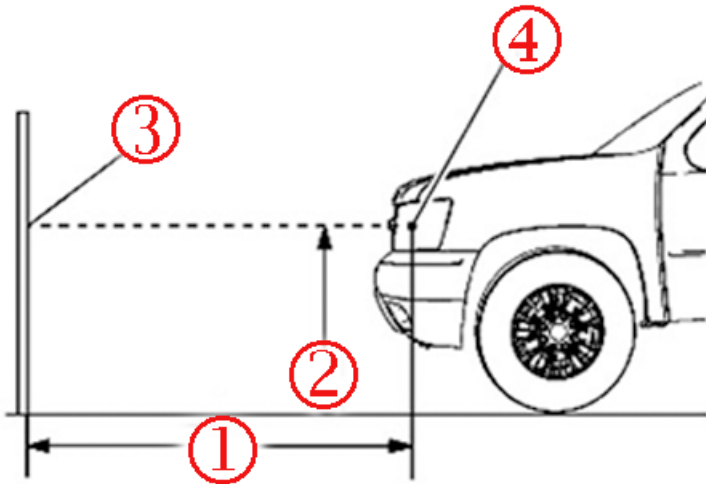
1. 25 ft (7.62 m)
 2. Height of Horizontal Aiming Line on screen
 3. Aiming Screen or Wall
 4. Reference mark (small circle) on headlamp lens
9. Turn the headlamps ON.
 10. Block the light from projecting onto the screen from the passenger side headlamp. This will allow the cutoff (“top” of the beam pattern) in the beam pattern from the driver’s side to be more pronounced for easier aim verification.
- Important:** DO NOT cover the headlamp, this may cause excessive heat buildup.
11. On this vehicle you will be verifying the vertical aim of the cutoff (top of the beam pattern) on the right side of the “step” in the beam pattern
 12. If the vertical location of the cutoff projected onto the screen or wall differs from the figure below, then an adjustment to the beam pattern location is necessary.

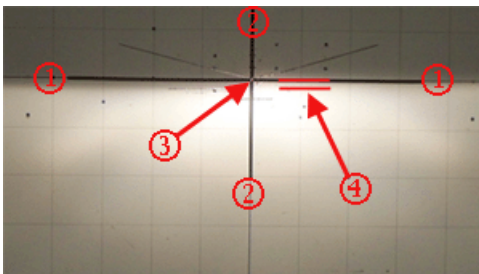
Note: GMC Sierra Low beam pattern (1 Lamp) on wall/aiming screen at 25 ft (7.62 m)

1. Horizontal Aiming Line
2. Reference line only, Not needed for proper aiming
3. Step in beam pattern
4. Top of beam pattern (cutoff line) positioned at the horizontal aiming line +0 / -0.75" (-19mm)

13. Adjust the vertical headlamp aim adjustment screw until the cutoff (top of the beam pattern) on the right side of the beam pattern step is set between the Horizontal Aim Line and 0.75 (19mm) inches below
14. Repeat the aiming procedure for the passenger's side headlamp while blocking the light from projecting onto the screen from the driver's side headlamp
