# Service Bulletin

## PRELIMINARY INFORMATION

**Subject:** OnStar and XM Antenna Malfunction Setting DTC B2462 B2470 Or B125C

**Models:** 2015 Cadillac Escalade  
2015 Chevrolet Silverado, Suburban, Tahoe  
2015 GMC Sierra, Yukon  
Equipped with high frequency painted antenna assembly

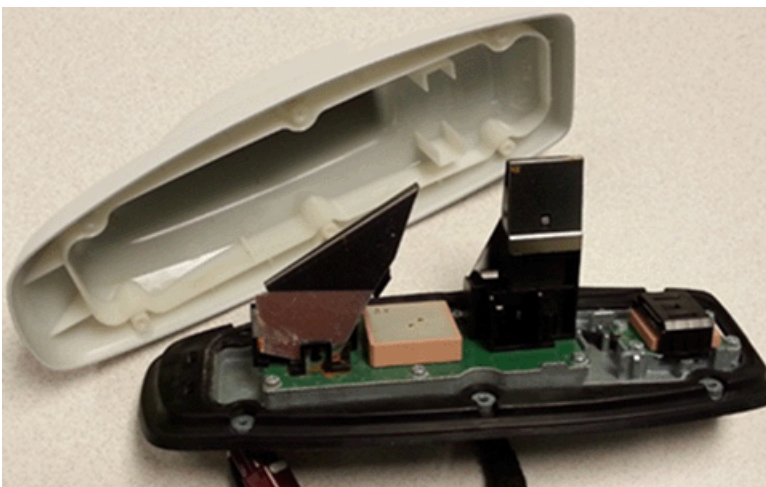
**Important:** The painted antenna cover is not intended to be removed. Do Not remove the antenna cover as this may compromise the sealing performance. Do Not reuse the original antenna painted plastic cover, there is a potential quality concern with the cover. Latest service parts include updated covers.

**Note:** DO NOT use and any form of Sealants on the antenna or it's seals/gaskets  
Engineering has identified an issue of water intrusion into the antenna assembly.

If this concern is encountered, replace the antenna ensuring to use the new updated antenna cover without removing the cover from the base.

Mask and spray paint to match as necessary
