Service Bulletin

Subject: Service Stability – Traction – ABS Rear Wheel Speed DTC Or Chassis Expansion And High Speed Bus Communication Fault

Models: 2010 - 2015 Chevrolet Equinox

2010 - 2015 GMC Terrain

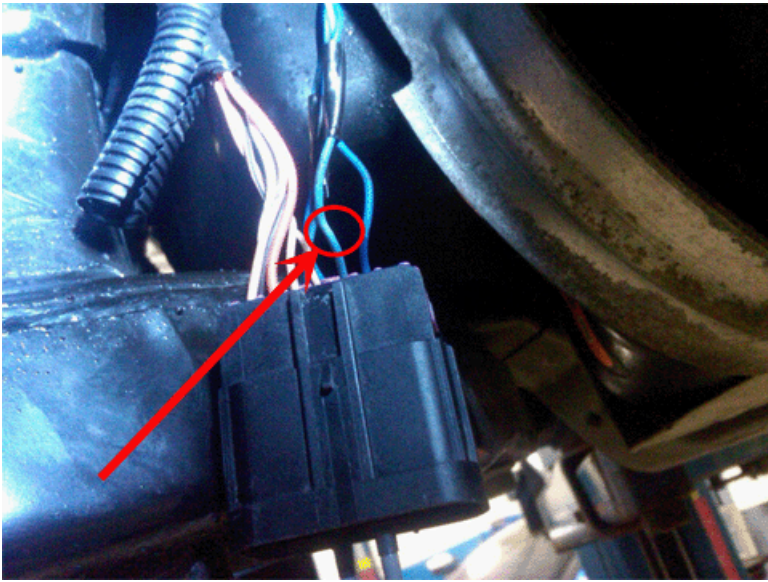
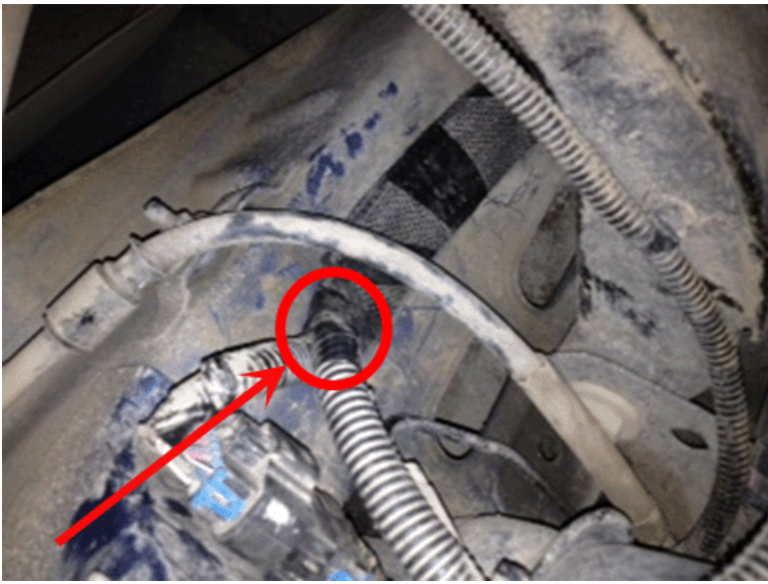
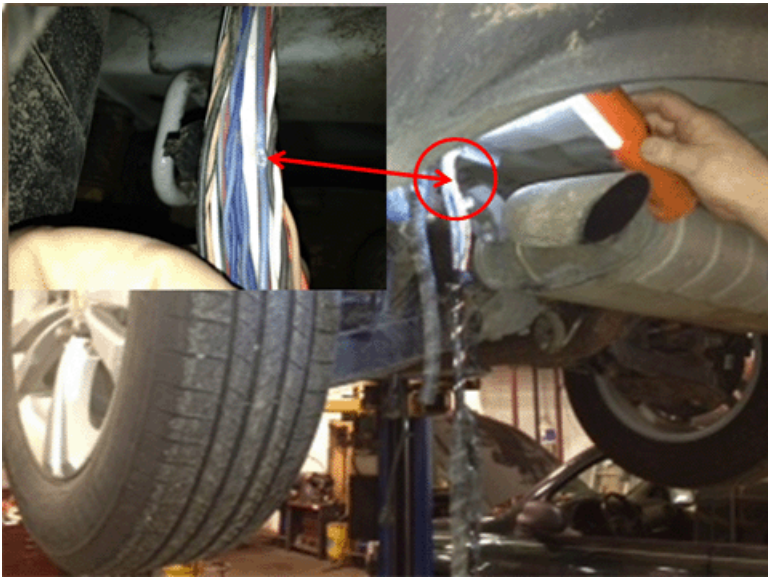
During inspection you may notice chewed up conduit or a discoloration in insulation in one spot of the wire.

Note: Wire broken within the insulation has also been found high up in the harness X411. It will be necessary to lower the harness to gain access. Reference the following photos:

If you pull the wire near that area the insulation it will break exposing the broken wire and possible corrosion or rodent damage. Repair the circuit to complete the procedure.

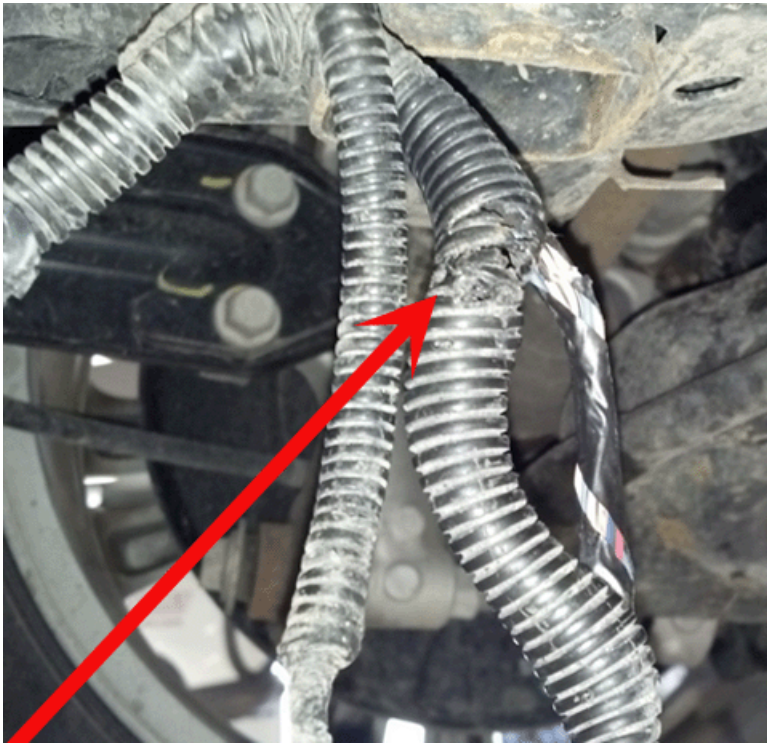
Damaged conduit

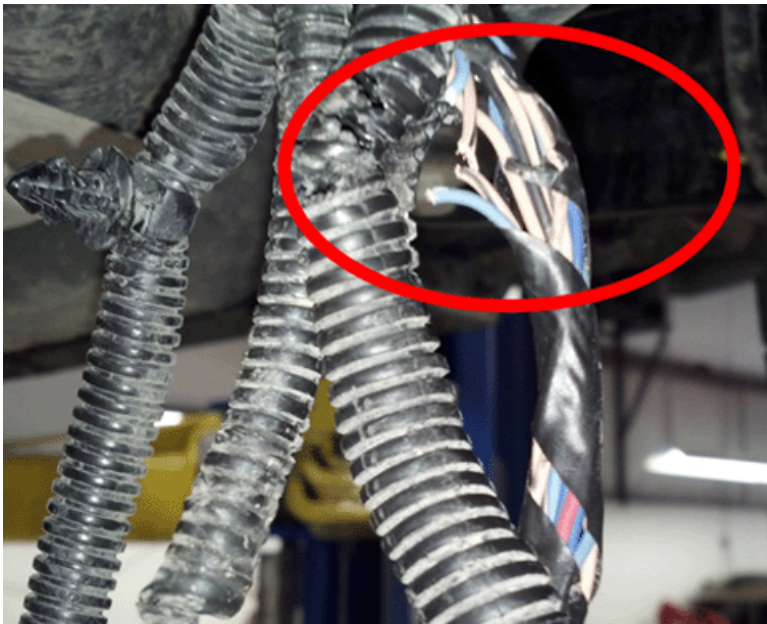
Wires chewed through
