Service Bulletin

PRELIMINARY INFORMATION

Subject: Cold Start Misfires

Models: 2012-2015 Buick LaCrosse
2013-2015 Cadillac ATS
2012-2015 Cadillac CTS
2012-2015 Cadillac SRX
2013-2015 Cadillac XTS
2012-2015 Chevrolet Camaro
2012-2014 Chevrolet Caprice PPV
2012-2014 Chevrolet Captiva Sport
2015 Chevrolet Colorado
2012-2015 Chevrolet Equinox
2012-2015 Chevrolet Impala
2015 GMC Canyon
2012-2015 GMC Terrain
with 3.0 LF1 or LFW and 3.6 LFX

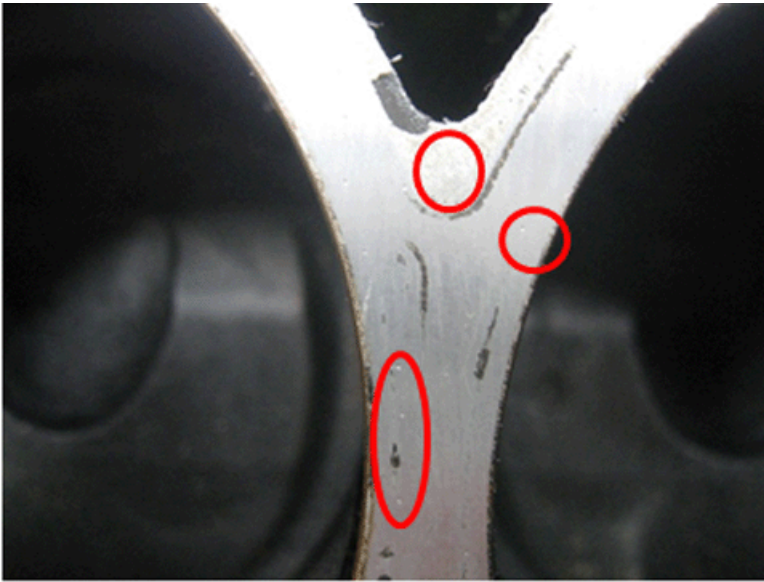
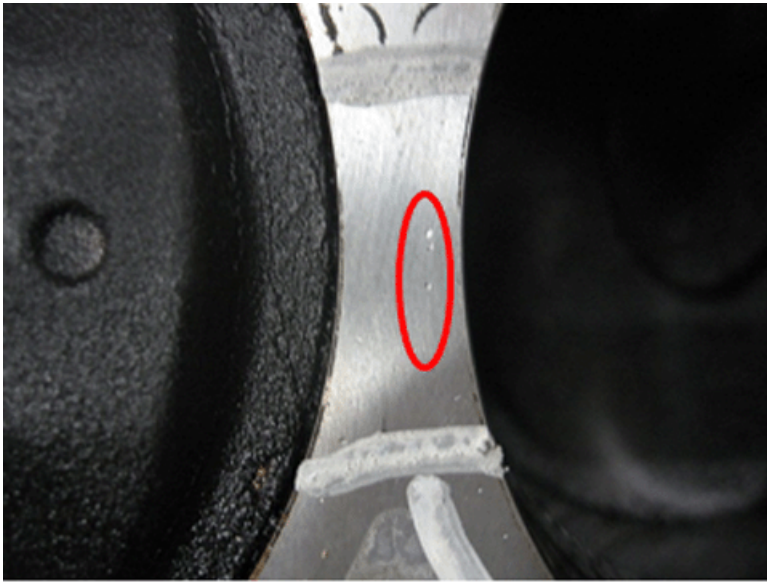
Small surface pock marks or pitting appearance on the deck surface is normal and engines should not be replaced for such appearance as they do not connect to coolant passages and cause a leak path that generate engine misfires.

During engine warranty analysis studies, engines are being replaced for small pitting in the deck face as described above, when the subject cylinder / piston is saturated with fuel and not coolant

Engine replaced for subject pitting conditions will be returned to the dealership as non defective.

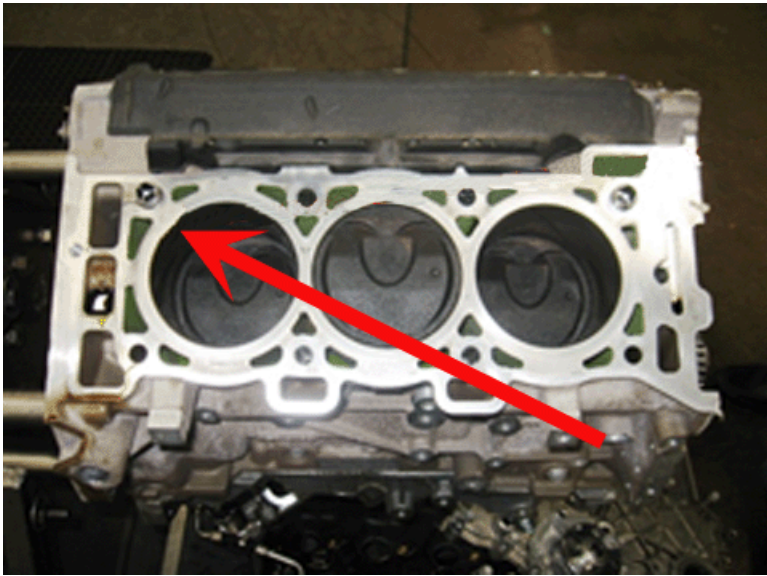
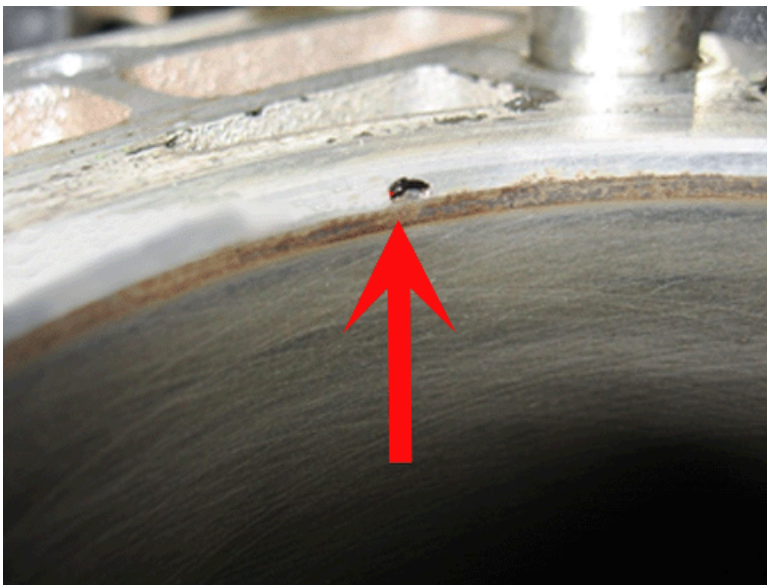
Location: # 5 at the 10:00 o'clock position.

The photo above is an example of what true porosity is.

Cylinder deck face to cylinder liner interface location can cause a leak path into the cylinder for rapid large counts of misfires when cold.

Such Porosity is rare, therefore technicians should inspect the subject cylinder and look for a break in the carbon ring.

Usually if porosity is present there will be a break in the carbon ring.

Coolant present in a cylinder cleans the area of entry and can be found by wiping the carbon ring dry with a clean soft towel, exposing the leak path.

Only if true porosity is found would engine replacement become necessary.

Call PQC per the latest version of 02-07-30-029, if required, reference this PI and replace the engine, ONLY in cases where porosity has been found to be the cause.
