Service Bulletin

PRELIMINARY INFORMATION

Subject: Blower Motor Fan Speed Frozen on Display

Models: 2013 Chevrolet Camaro
Equipped with MyLink Radio (RPO UFU or UHQ)

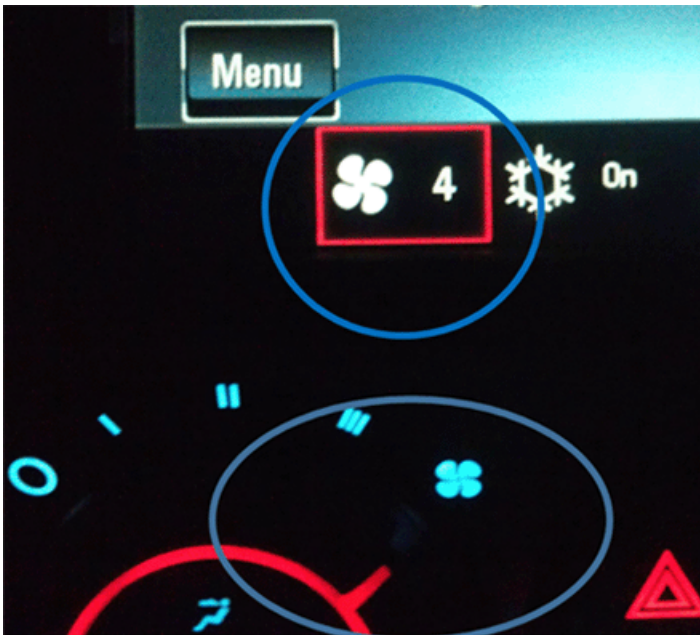
Some customers may comment that the blower motor fan speed display is "frozen" on the radio display.

This will be noticed after the vehicle has been started. For example, in the photograph below, notice that the blower motor rotary knob has been set to the "high" position but the indicated blower motor speed above it shows blower speed as level 4.

This is shown as an example only. The actual car may freeze on any indicated blower motor speed.

The cause of this specific concern is due to a software mismatch between the ECC (Electronic Climate Control Module) and the radio.

If the customer's vehicle exhibits the concern described above, dealership technicians are to contact the General Motors Technical Assistance Center (TAC) to request the software fix for this issue.
