Service Bulletin

Subject: Black Bar On Left Side Of Display While On Bluetooth Audio Streaming Page

Models: 2014 GMC Sierra 1500 models
2015 GMC Sierra 2500/3500 models (without RPO AVF), Yukon models (without RPO AVF)
Equipped with RPO IO5 or IO6

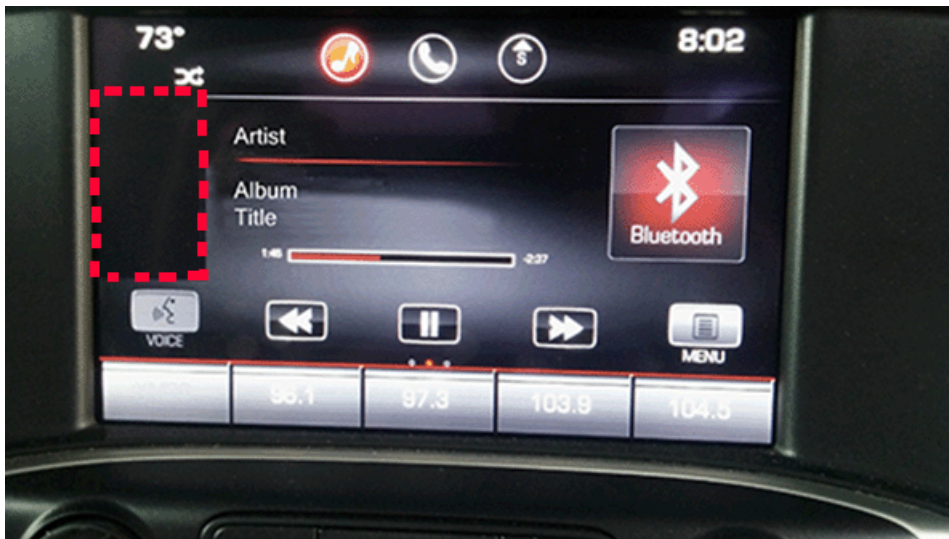
Some customers may comment about a vertical black bar while on the Bluetooth audio streaming source as shown below:

No repairs should be made as a result of this concern. Please communicate to the customer this condition is a normal operating characteristic of their vehicle. It will not impact the designed performance or reliability of the vehicle. Please share this information with the customer, including a copy of this message.
