Service Bulletin

Bulletin No.: PIP5270

Subject: Oil Leak From Timing Belt Upper Front Cover

Models: 2014-2015 Chevrolet Cruze
2014-2015 Chevrolet Sonic
2014-2015 Chevrolet Trax
Equipped with 1.8L 2H0, LUW or LWE (US and Canada Only)

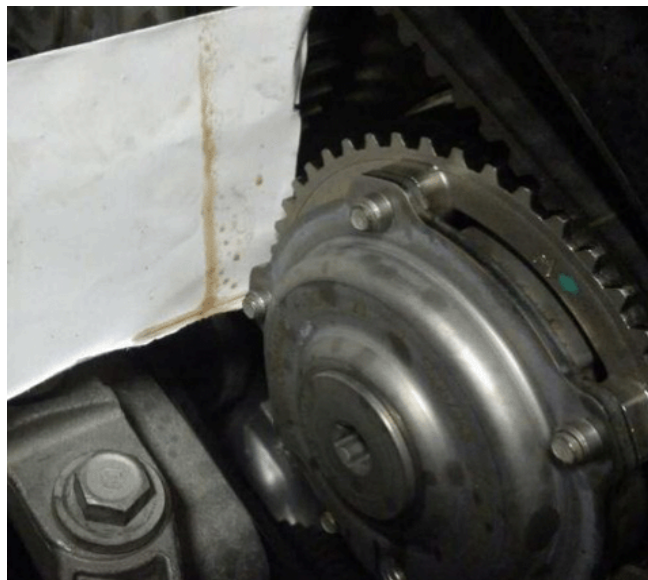
Using paper, run the engine off idle at 2000 RPM to check for oil being ejected from the camshaft actuator covers. (First picture below)

The oil on the paper in the picture below was seen after approximately 30 seconds of operation at 2000 RPM.

If oil is ejected from the camshaft position actuators, then replace the leaking actuator or actuators and the timing belt.

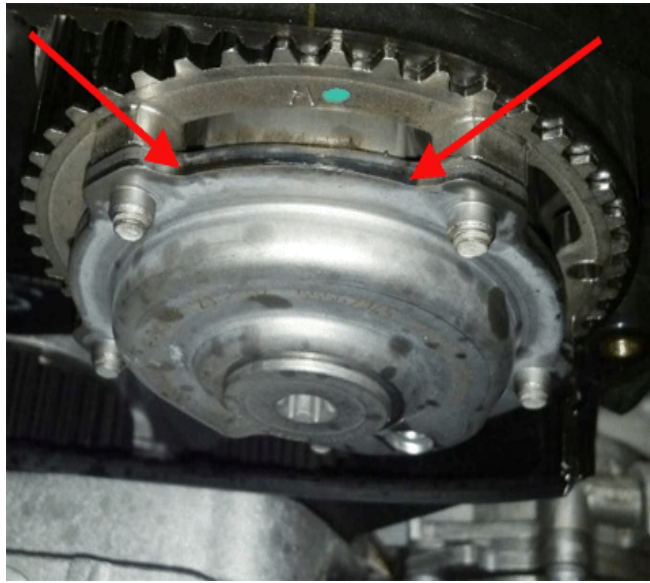
4074331

The arrows in the picture below indicate the area of the potential leak. (Second picture below)
