Service Bulletin

PRELIMINARY INFORMATION

Subject: Diagnostic Tip - Orientation Of The Rear Wheel Bearing During Installation

Models: 2011 - 2015 Chevrolet Caprice PPV
2014 - 2015 Chevrolet SS
2008 - 2009 Pontiac G8

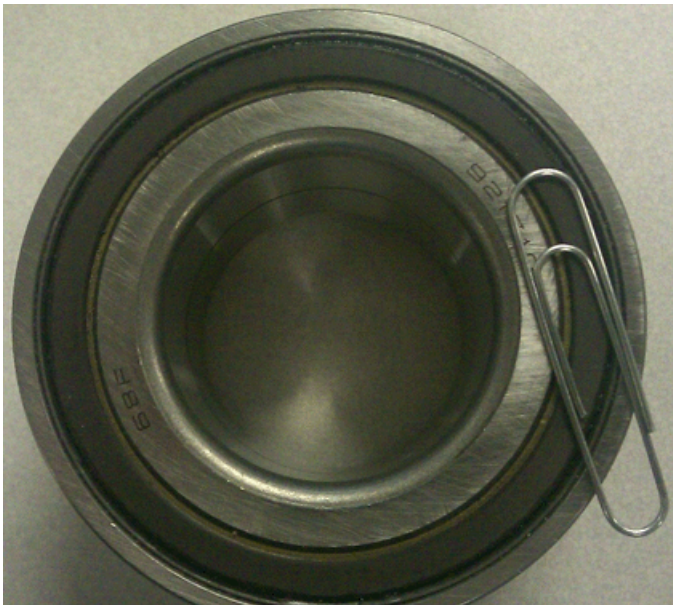
The decoder ring side of the bearing is the side that is both darker in color, and it is also magnetic.

The picture below indicates the decoder ring side. Note that the paper clip is stuck to it because it is magnetic.

Service Information directs the technician to install the wheel bearing so the decoder ring faces inboard towards the wheel speed sensor but does not describe how to determine which side of the bearing is the decoder ring side.

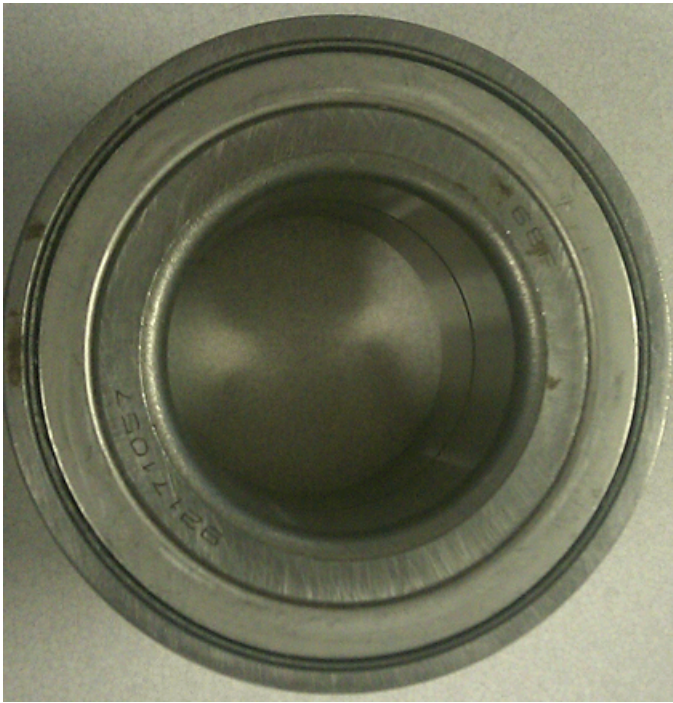
The picture below shows the opposite side of the wheel bearing for reference. This side would be facing outboard, away from the wheel speed sensor.
