Service Bulletin

PRELIMINARY INFORMATION

Subject: Power Liftgate Erratic Operation Will Not Power Close DTC B153A And/Or Motor Running But Does Not Move

Models: 2015 Cadillac Escalade Models
2015 Chevrolet Tahoe, Suburban
2015 GMC Yukon Models
Built Before 7/30/2014

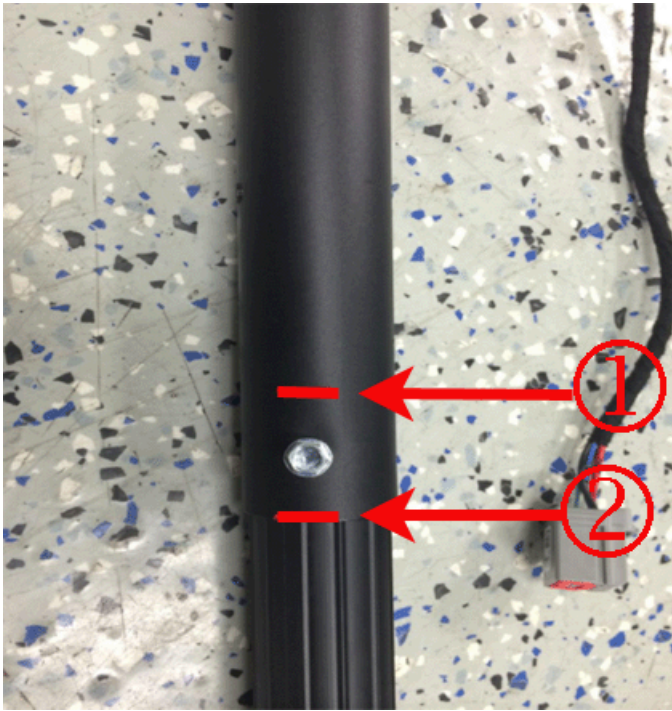
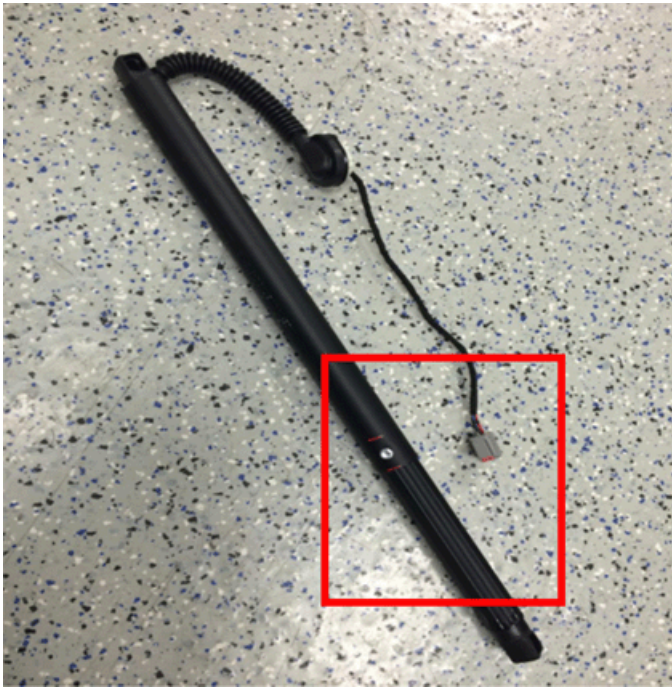
These concerns may occur if the left liftgate actuator is internally coming apart. It will need to be replaced, but care must be taken when removing the left liftgate actuator from the vehicle. There is an assist spring inside the left actuator. If the internal portion of the actuator has completely separated, and if it is removed from the vehicle without following the procedure listed below, the end of the actuator can become a projectile.

1. Obtain one #8 self-tapping screw 1 1/2 inches long.
2. Fully open the liftgate
3. Install the self-tapping screw any place in the 30 mm space (from the bottom of the smooth tube) between location 1 and 2. As reflected below, a location of 20 mm (approximately 3/4") is ideal to secure the tubes

Note: The screw will hold the actuator together for removal.
