# Service Bulletin

## PRELIMINARY INFORMATION

**Subject:** Normal Characteristic - Frame Coating Appearance

**Models:** 2015 Cadillac Escalade Models

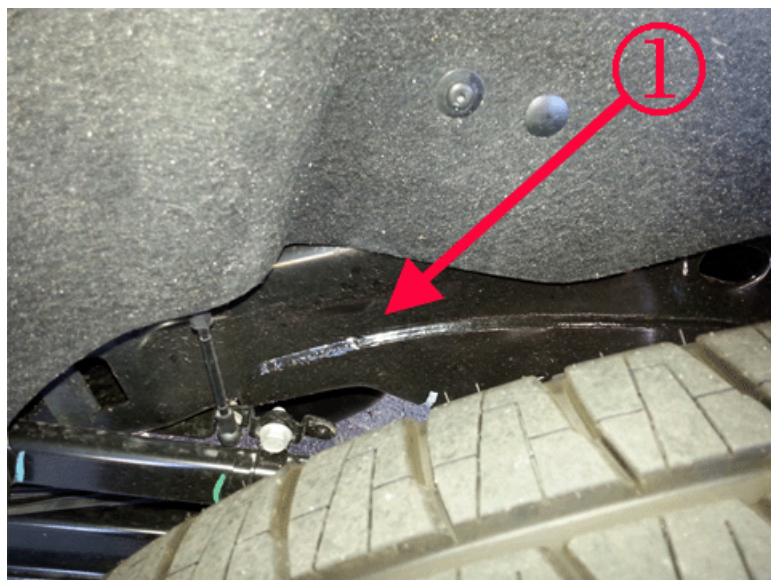
Some dealers/owners may comment that the frame on their truck has a shiny black appearance, rather than the normal dull black appearance. There was a temporary change to the frame coating on some Arlington and Silao built trucks. These trucks may have a frame painted with e-coat (1), rather than coated with frame wax (2) between the following dates:

The trucks are built as intended and the e-coated frames meet or exceed GM's specifications for corrosion.

**Note:** If a repair needs to be made to the frame and the black e-coat paint needs to be reapplied, use the latest version of PI0564.
