Service Bulletin

PRELIMINARY INFORMATION

Subject: Second Row Seat Belt Wet And/Or Carpet Wet Near The C-Pillar Area

Models: 2015 Cadillac Escalade Models
2015 Chevrolet Tahoe, Suburban
2015 GMC Yukon Models

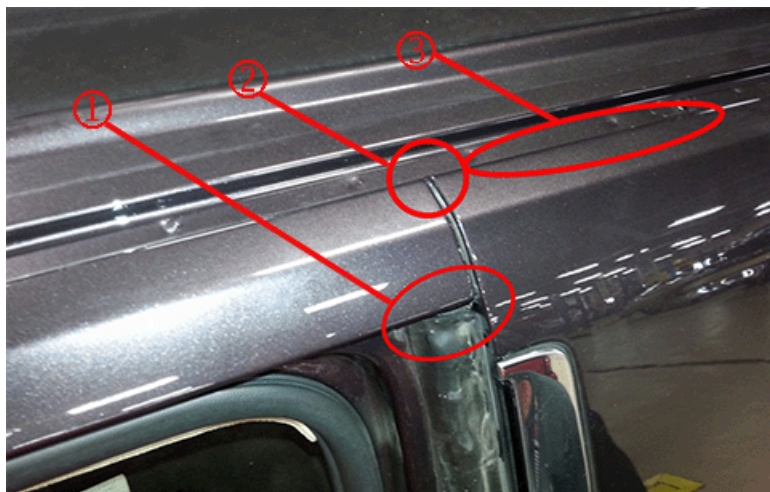
1. On the affected side, reposition away the c-pillar / body lock pillar upper trim panel, and partially release the forward portion of the cargo area / quarter lower rear trim panel to allow for inspection of the second row outboard seat belt webbing and retractor.
2. Inspect for water stains on the retractor, webbing, and on the sheet metal near the retractor. Webbing may not show evidence of being wet after it dries.
3. If the seat belt webbing or retractor or sheet metal near the retractor shows signs of having become wet, or if the customer mentioned that the seat belt was wet as a result of a water leak, the seat belt retractor assembly must be replaced. Replace the seat belt retractor assembly following water leak repair and verification testing.

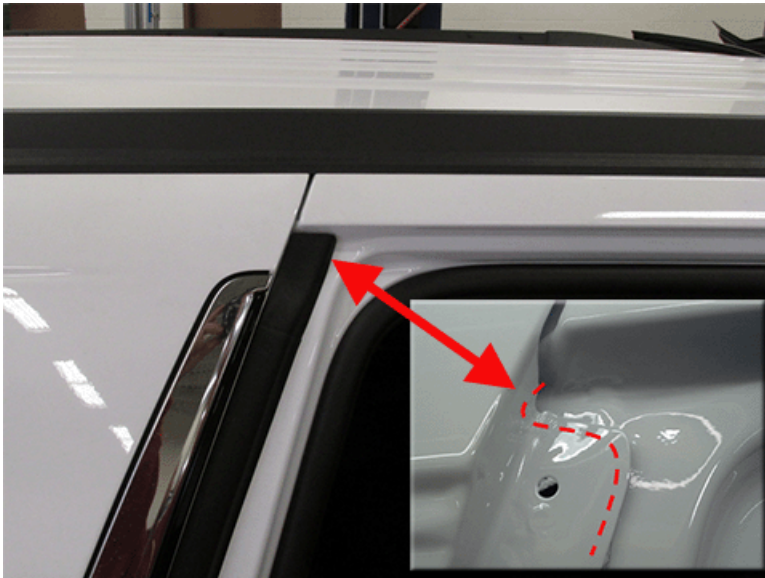
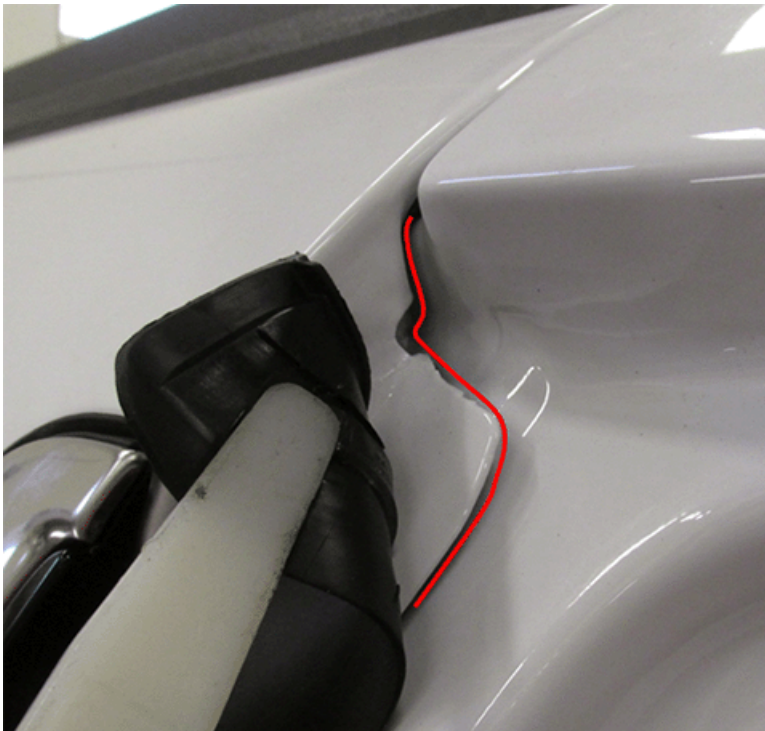
4. With the quarter panel weather strip removed, inspect for clear seam sealer between the c-pillar and rear quarter panel (Area 1).
5. If seam sealer is not present, or if any gaps are found in the sealer, apply clear flowable seam sealer between the c-pillar and rear quarter panel sheet metal as shown per red line in picture.

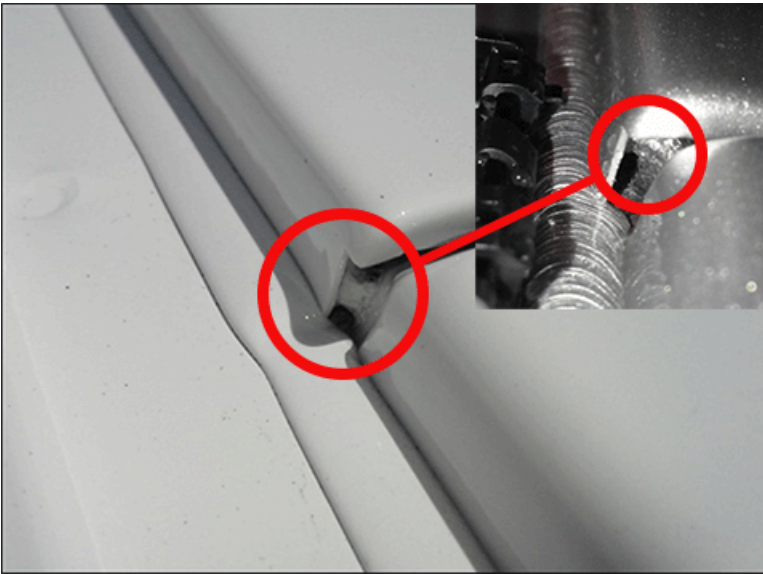
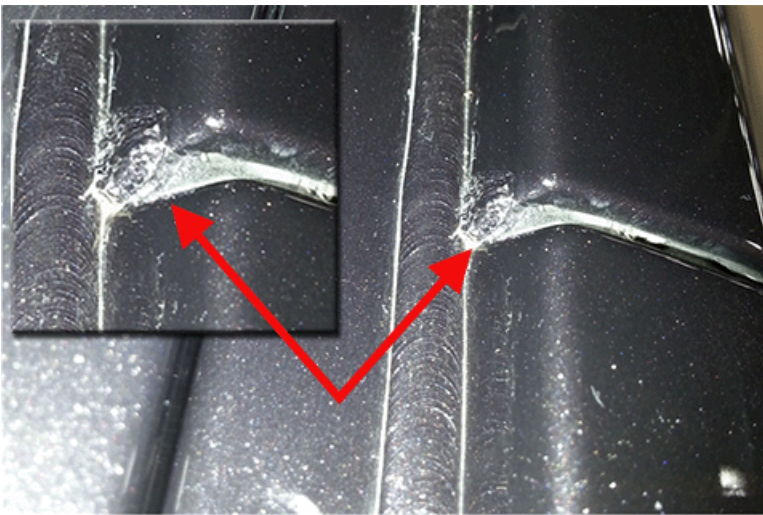
6. With the roof rail removed on the affected side, inspect existing seam sealer in the area shown; door surround to quarter panel and roof panel (Area 2) for skips or pin holes in the sealer
7. Fill any voids or pins holes found in the existing seam sealer with clear flowable seam sealer

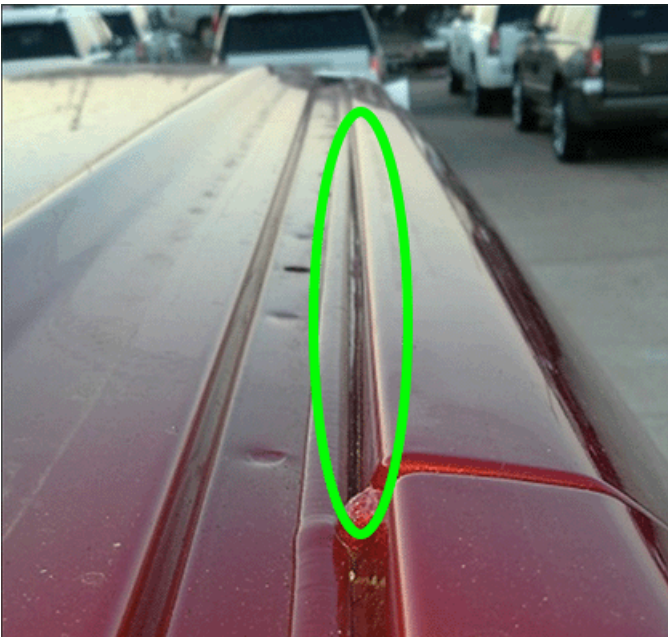
8. With the roof rail removed on the affected side, inspect existing seam sealer in the area shown; quarter panel to roof panel (Area 3) for skips or pull-

away along the outboard edge.

9. Apply clear flowable seam sealer along the rear quarter panel to roof seam as illustrated in picture above.
10. Test to ensure the water leak has been repaired.
11. If it was determined that the seat belt retractor requires replacement, replace the retractor, then reinstall the interior trim.
