Service Bulletin

PRELIMINARY INFORMATION

Subject: Poor Engine Performance P0089 P228D P0171 Whine Noise From High Pressure Fuel Pump

Models: 2010-2011 Buick LaCrosse
2011 Buick Regal
2010 - 2011 Chevrolet Equinox
2010-2011 GMC Terrain
Equipped with 4 cyl engine (RPO LAF)

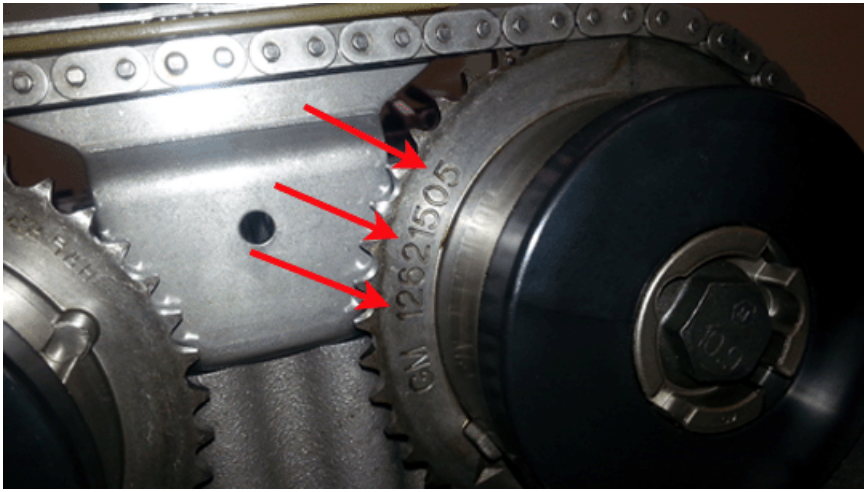
Below is an example of a 2011 Chevrolet Equinox intake camshaft actuator part number 12621505 and black in color (plastic cover piece).

If the symptoms above are noted after engine, intake camshaft or intake camshaft actuator replacement. It is likely the incorrect parts have been installed. This can be confirmed by removing the camshaft cover and noting the camshaft actuator sprocket colors or part number on the actuator sprockets. Also verify the correct intake camshaft and injectors are installed

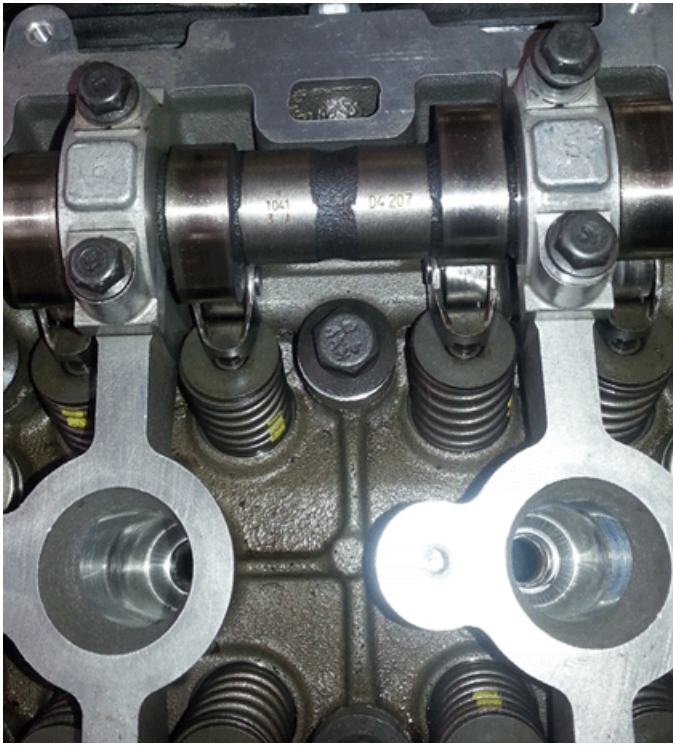
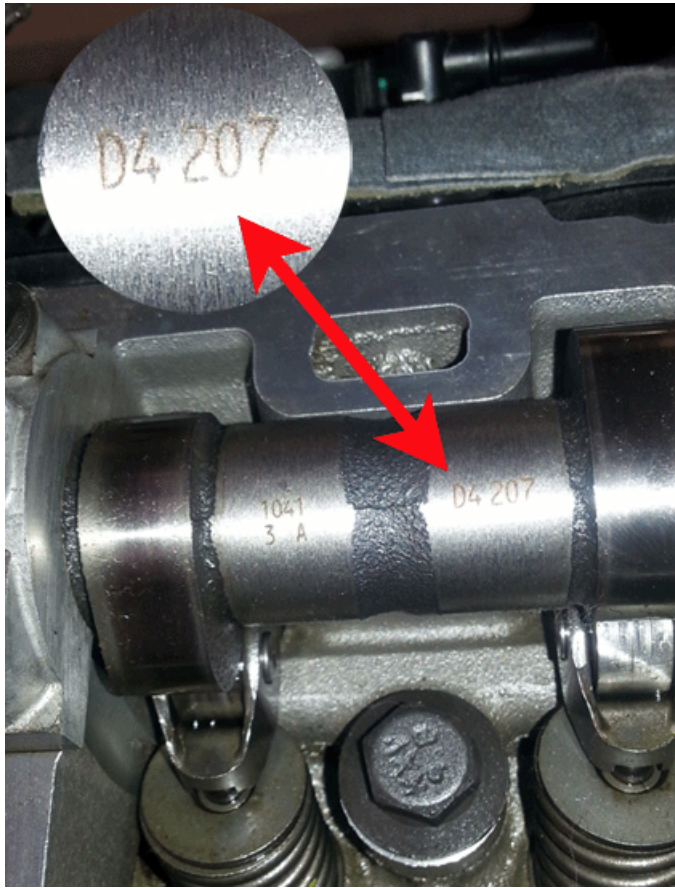
The camshafts can be identified by the last four digits of the part number located on a machined surface between the number 2 and number 3 cylinder camshaft lobes.

Below is an example of a 2011 Chevrolet Equinox intake camshaft part number 12634207.
