Service Bulletin

PRELIMINARY INFORMATION

Subject: **BAS+ (HYBRID) eAssist Drive Motor Generator Battery Module (Powerpack) or Drive Motor Generator Battery Section Exchange Process And Order Instructions**

Models: **2012 - 2015 Buick Lacrosse, Regal**
2013 - 2014 Chevrolet Malibu ECO
2014 - Chevrolet Impala
All equipped with eAssist (RPO HP6)

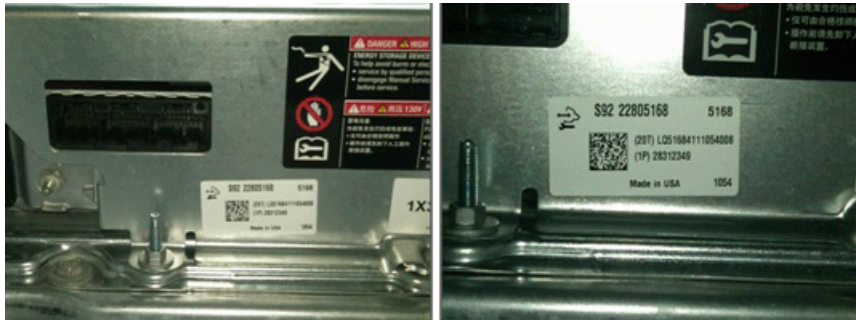
- The parts department fax number
 - The Powerpack serial number (Battery Identification Number)
9. The Battery Identification Number (BIN) tag is located on the side of the assembly cover. Locate the tag and record the 16 digit Battery Identification Number. The BIN number begins with digits "20T" (See Photo Below). If the Generator Control and Battery Module is not out of the vehicle yet, you can find the assembly ID number by installing the MDI and using GDS2. Access the Battery Energy Control Module menu and look under the ID Information section for the sixteen digit number. It will be listed under the parameter: Hybrid Battery Pack Identification Number. You will need to record the serial number and supply it to TAC when requesting a Powerpack or Battery Sections.
