Service Bulletin

Subject: DTCs P0011 P0014 P0016 Or P0017 After Cylinder Head Or Cam Actuator Removal

Models: 2009 - 2011 Chevrolet Aveo
2009 - 2010 Pontiac G3
2009 - 2010 Pontiac Wave (Canada Only)
2008 - 2009 Saturn Astra
2012 - 2016 Chevrolet Sonic
2011 - 2015 Chevrolet Cruze
2016 Chevrolet Cruze Limited
With 1.6L or 1.8L Engine RPO LXV, 2HO, LUW LWE

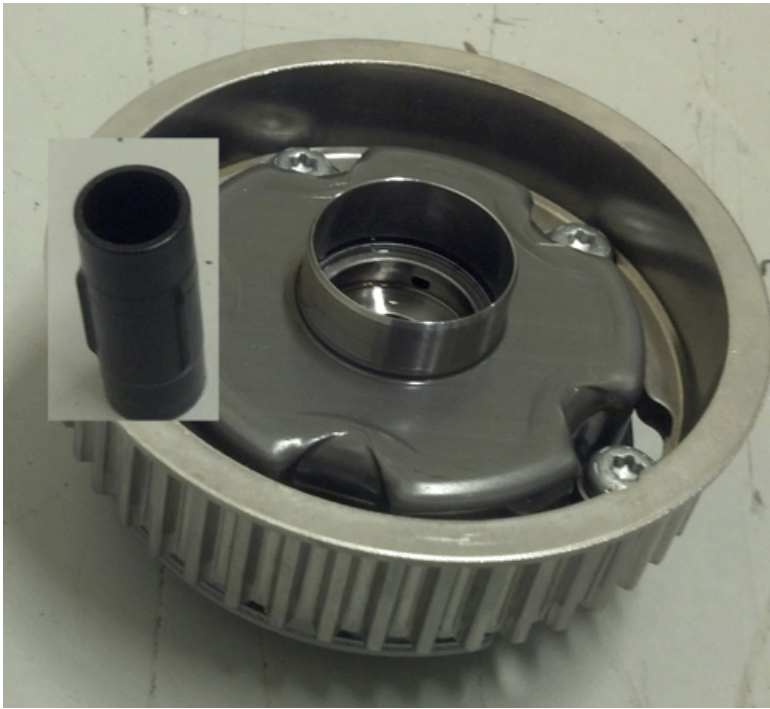
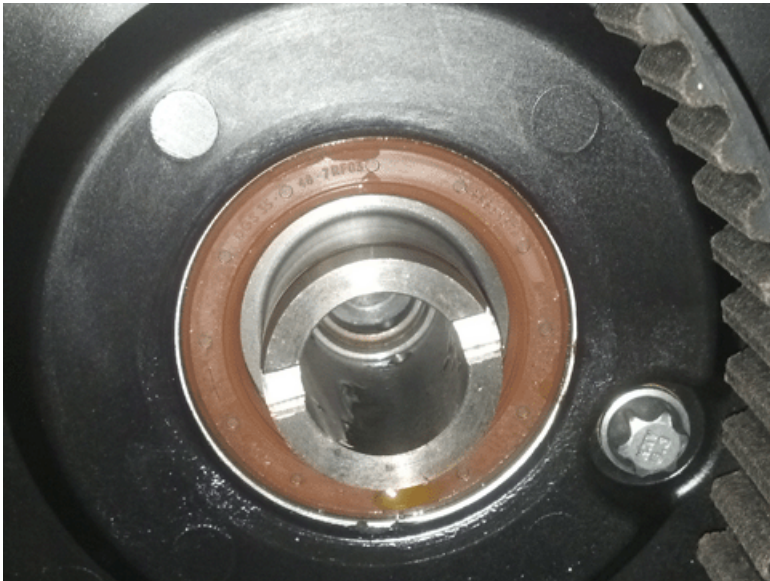
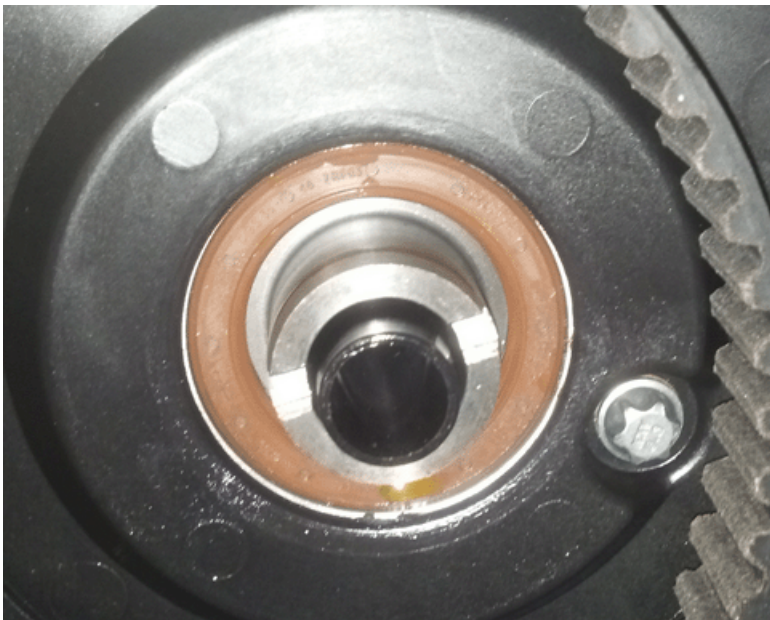
See Photos below.

These engines have a unique black plastic oil sleeve that is between the end of the cam actuator and camshaft.

This sleeve directs oil to the actuator to advance or retard the cam timing.

If a sleeve is missing or damaged, the ECM cannot control the actuator movement, which may result in one or more timing DTCs.

Remove the cam actuators and inspect for a missing actuator oil sleeve.

Note: When removal of the actuator is required, insure installation of these sleeve's during the reassembly of the engine. These sleeves are not shown in the parts imager and are only available as part of the camshaft actuator assembly.
