Service Bulletin

PRELIMINARY INFORMATION

Subject: Wind Buffeting Drone Type Noise And/Or Body Pressure Booming And/Or Water Leak

Models: 2015 Cadillac Escalade Models
2015 Chevrolet Suburban, Tahoe
2015 GMC Yukon Models

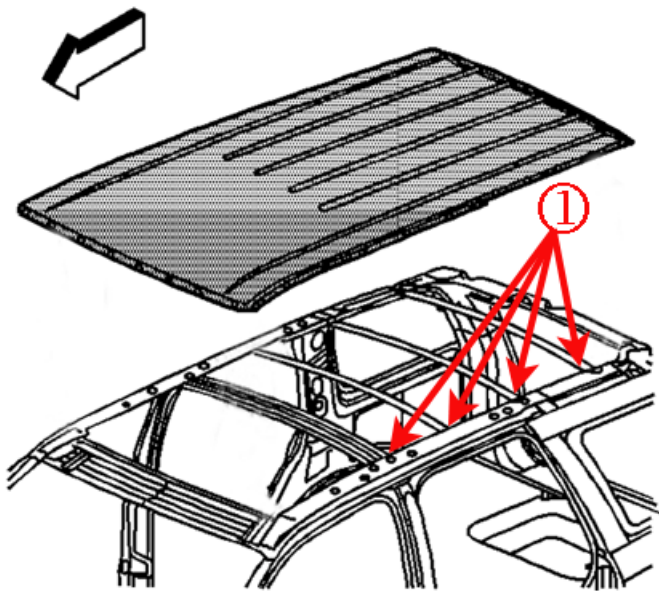
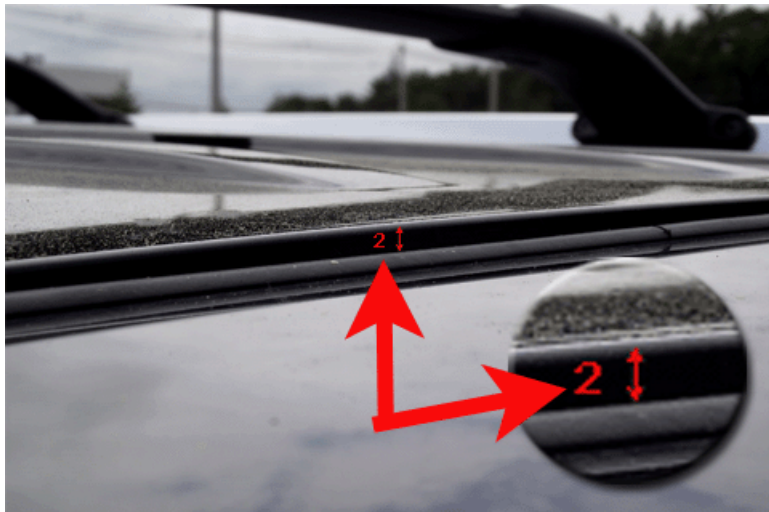
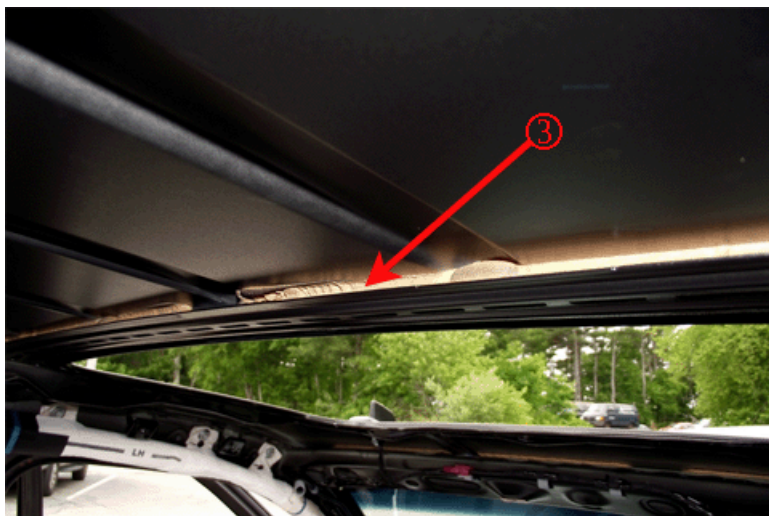
These concerns could be caused by the roof sheet metal no longer being attached fully to the roof bows (1). On trucks with a sunroof, it may be noticed that the rear edge of the sunroof glass is considerably lower than the roof (2). This is due to the roof sheet metal being detached from the roof bow directly behind the sunroof opening (3).

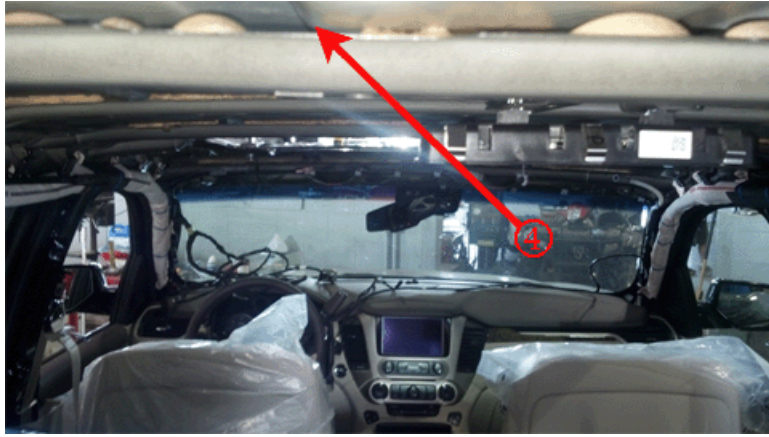
To correct this concern, apply panel vibration control material between the roof bow and roof sheet metal, along with foam shim material when necessary. Remove the headliner to access the underside of the roof. Inspect all 4 roof bows for insufficient bonding to the roof sheet metal (4). Any roof bow that is not

bonded to the sheet metal will need to be repaired.

Use a plastic scraper or similar tool to remove the old foam. Measure the gap between the top of the roof bow and bottom of the roof sheet metal. If the gap is 1/4" (6mm) or greater, use a combination of 3/4" wide by 5/16" or 7/16" thick foam shim material (as listed below) to fill the gap between the roof bow and the sheet metal. Care should be taken to add only the correct thickness of foam to fill the gap so it does not push up on the roof. Cut the foam into 5 inch lengths and evenly place in five spots along the roof bow. With the foam shim material in place, or if the gap is less than 1/4" (6mm), use the panel control vibration material (as listed below) to fill the voids between the roof bow and sheet metal. In some cases, it may take a couple layers of material to fill the void.
