Service Bulletin

PRELIMINARY INFORMATION

Subject: Hood Shakes / Lifts On Sides Or Flutters At The Rear

Models: 2015 Chevrolet Colorado
2015 GMC Canyon

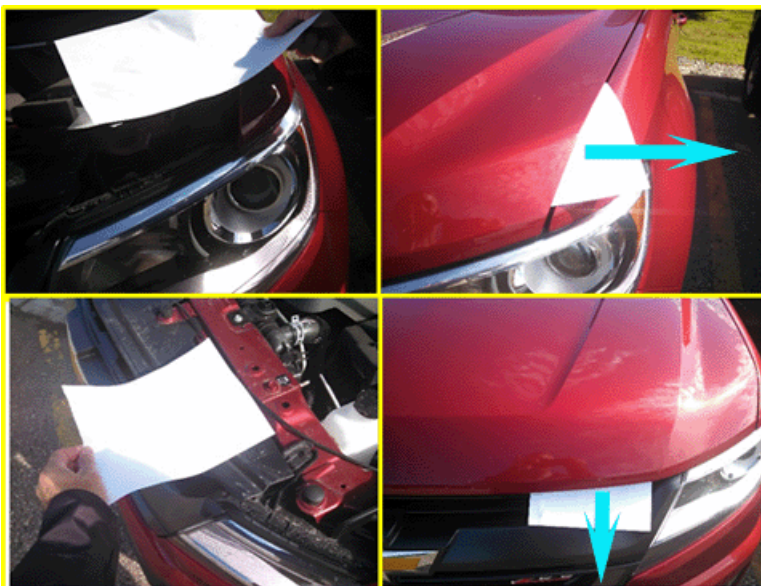
The 4 outboard bumpers must have good contact and the paper should not pull free when the hood is closed

The 2 inboard bumpers must have slight clearance to the hood so the paper should pull out but with some drag.

2. With a piece of paper, check all 6 bumpers with this paper test.
