Service Bulletin

PRELIMINARY INFORMATION

Subject: Trunk Does Not Open With Key Fob Touchpad Or Inside Release Button

Models: 2015 - 2016 ATS Cadillac Coupe
2016 Cadillac ATS V Coupe
2014 - 2016 Cadillac CTS Sedan
2014 - 2016 Cadillac CTS V Sport

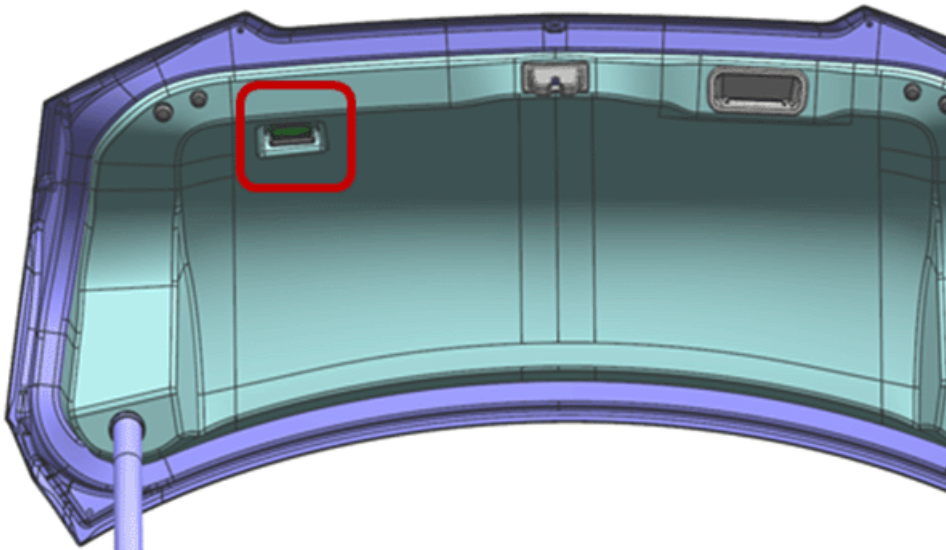
The Emergency Trunk Release (ETR) handle bezel may have been positioned incorrectly where it comes through the opening in the deck lid liner or there maybe interference from the deck-lid liner.

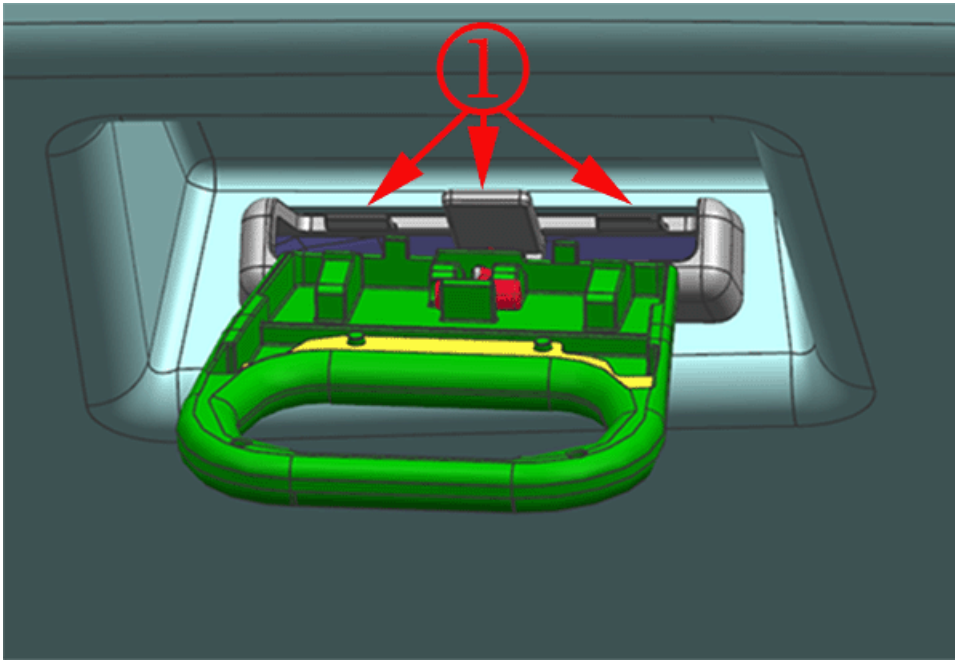
Using the image below as reference check the orientation of the tabs on the bezel. Are the three tabs on the retainer visible or are they obscured by the carpet?

Interference from the trim can cause the handle and cable to bind. Any sort of preload on the ETR cable will not allow the latch to release when any of the electric switches are used.

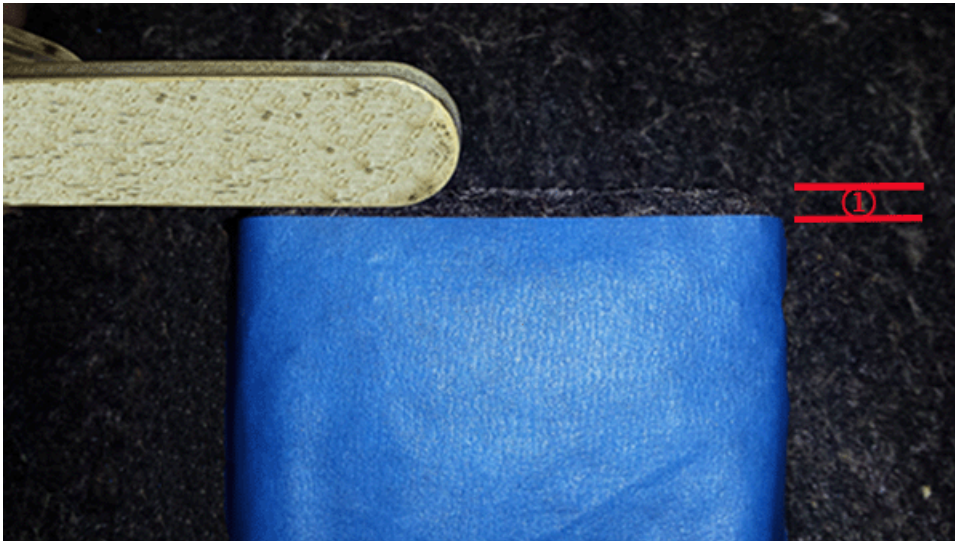
The handle has been removed from the image for clarity.

Using the images below as reference, on the back side of the liner, mark off and remove a 5mm (1) rectangle along the flat surface of the deck lid liner.

Do not extend past the where the corners of the bezel would be.

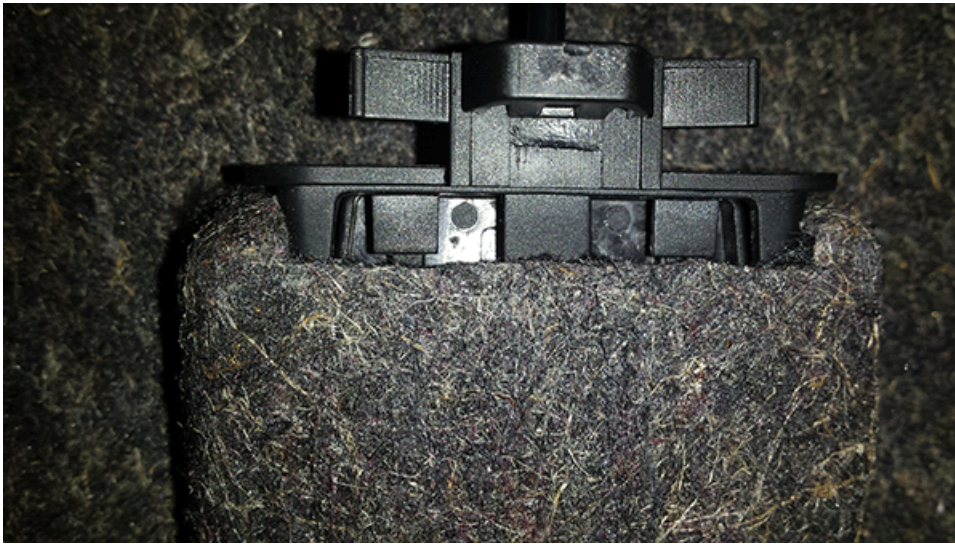
After removal of the material from the truck lid liner and installation of the bezel and ETR the assembly.

Reinstall liner, ETR and bezel and confirm smooth operation.
