Service Bulletin

PRELIMINARY INFORMATION

Subject: **BAS+ (HYBRID) eAssist Drive Motor Generator Battery Module (Powerpack) or Drive Motor Generator Battery Section Exchange Process And Order Instructions**

Models: **2012 - 2015 Buick Lacrosse, Regal**
2013 - 2014 Chevrolet Malibu ECO
2014 - Chevrolet Impala
All equipped with eAssist (RPO HP6)

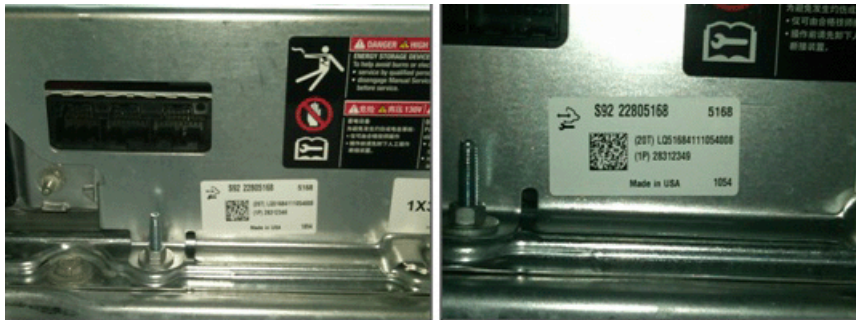
8. Prior to contacting TAC, make sure you know:
 - The parts department fax number
 - The Powerpack serial number (Battery Identification Number)
9. The Battery Identification Number (BIN) tag is located on the side of the assembly cover. Locate the tag and record the 16 digit Battery Identification Number. The BIN number begins with digits "20T" (See Photo Below). If the Generator Control and Battery Module is not out of the vehicle yet, you can find the assembly ID number by installing the MDI and using GDS2. Access the Battery Energy Control Module menu and look under the ID Information section for the sixteen digit number. It will be listed under the parameter: Hybrid Battery Pack Identification Number. You will need to record the serial number and supply it to TAC when requesting a Powerpack or Battery Sections.

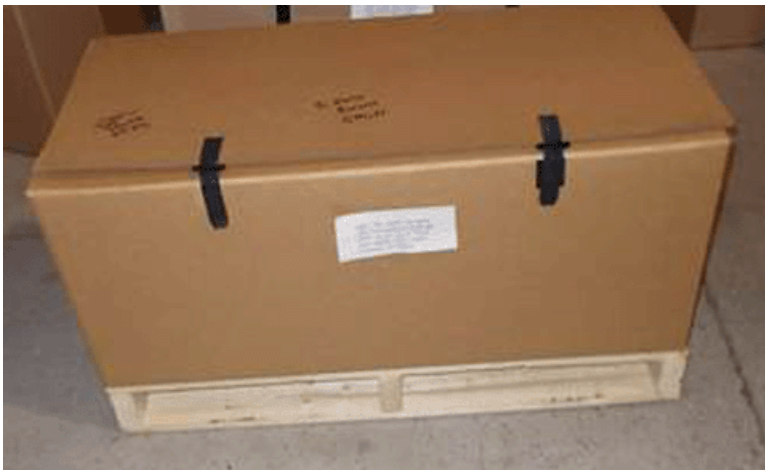
9. Place a copy of the completed repair order with any technician comments, inside the shipping container with the failed battery.
10. Close the top lid and adhere using the two Velcro straps.
