Service Bulletin

Subject: DTC P0016 P0017 P0018 P0019 P0008 P0009

Models: 2007-2016 Buick Enclave
2005-2016 Buick LaCrosse Allure (Canada Only)
2013-2015 Cadillac ATS XTS
2004-2015 Cadillac CTS SRX
2004-2011 Cadillac STS
2010-2015 Chevrolet Camaro
2015-2016 Chevrolet Colorado
2008-2016 Chevrolet Equinox
2012-2016 Chevrolet Impala
2008-2012 Chevrolet Malibu
2009-2016 Chevrolet Traverse
2007-2016 GMC Acadia
2015-2016 GMC Canyon
2010-2016 GMC Terrain
2007-2009 Pontiac G6
2008-2009 Pontiac G8, Torrent
2007-2010 Saturn Aura, Outlook
2008-2010 Saturn Vue
Equipped with 2.8L LP1, 2.8 LAU, 3.0 LF1, LFW 3.6L LY7, LLT, LFX engines

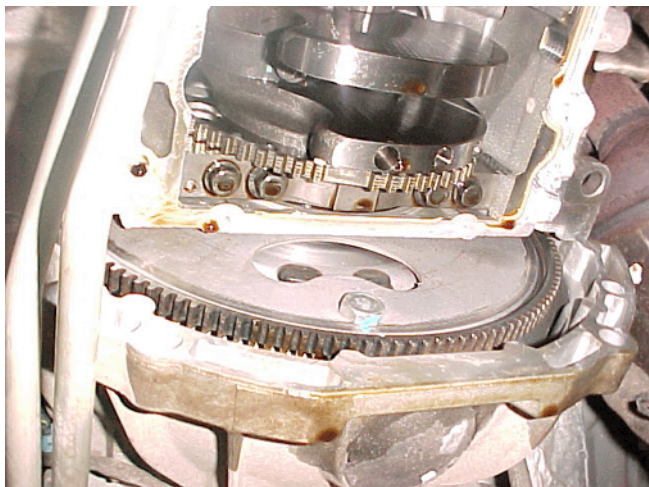
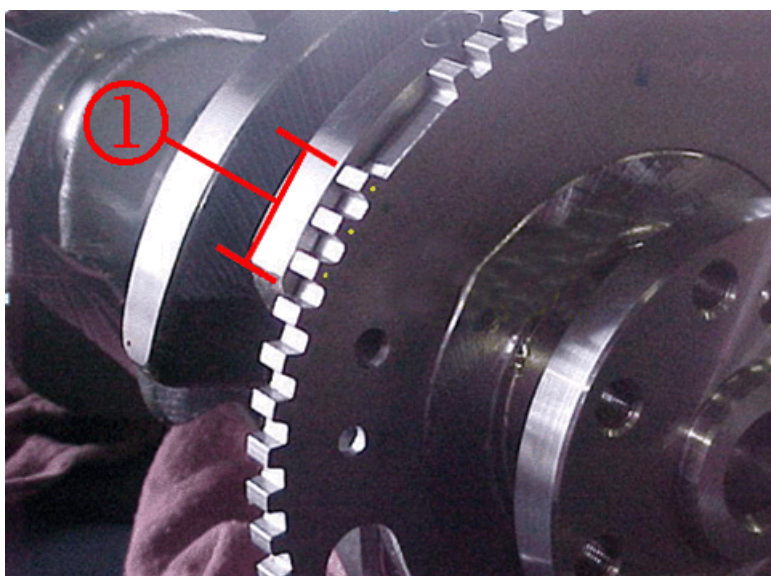
1= The actual measurement of a good Reluctor wheel.

25 to 26 mm This measurement is from the end of the machined surface of the crankshaft throw to the edge of the open space in the reluctor. (approximately 3 1/2 teeth)

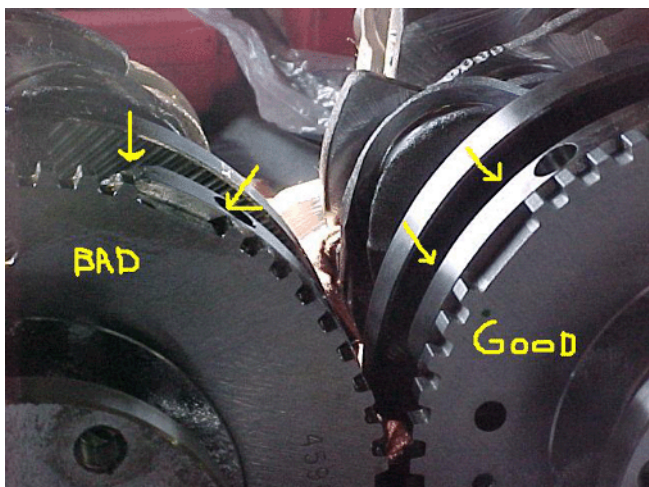
2 and 3 = Show a good reluctor next to a bad reluctor.
