Service Bulletin

PRELIMINARY INFORMATION

Subject: Tire Sidewall Irregularities

Models: 2007 - 2016 Cadillac Escalade Models
2007 - 2016 Chevrolet Avalanche, Silverado, Suburban, Tahoe
2007 - 2016 GMC Sierra Models, Yukon Models

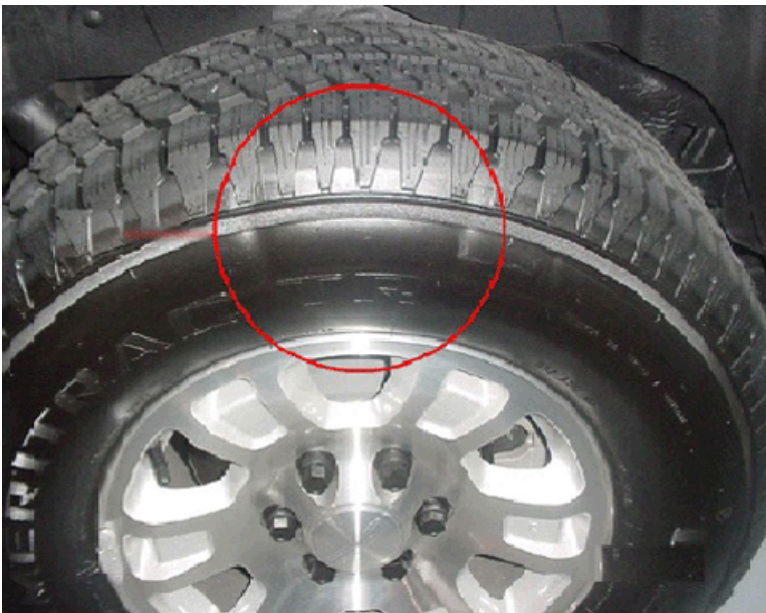
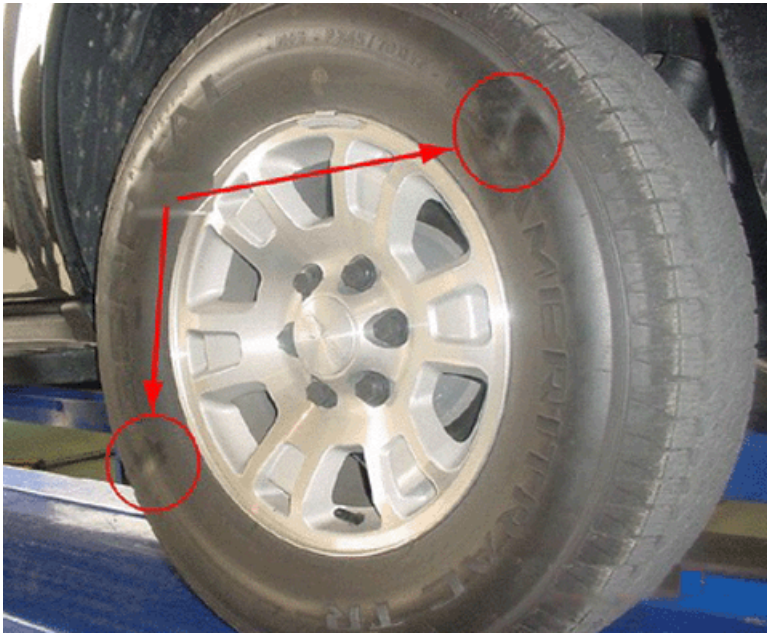
Slight sidewall indentations are a common characteristic of radial tire construction. These indentations are more noticeable on larger size tires having a larger side wall height. Radial tire body construction includes individual cords that run parallel to each other from bead to bead (down the sidewall, across the tread and up the other sidewall). These cords will overlap at points on the circumference of the tire. When the tire is mounted and inflated, it is free to naturally expand. The overlapped areas may create slight indentations, undulations, or protrusions since the stretching capacity of the overlapped area is slightly different than the rest of tire sidewall area.

The following two photo's show examples of tires with a sidewall indentation

This is a visual condition that will not affect durability, reliability or performance of the tires. Tire replacement to address this condition is not recommended and will lead to customer dissatisfaction as the replacement tires will likely have the same or similar condition.
