Service Bulletin

Subject: DTC P0016 P0017 P0018 P0019 P0008 P0009

Models: 2007-2016 Buick Enclave
2005-2016 Buick LaCrosse Allure (Canada Only)
2013-2015 Cadillac ATS
2013-2016 Cadillac XTS
2004-2015 Cadillac CTS
2004-2016 Cadillac SRX
2004-2011 Cadillac STS
2010-2015 Chevrolet Camaro
2015-2016 Chevrolet Colorado
2008-2016 Chevrolet Equinox
2012-2016 Chevrolet Impala
2008-2012 Chevrolet Malibu
2009-2016 Chevrolet Traverse
2007-2016 GMC Acadia
2015-2016 GMC Canyon
2010-2016 GMC Terrain
2007-2009 Pontiac G6
2008-2009 Pontiac G8, Torrent
2007-2010 Saturn Aura, Outlook
2008-2010 Saturn Vue
Equipped with 2.8L LP1, 2.8 LAU, 3.0 LF1, LFW 3.6L LY7, LLT, or LFX HFV6 engines

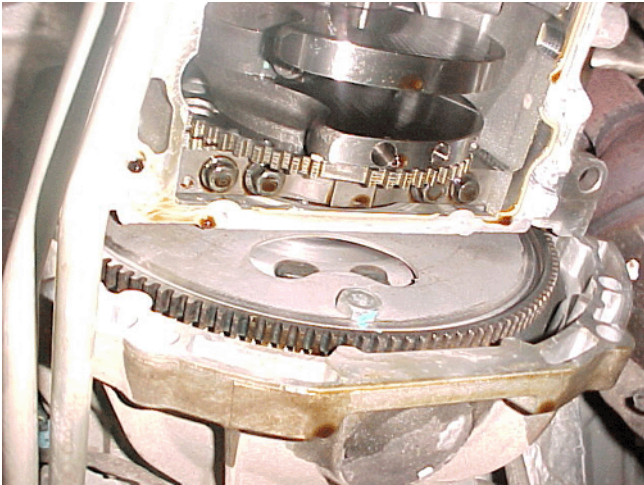
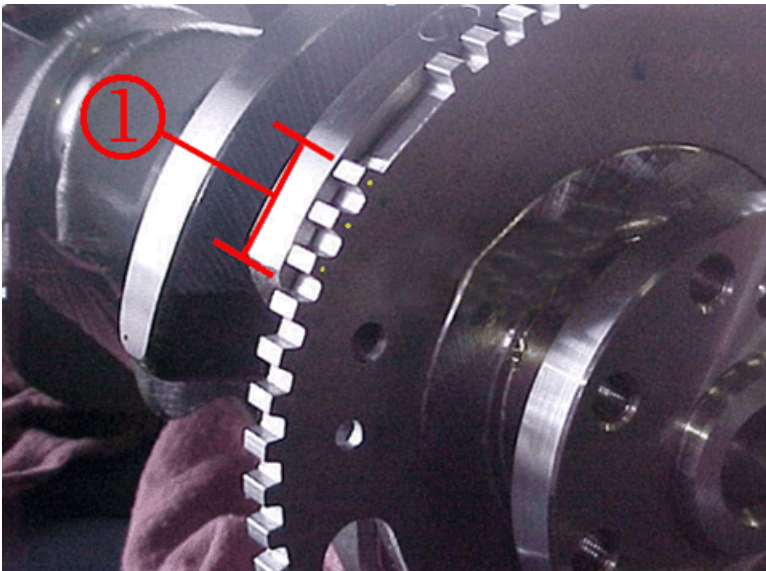
1= The actual measurement of a good Reluctor wheel.

25 to 26 mm This measurement is from the end of the machined surface of the crankshaft throw to the edge of the open space in the reluctor. (approximately 3 1/2 teeth)

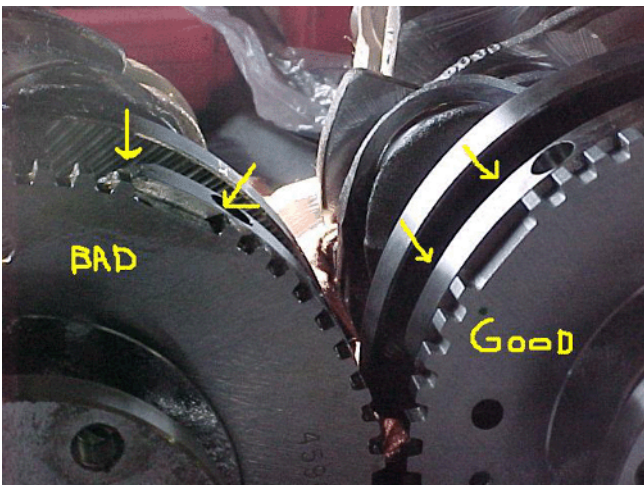
2 and 3 = Show a good reluctor next to a bad reluctor.

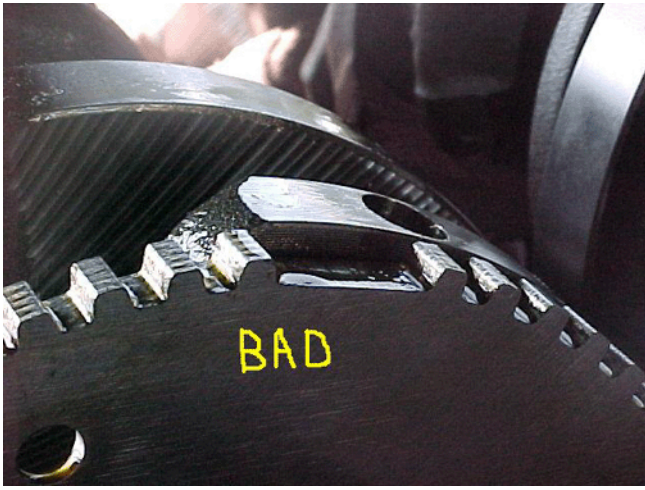
The reluctor for the crankshaft sensor pressed onto the rear of the crankshaft may have moved.

Crankshaft with bad reluctor wheel

Note: The distance can be offset either clockwise or counter clockwise. Both will result in these codes.

Note: The balance hole does not come into play when determining if the reluctor has slipped or not.

If the reluctor has moved then replace crankshaft.
