Service Bulletin

Subject: Burning Odor on Volts When Operating in Extended Range, Hold, or Mountain Modes

Models: 2016 Chevrolet Volt

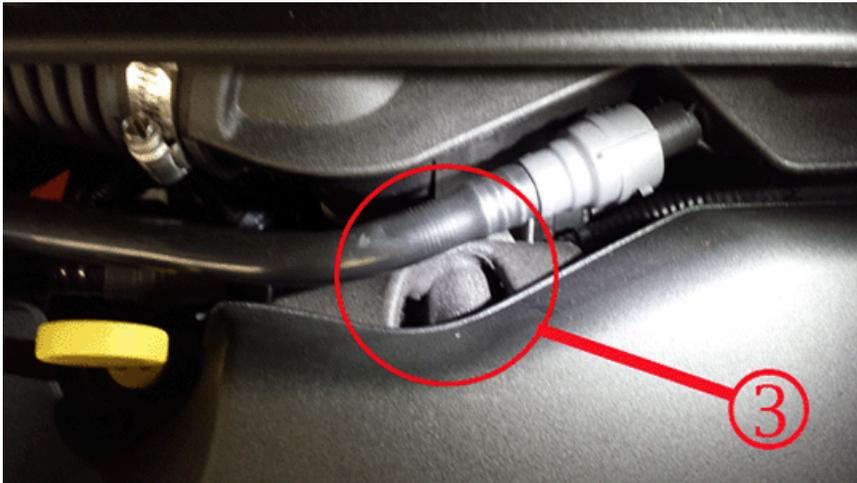
Engine Cover Foam not installed correctly

3) Foam installed folded over, contacting the line

Please inspect the Engine cover and Compare to the pictures to see if the foam is folded.

- 1) If the Foam is deformed then replace the cover.
- 2) If a burning odor was found replace the cabin filter.

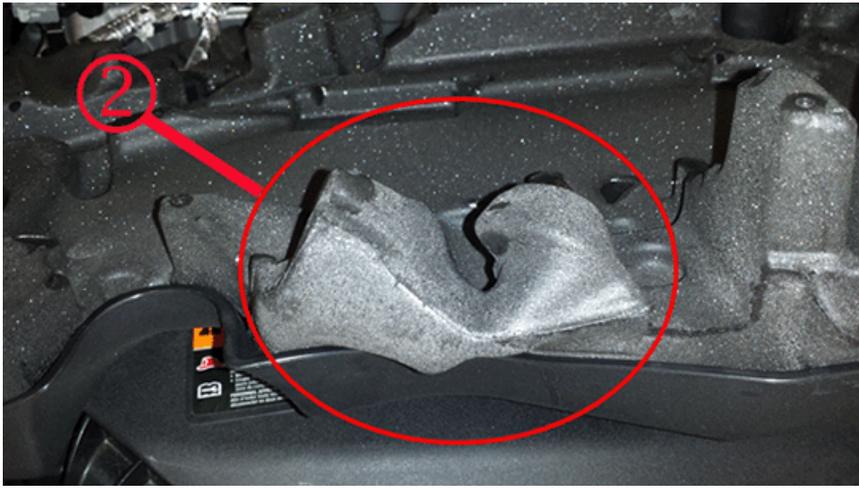
2) Foam is Deformed from heat

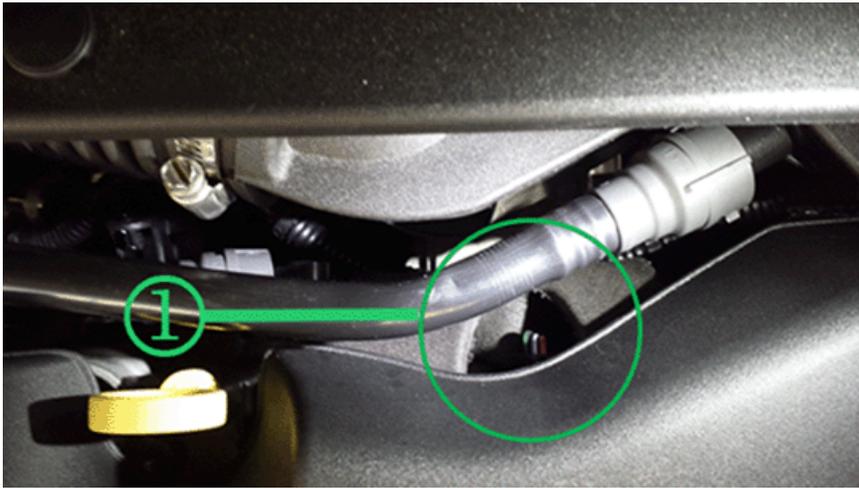
1) Cover and foam installed Correctly
