Service Bulletin

PRELIMINARY INFORMATION

Subject: Diagnostic Tips - Water Leaks

Models: 2015 - 2016 Chevrolet Colorado
2015 - 2016 GMC Canyon

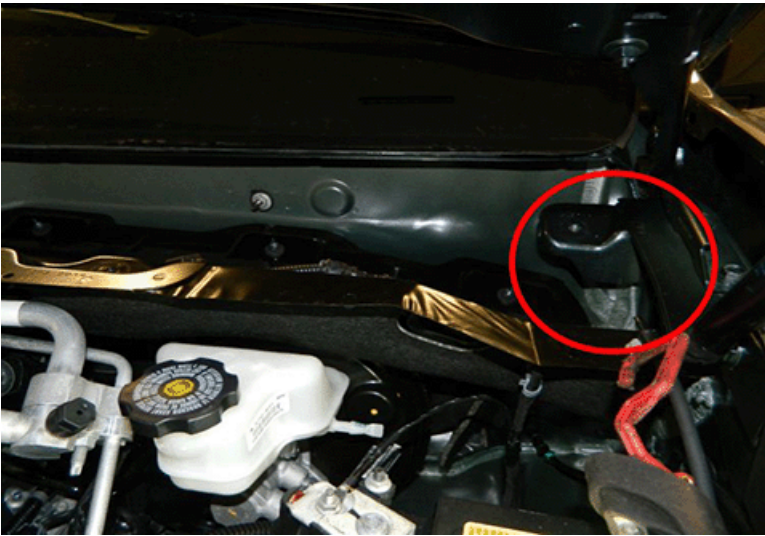
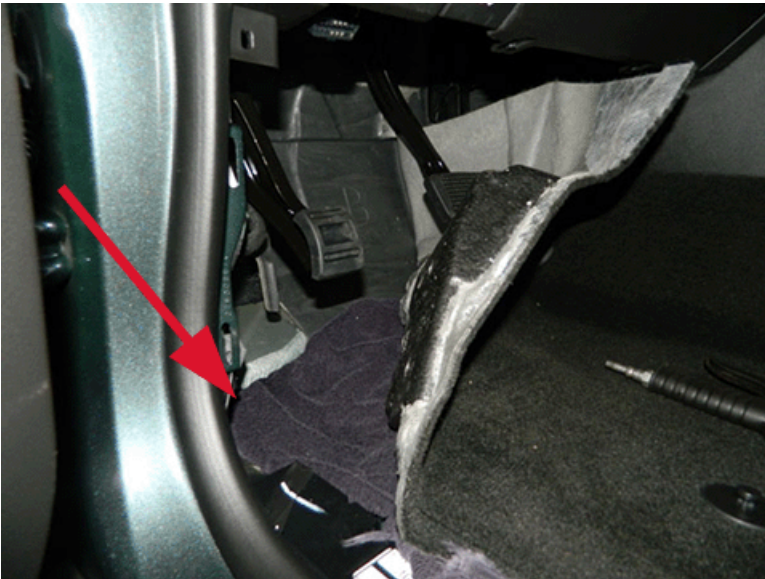
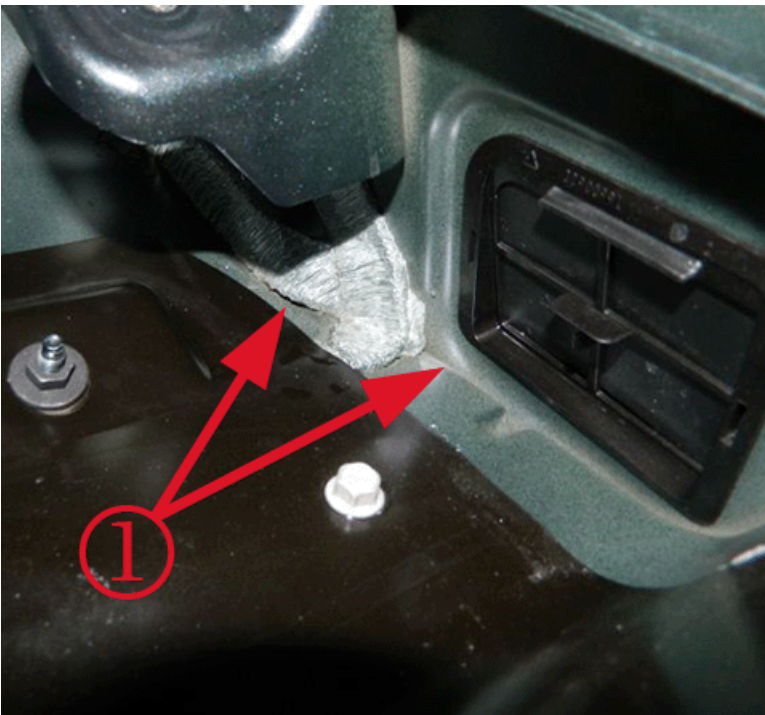
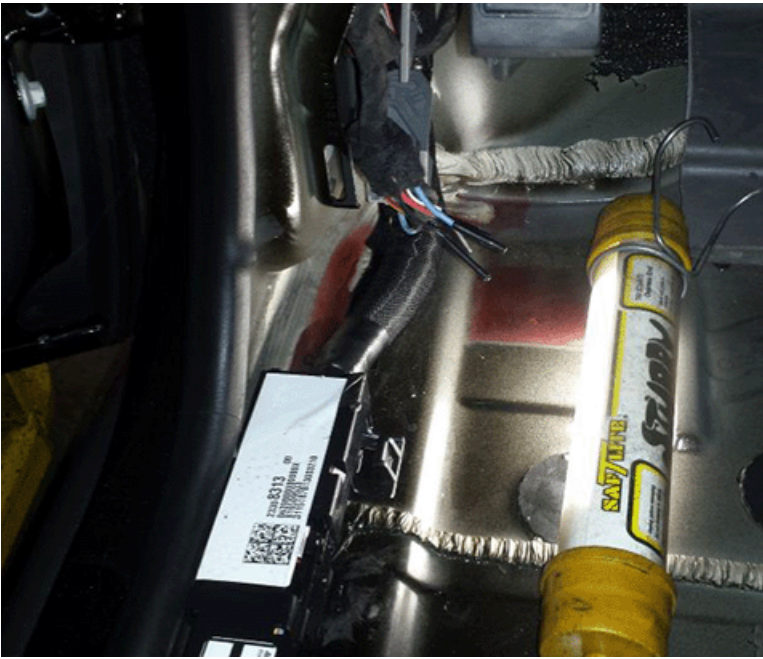
5. Cowl seam: May allow water to accumulate on the floor. Water test by cowl drain left and right side. Water may enter from outside cowl area under hood from left and right side add seam sealer.

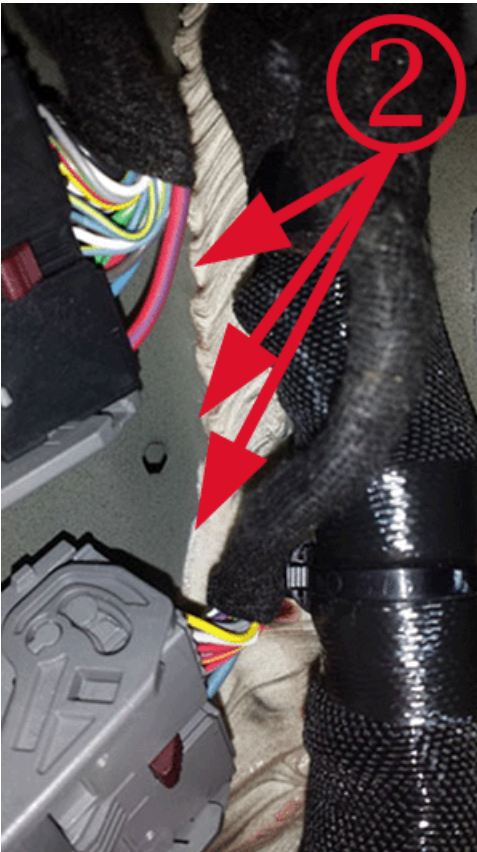
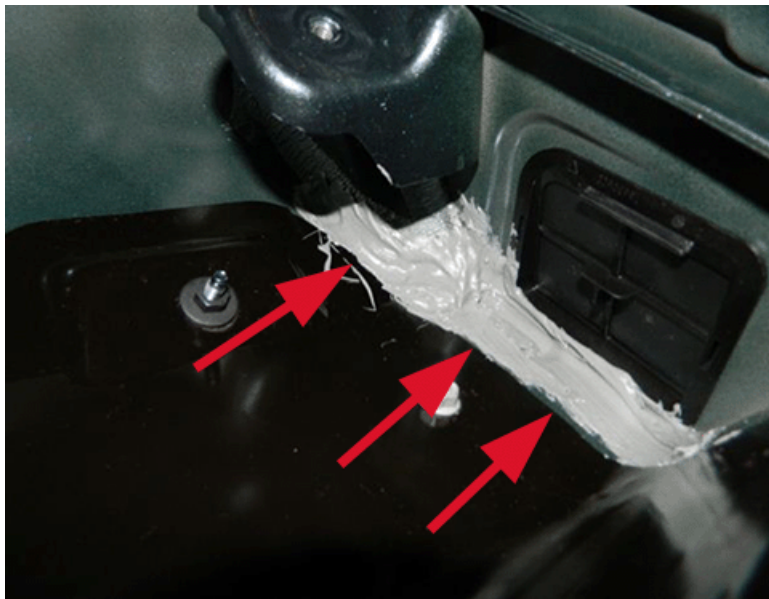
The other area is under dash in the left and right side vertical seams. Reseal as needed
