Service Bulletin

PRELIMINARY INFORMATION

Subject: Unable To Achieve Preload On Pinion Bearings 9.5/9.76 Inch Rear Axles

Models: 2014-2016 Chevrolet Silverado
2015-2016 Chevrolet Tahoe, Suburban
2014-2016 GMC Sierra
2015-2016 GMC Yukon
2015-2016 Cadillac Escalade
Equipped with 9.5 inch or 9.76 inch rear axle.

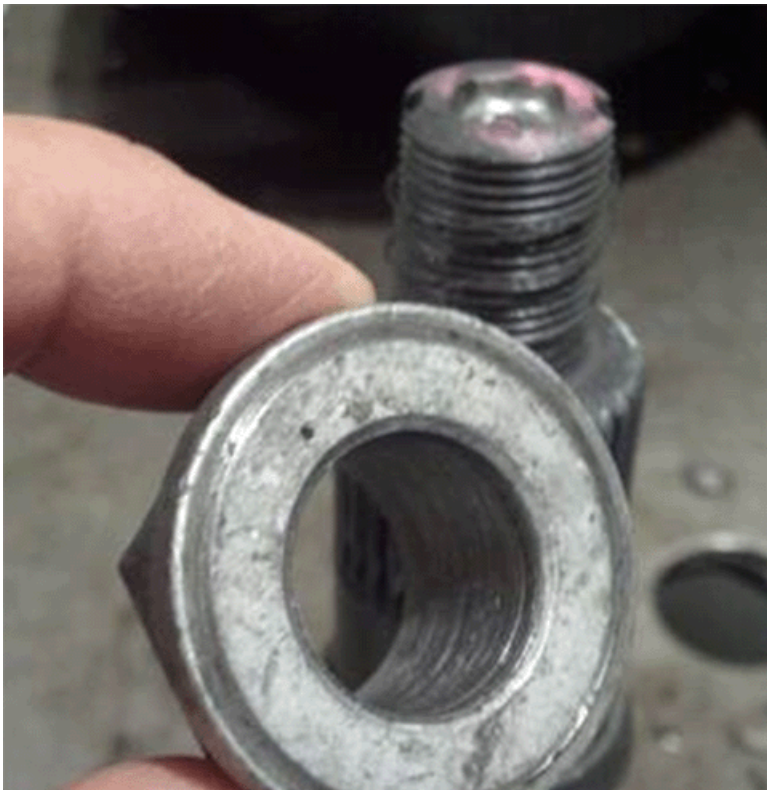
Technicians may be unable to achieve pre-load when setting up the pinion bearing pre-loads during reassembly of the 9.5/9.76 inch rear axles. Reports from the field include breaking of sockets, breaker bars, ratchets and pinion holding tool without achieving preload. Also we have seen pinion gears with stripped threads.

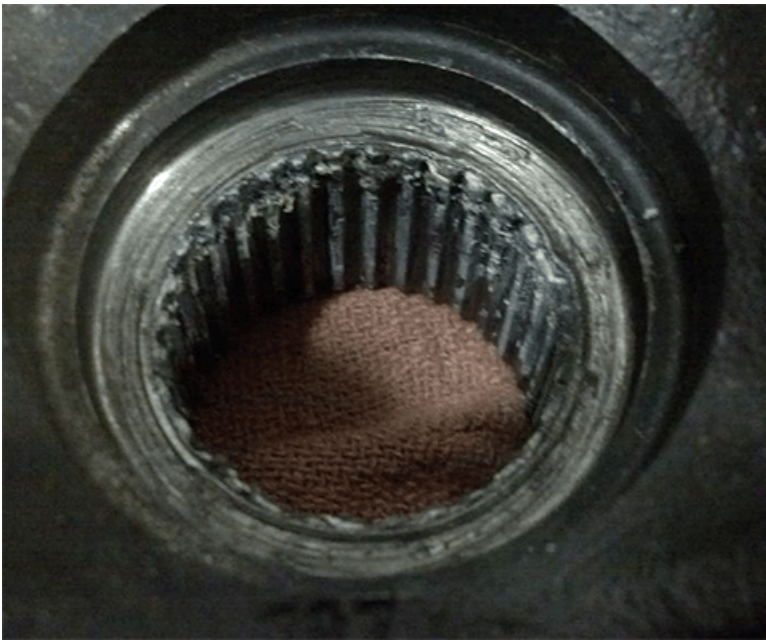
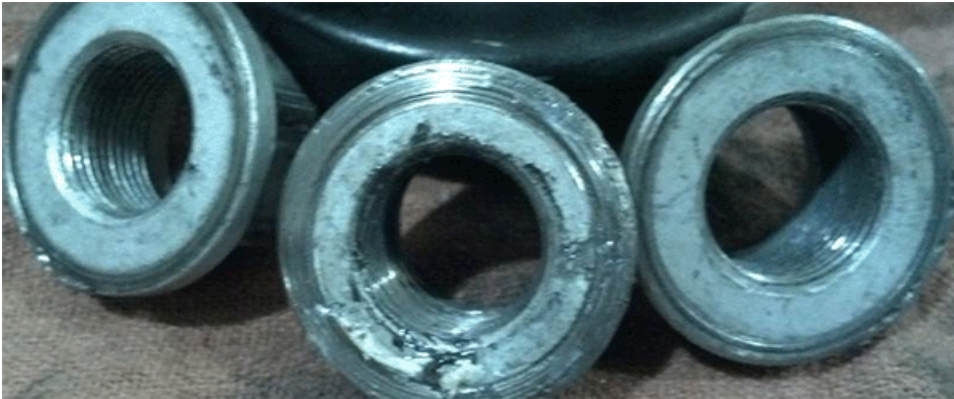
This has been identified to be caused when reusing a pinion flange that has imperfections in the mating surface where the nut contacts the flange. In rare occasions it has also been experienced with a new flange as the nut and flange mating surface start to wear into each other with high pressure associated with

drawing the bearing and flange onto the gear. When there is extremely high amounts of torque applied to the pinion nut it is possible to deform the nut which starts the thread damage.

To aid in assembly the following information can be used in conjunction with Differential Drive Pinion Gear Bearing Replacement procedure in service information. With the pinion flange started onto the pinion gear install washer part number 11609638 onto the pinion shaft between the flange and nut.

Tighten the pinion nut until you achieve 10 lb in. (1.0 Nm) rotating torque.

Back the nut off and remove the washer.

Tighten the nut back down until you achieve 15 lb in. (1.7 Nm) for used bearings or 20 lb in (2.25 Nm) for new bearings.
