# Service Bulletin

**Subject:** Engine Replacement Recommendations HFV6 Gen 1 Only

**Models:** 2008-2016 Buick Enclave  
2010-2016 Buick LaCrosse  
2013-2015 Cadillac ATS  
2016 Cadillac ATS-V  
2007-2015 Cadillac CTS  
2014-2016 Cadillac CTS V-Sport  
2007-2010 Cadillac STS  
2007-2016 Cadillac SRX  
2013-2016 Cadillac XTS  
2010-2015 Chevrolet Camaro  
2012-2013 Chevrolet Caprice PPV  
2012-2015 Chevrolet Captiva Sport  
2015-2016 Chevrolet Colorado  
2008-2016 Chevrolet Equinox  
2012-2016 Chevrolet Impala Vin W  
2014-2016 Chevrolet Impala Vin 1 (including Bi-fuel)  
2008-2012 Chevrolet Malibu  
2009-2016 Chevrolet Traverse  
2007-2016 GMC Acadia  
2015-2016 GMC Canyon  
2010-2016 GMC Terrain  
2008-2010 Pontiac G6  
2008-2009 Pontiac G8  
2008-2009 Pontiac Torrent  
2007-2009 Saturn Aura  
2008-2010 Saturn Vue  
2007-2010 Saturn Outlook  
Equipped with HFV6 Gen 1 engines including RPO codes LAU, LF1, LF3, LF4, LFR, LFW, LFX, LLT, LP1, and LY7

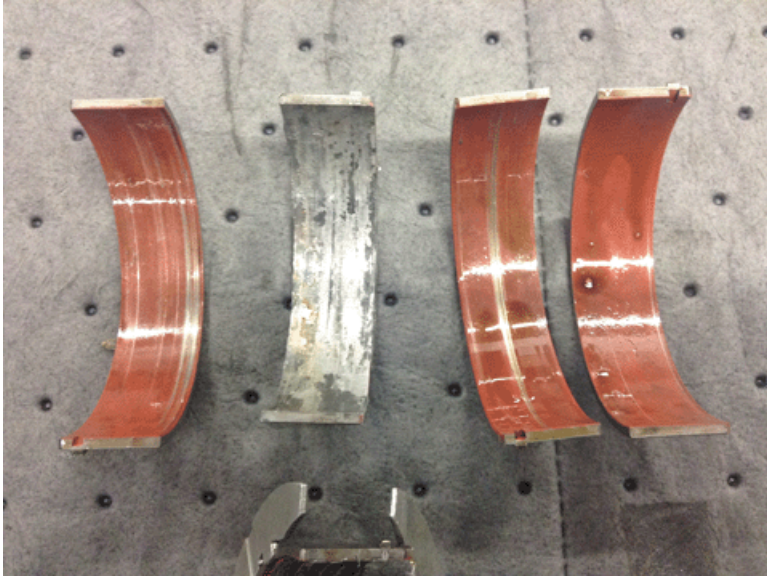
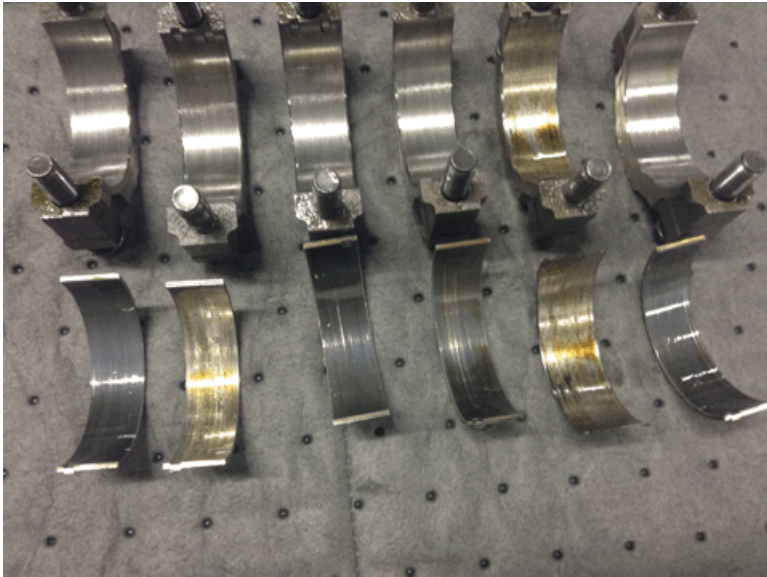
First, verify there is metal in the engine oil caused by BEARING DAMAGE / debris by removing the oil pan.

If Due To BEARING FAILURE when completing diagnosis, and deciding whether to replace the engine or repair it, complete the following before making that determination.

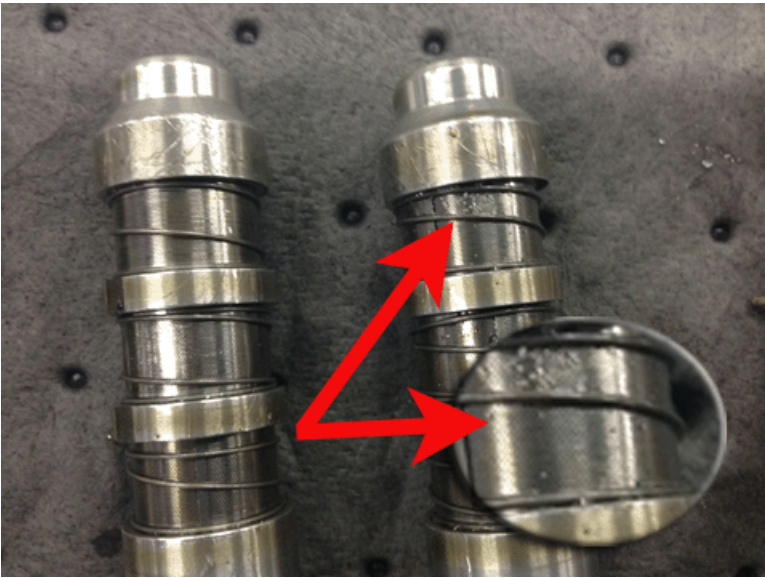
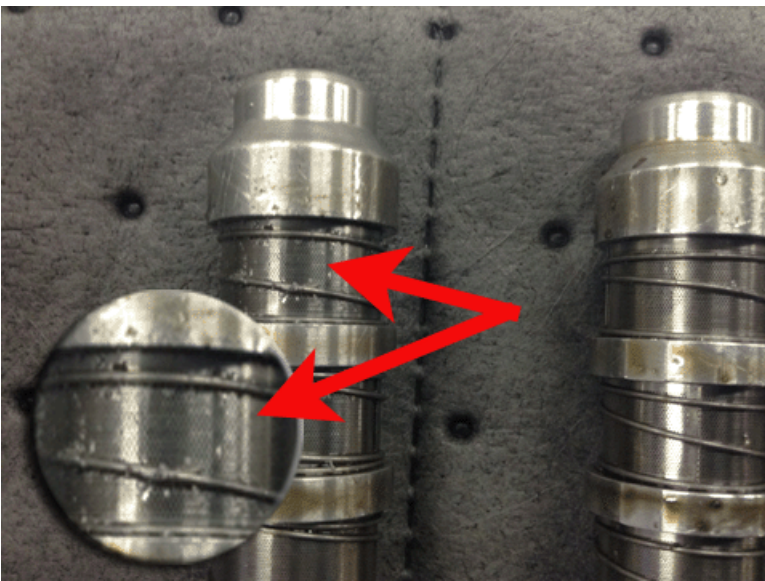
1. Inspect the oil control solenoids for metal debris. This shows the oil filter is in by-pass and unfiltered oil with bearing debris was pumped into the oil lubrication galleries, throughout the engine

Any Of These 3 instances would be cause to replace the engine instead of repair.

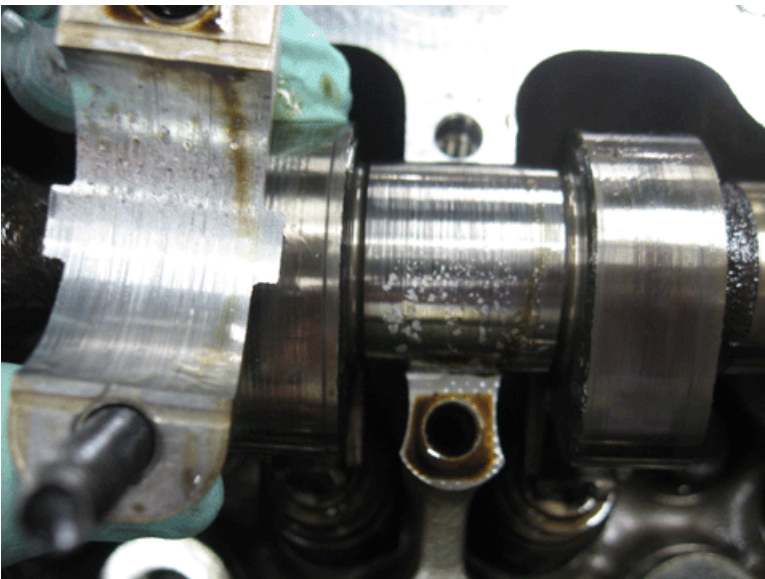
2. Inspect for damage to the cam caps Journals and camshaft journals on the heads (obvious signs of metal through the cap).

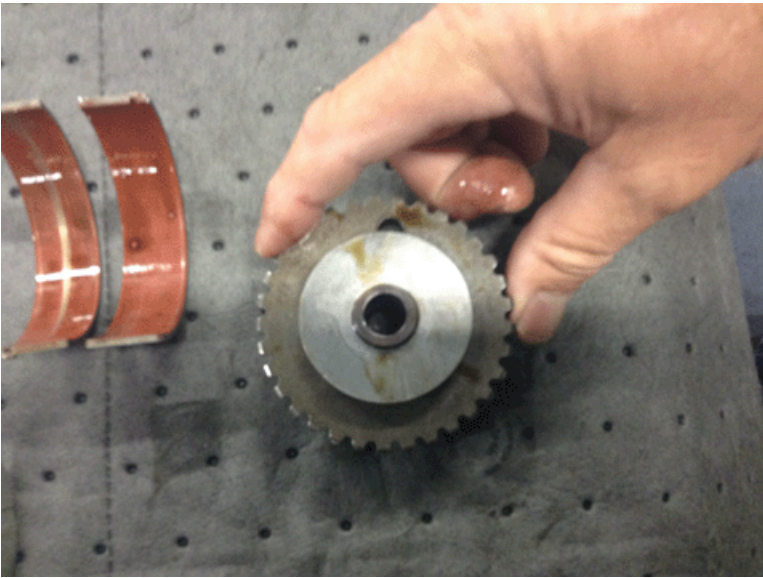
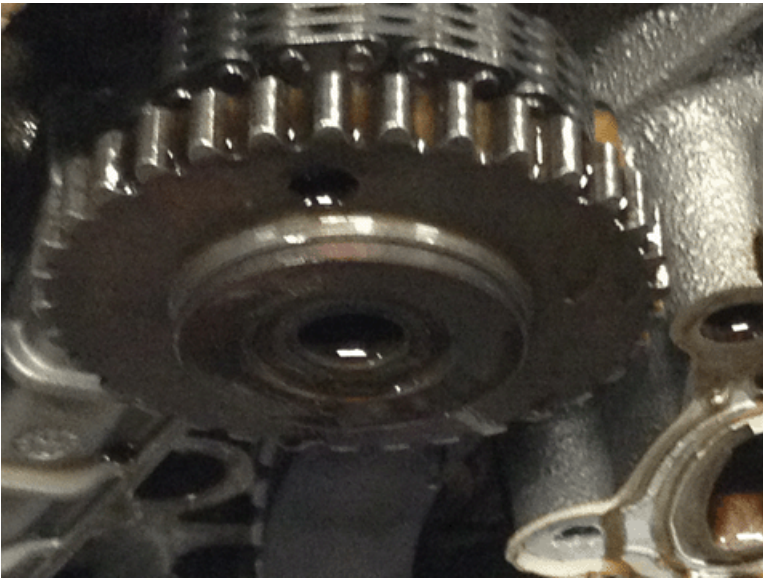
3. Inspect the timing chain idler sprockets for stiffness when turning. (Should turn smooth and free)
