Service Bulletin

PRELIMINARY INFORMATION

Subject: MIL On With DTC P0016 And/Or P0017 Setting On A Properly Timed Engine Or Crank No Start

Models: 2011-2016 Buick Regal
2010-2016 Buick LaCrosse
2013-2016 Buick Verano
2013-2014 Chevrolet Captiva
2006-2010 Chevrolet Cobalt
2010-2016 Chevrolet Equinox
2006-2011 Chevrolet HHR
2014 Chevrolet Impala
2007-2013 Chevrolet Malibu
2010-2016 GMC Terrain
2007-2010 Pontiac G5
2006-2010 Pontiac G6
2006-2010 Pontiac Solstice
2007-2010 Saturn Aura
2006-2007 Saturn Ion
2007-2010 Saturn Sky
2007-2010 Saturn Vue
Equipped with the following engines
2.0L (LNF LHU)
2.2L (L61 LAP LE8)
2.4L (LAT LAF LE5 LE9 LEA LUK)

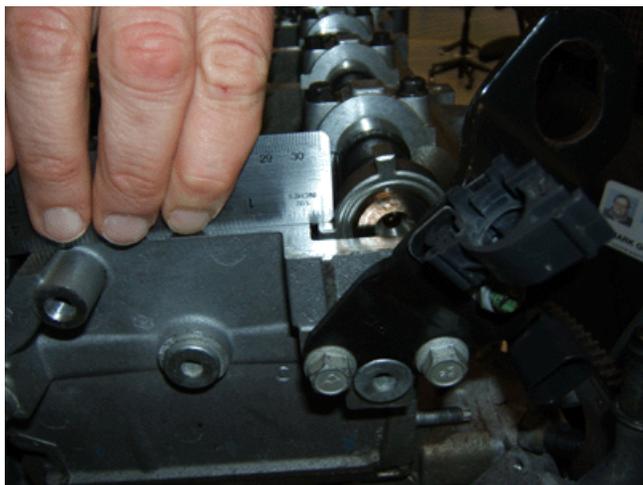
To check the Exhaust Cam reluctor position LE5 ONLY:

With the exhaust camshaft positioned so that the valves for #4 cylinder are at maximum lift (fully opened valves), the reluctor should be flush/parallel to the rocker cover gasket surface as shown in the photo below. If the reluctor position does not line up correctly, the exhaust camshaft must be replaced. To check

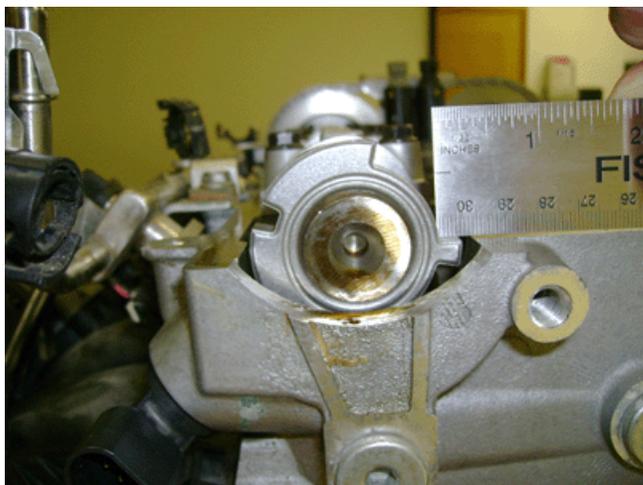
To check the Intake Cam reluctor position LE5 ONLY:

With the Intake camshaft positioned so that the valves for #1 cylinder are at maximum lift (fully opened valves), the reluctor should be flush/parallel to the rocker cover gasket surface as shown in the photo below. If the reluctor position does not line up correctly, the intake camshaft must be replaced.
