Service Bulletin

PRELIMINARY INFORMATION

Subject: Top Front Strut Mount Appearance Concern

Models: 2016 Chevrolet Camaro

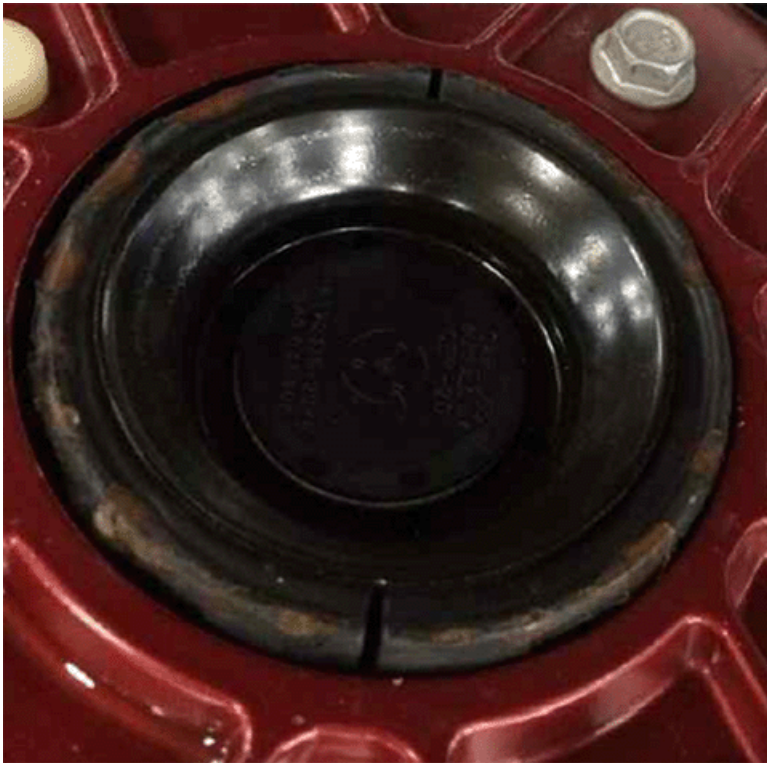
Some customers may comment on the appearance of the front struts inside the shock towers. They may see what appears to be a rust-like material around the rim of the upper strut mount. This can be seen in the picture below.

This concern is not actually rust, rather, is caused by an applied layer of rubber to the top of the strut that does not completely cover the nylon underneath. This appearance will not affect performance or durability of the vehicle. It is strictly a cosmetic concern..

Important: IMPORTANT: Do NOT replace any parts for this condition. Engineering is aware of the condition and working on a resolution. This PI will be updated once a repair becomes available. New parts are expected to be ready in the late 1st / early 2nd quarter of 2016 to resolve this concern.
