Service Bulletin

Subject: Creak Or Pop Type Noise Coming From Windshield Area During Cold Ambient Temperatures

Models: 2012-2016 Buick Enclave
2012-2016 Chevrolet Traverse
2012-2016 GMC Acadia

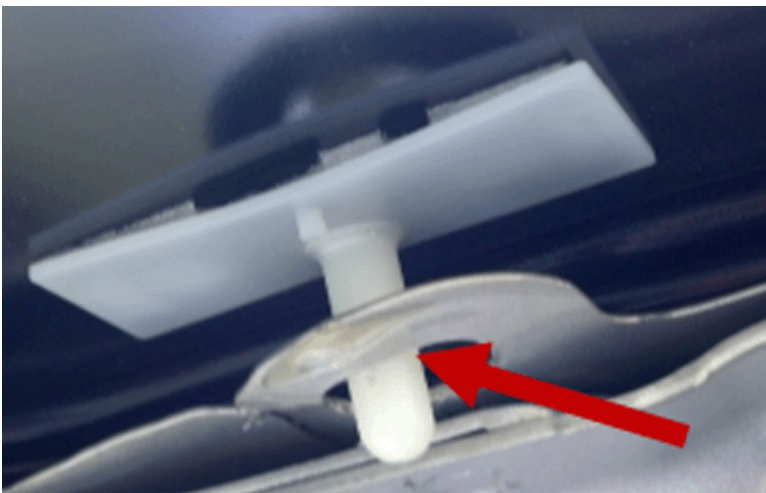
If the noise is coming from the upper windshield area, the condition may be caused by the windshield alignment pins in the upper corners of the glass, 5 inches in from the edge

If you cannot verify the concern, inspect the windshield alignment pins for rub/wear marks. If the pins shows rub/wear marks on them they will need to be removed.

The windshield alignment pins are in the upper corners of the glass.

If the noise changes or is gone remove the windshield alignment pins.
