# Service Bulletin

**Subject:** Drone Whine Type Noise From Front Of Transmission Area

**Models:** 2016 Cadillac ATS-V  
6-Speed Manual Trans Only (RPO MG9)

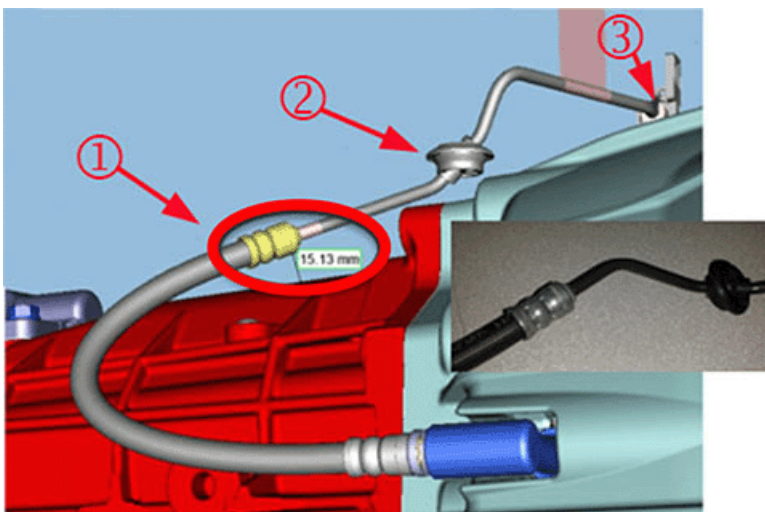
1. There is an issue with transmission bearing noise that can be heard with the vehicle at rest and the clutch pedal in the up position (clutch engaged so the trans internals are rotating). It's normal to hear a little bearing noise there, but can become exacerbated if an acoustic seal is not seated properly, including the clutch release line pass through so the two can be related. Please check the grommet passthrough at the transmission tunnel with a boroscope to make sure it is properly seated (Indicated by the number 2 in the picture below).
2. The Clutch release line's may not be installed properly, and contacting the transmission case, the noise will be worse when turning left as the transmission rolls into the line and better (or go away) when turning right.

This can be inspected & verified by viewing with a bore-scope on the passenger side of the transmission – the transition from steel line to rubber hose (Indicated by the number 1 in the pic below) will be very tight clearance and maybe a witness mark on the trans case may be visible, see image below.

To repair: the rear of the transmission needs to be dropped, and the rear of the cradle needs to be lowered a little to gain access to the line. the pass-through may be able to be reseated (indicated by number 2 in the picture above), and the line checked at the clip (indicated by number 3 in picture above) if necessary at this time. If the crimp section of the release line (indicated by the number 1 in the above image) is contacting or close to contacting the transmission case with the transmission at installed height and inspected by boroscope, the steel portion of the line can be carefully bent away from the transmission case to create clearance using the following procedure:

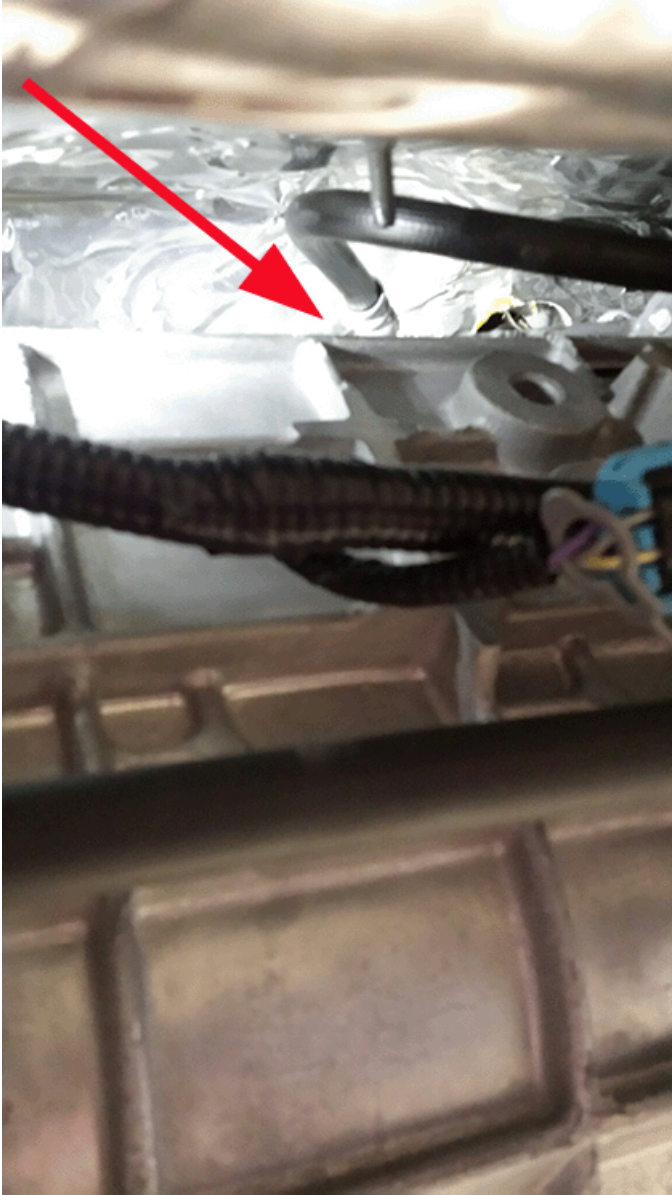
- f. Support the transmission with a jack forward of the transmission cross-member.
- g. Remove the transmission cross-member and lower the rear of the transmission to its full range of motion. Looking upward from the right side of the trans, the clutch line should be visible (Indicated by picture below).
