Bulletin No.: PIC6140B

Service Bulletin

Subject: Red LED and B2455 After Performing Canada Upgrade Bulletin 15-08-44-001

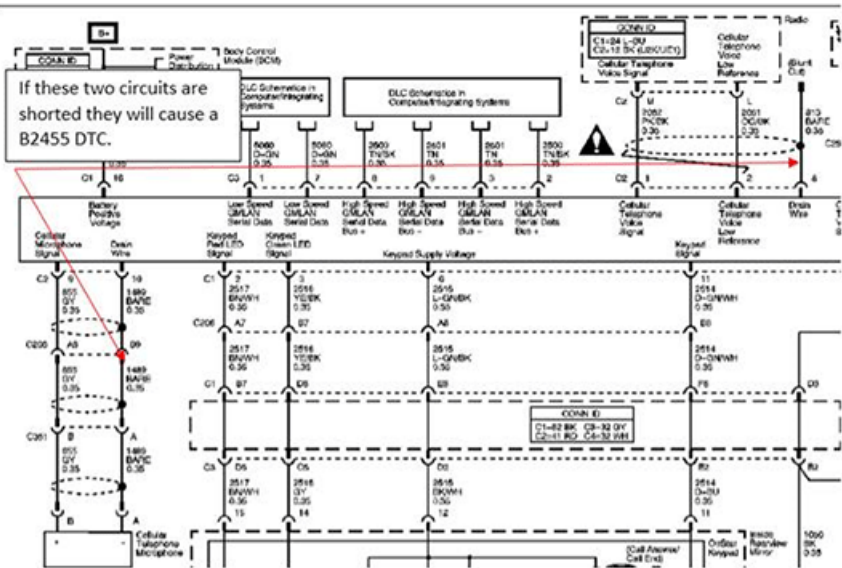
A dealer or customer may notice a red LED and DTC B2455 setting current in the VCIM after performing Canada upgrade bulletin 15-08-44-001. When placing calls or connecting to OnStar, the person on the other end is able to hear the caller clearly.

1. It has been found that a short between the audio drain wire and microphone drain wire will cause this concern.
2. Pull back the tape at X2 of the VCIM far enough to see where the bare wires are covered.
3. Tape the bare wires individually to prevent them from shorting. Then tape the harness back up.
